Request for Expression of Interest – Former New Jersey School of Conservation Building Complex

2021 REGULAR INSPECTION REPORT

SKELLINGER DAM

(NJDEP File No. 22-113)

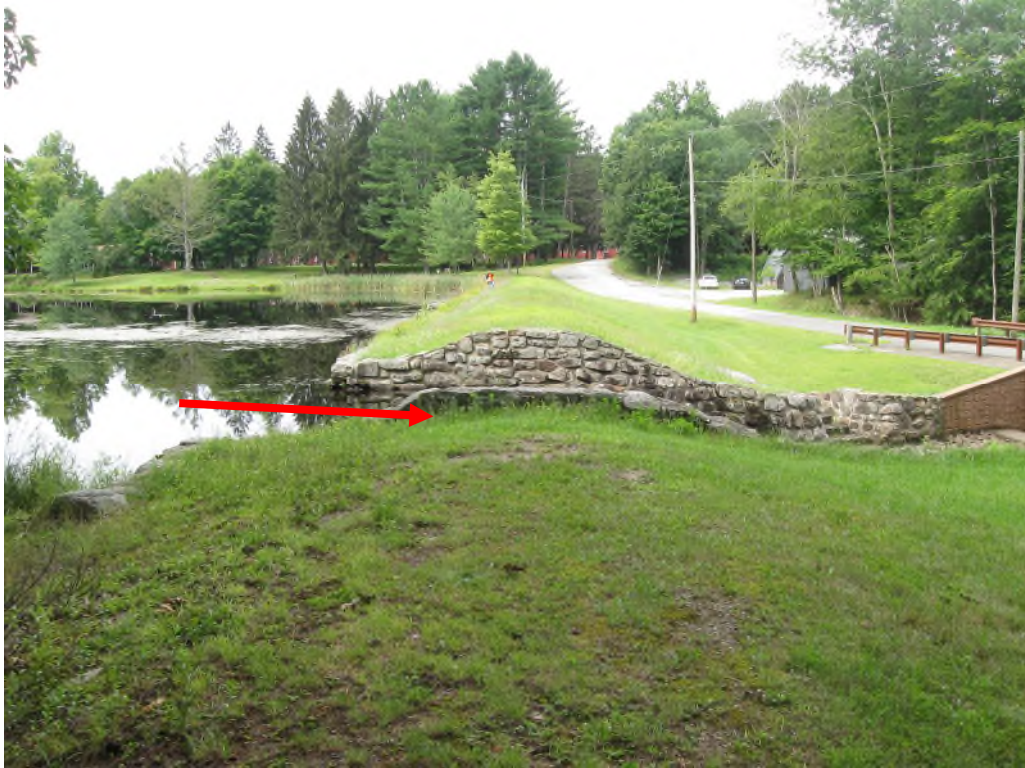
**Photo No. 1: Right side crest of the dam looking left toward the spillway.
Note the sparse grass cover on the crest and the low area
adjacent to the right training wall.**

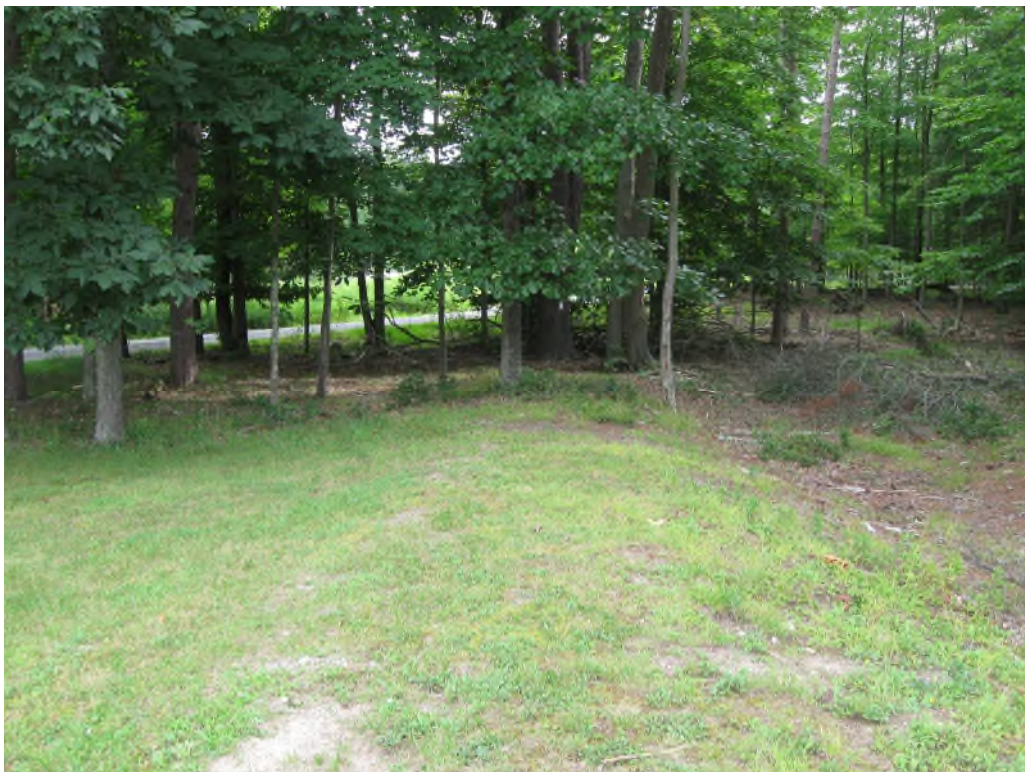
**Photo No. 2: Right side crest of the dam looking toward the right abutment.
Note the sparse grass cover on the crest.**

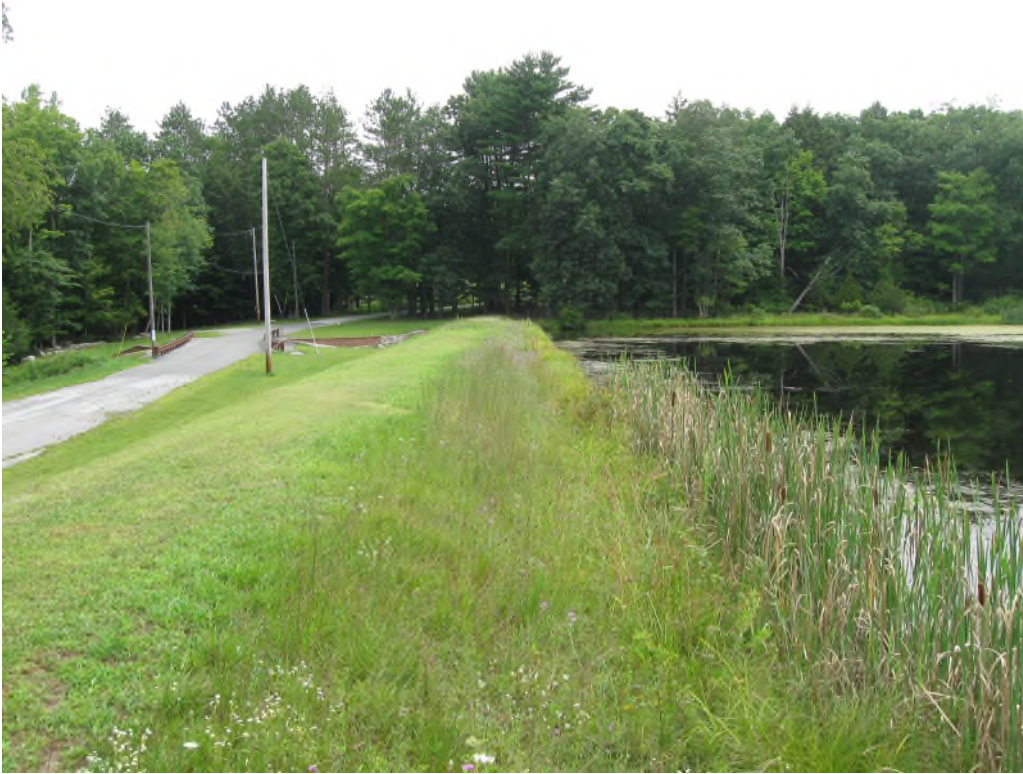
Phragmites and cattails were observed along the water's edge approaching the left abutment. The start of possible burrows were observed at a few locations near the top of slope on the left side near the center of the dam.

**Photo No. 7: Left side upstream slope of the dam looking right.
Note the tall vegetation on the slope.**

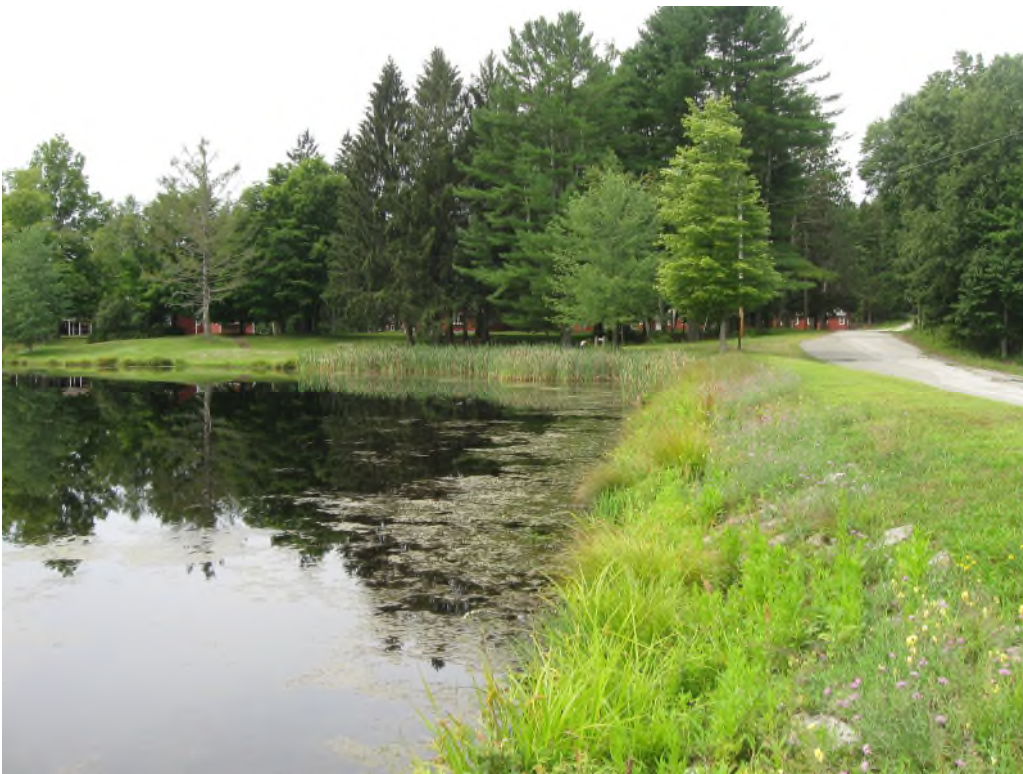
**Photo No. 8: Left side upstream slope of the dam looking left.
Note the tall vegetation on the slope.**

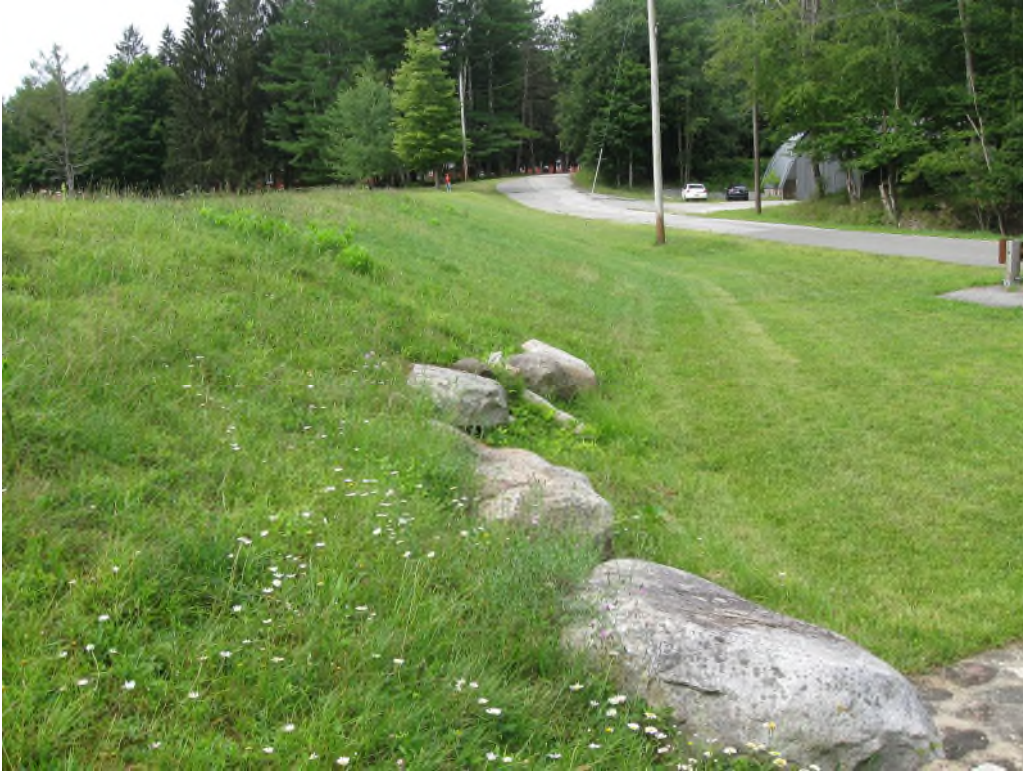
**Photo No. 11: Left side upper downstream slope of the dam looking left.
Note the large rocks along the bottom of the slope.**

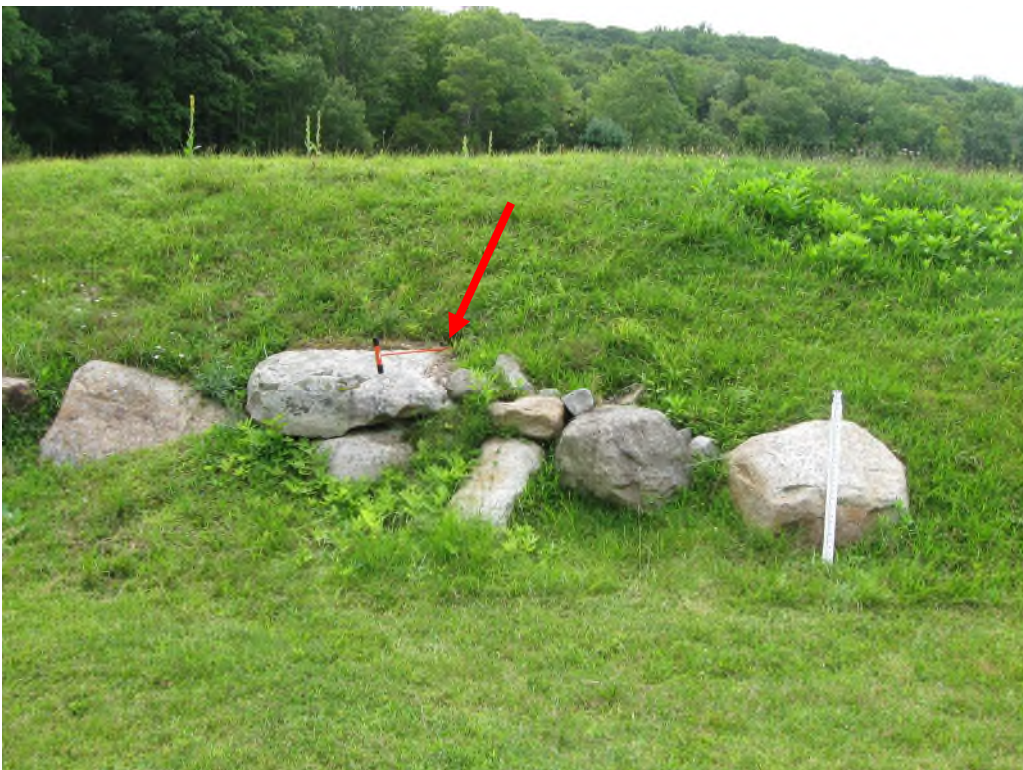
Trees, Undesirable Growth or Debris, Animal Burrows: Grass appeared well maintained along the upper slope. Most of the exposed stumps and roots previously observed throughout the upper slope on the left side were cleared and grubbed during the 2018 repair work. Minor rutting and area of sparse grass were observed on the far left side near the left abutment. The start of a burrow at the top of slope on the far left side was observed. One animal burrow was observed in left side upper slope above a large rock about 20 feet left of the spillway.

**Photo No. 12: Closeup of large rocks along the left side upper
downstream slope. Note the burrow hole above the rock.**

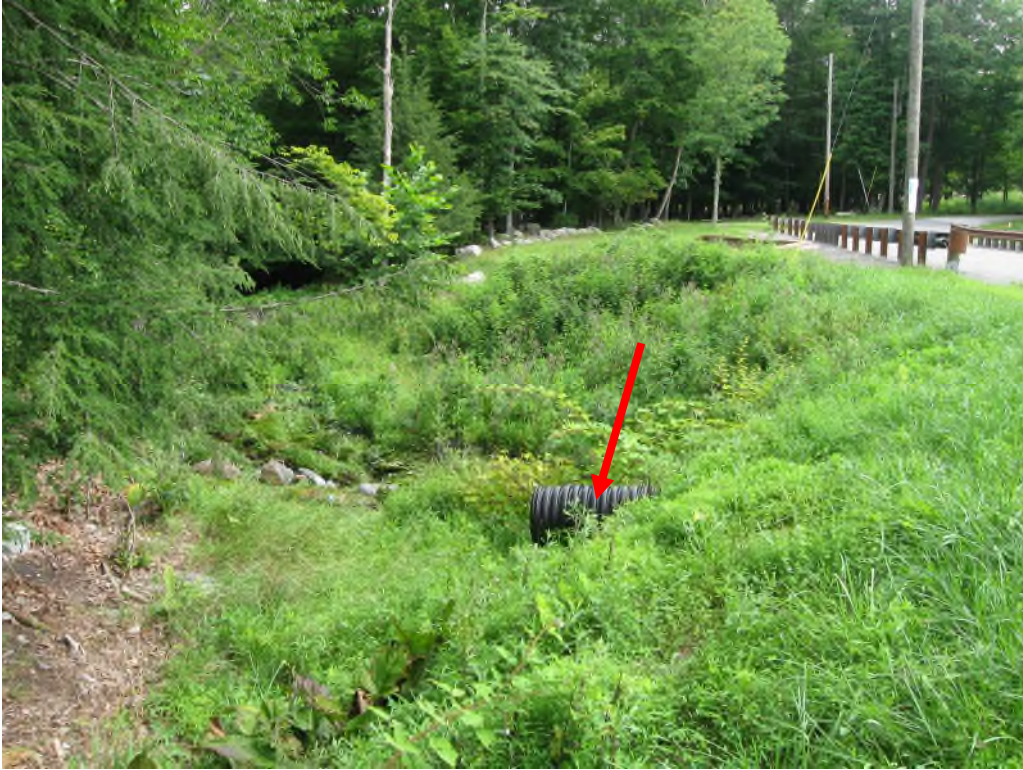
Lower slope on the left side was overgrown with tall, thick weedy/woody vegetation. Minor weedy/woody vegetation was observed growing within the large boulders and rocks along the right bank of the exit channel.

12-inch diameter HDPE roadway storm drainage pipe inlet at the bottom of the upper slope on the left side of the dam under Skellenger Road. Small riprap was observed around the inlet end of the pipe. The pipe discharges through the lower left downstream slope and no headwall was observed.

Photo No. 13: Left side lower downstream slope of the dam looking right.
Note the overgrown conditions throughout the slope. Note the storm drain discharge pipe through the slope.

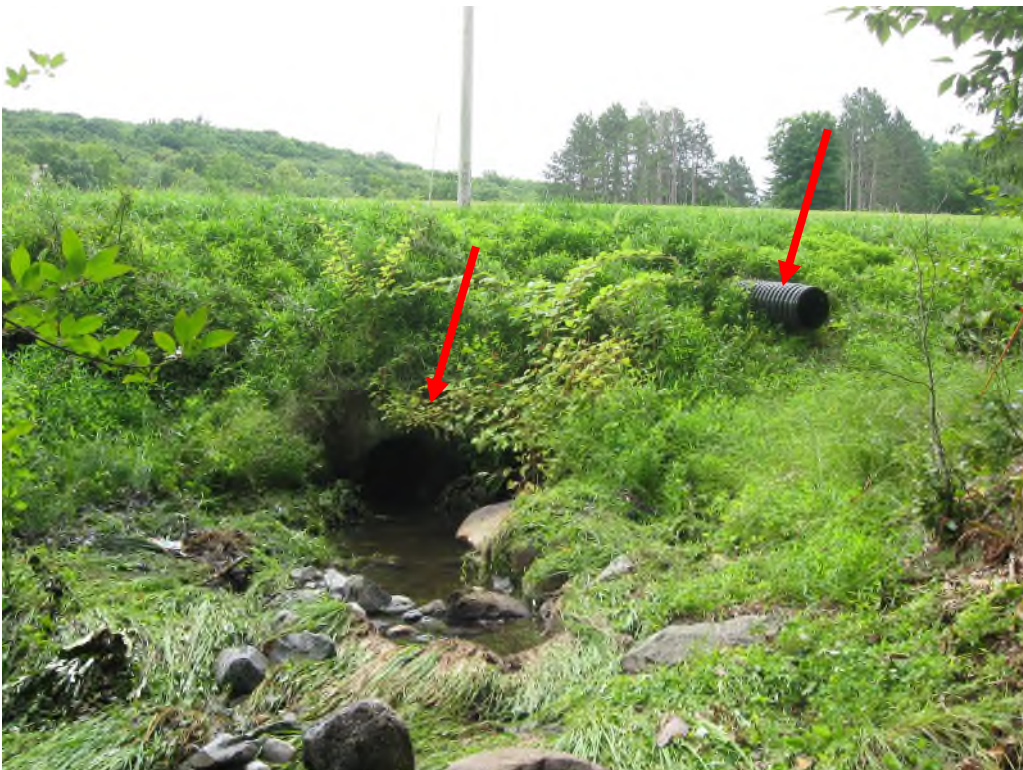
Condition around Outlet Structure: The low level outlet discharges through the left side lower slope downstream of Skellenger Road. The area around the outlet appeared stable but was difficult to observe due to overgrown conditions.

Photo No. 14: Left side lower downstream slope looking upstream at the storm drain discharge pipe and the low level outlet headwall.
Note the overgrown conditions on the slope.

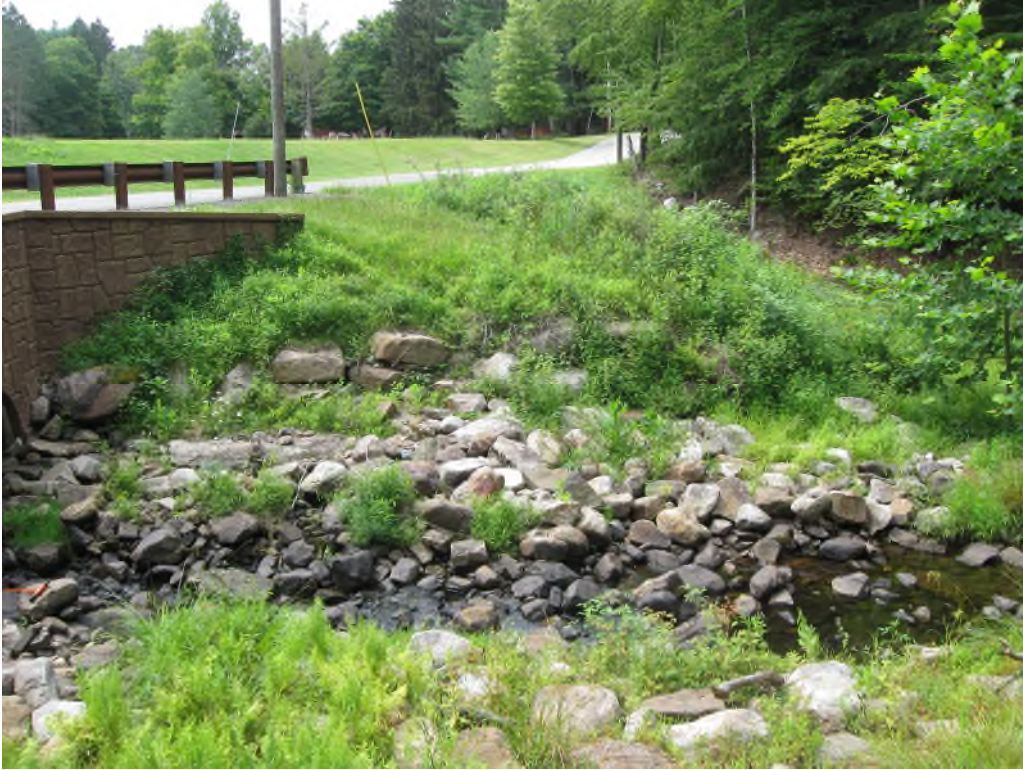
Seepage: None observed along the right and left upper slopes or right side lower slope. Unable to properly observe left side lower slope due to overgrown conditions.

**Photo No. 17: Left side lower downstream toe of the dam looking left.
Note the overgrown conditions throughout the toe area.**

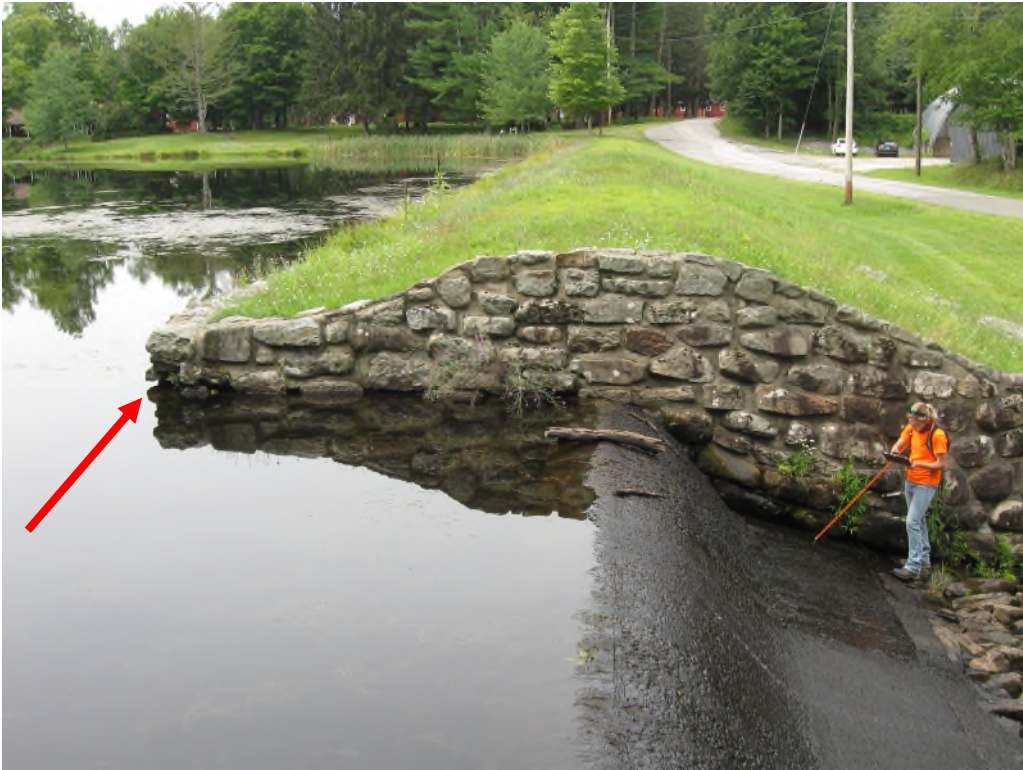
- Condition of Material:** Rock masonry walls appeared generally intact and stable. Minor deterioration was observed at the perpendicular return of the upstream right and left side walls. Specifically, a few loose and displaced stones were observed in the return of the right side wall. A few displaced stones were also observed in the return of the left side wall at the water line. The condition of the upstream walls appeared similar to the 2019 inspection.

Photo No. 19: Spillway weir and entrance channel looking toward the left training wall. Note the missing stones in the upstream return of the left training wall.

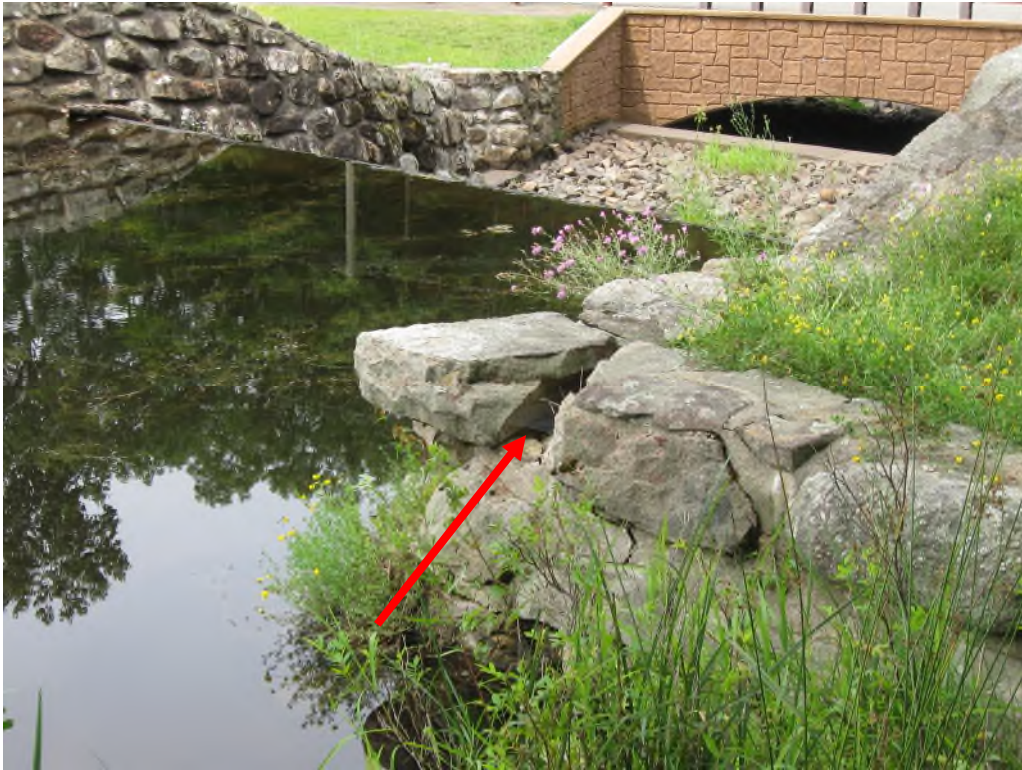
- Signs of Movement:** Localized horizontal displacement of the upstream rock masonry wall was observed at the perpendicular return of the right side wall. Displacement was measured to be approximately 5 inches during this inspection. This condition was observed during previous inspections and appeared similar to the 2019 inspection.

Photo No. 21: Closeup of the horizontal displacement of the upstream right rock masonry wall. Note that one of the stones was dislodged.

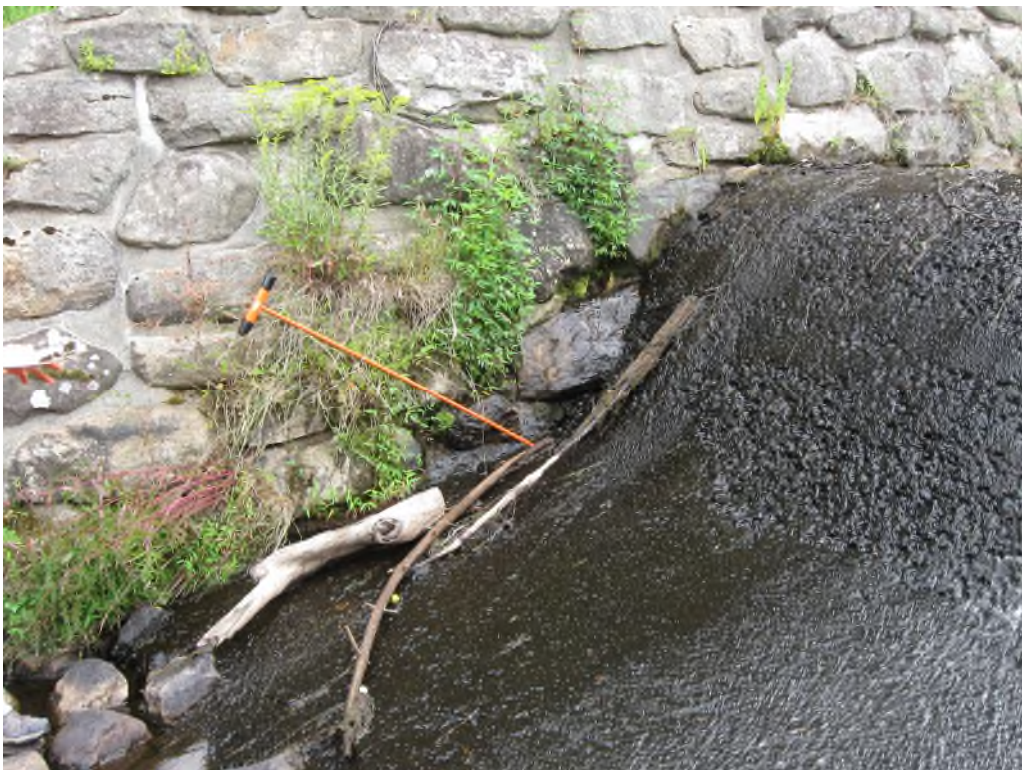
- Joints:** None observed. Contacts between older rock masonry walls and the newer concrete walls appeared in good condition.
- Leakage:** Similar to the 2017 and 2019 inspections, minor leakage was observed from the right masonry wall at the contact with the downstream face of the spillway. Leakage appeared clear and was estimated at less than 1 gpm during this inspection. Leakage was also observed along the left rock masonry wall at the contact with the left training wall.

Photo No. 22: Right side rock masonry spillway training wall at the contact with the spillway. Note that minor leakage was observed through the wall at the contact with the spillway.

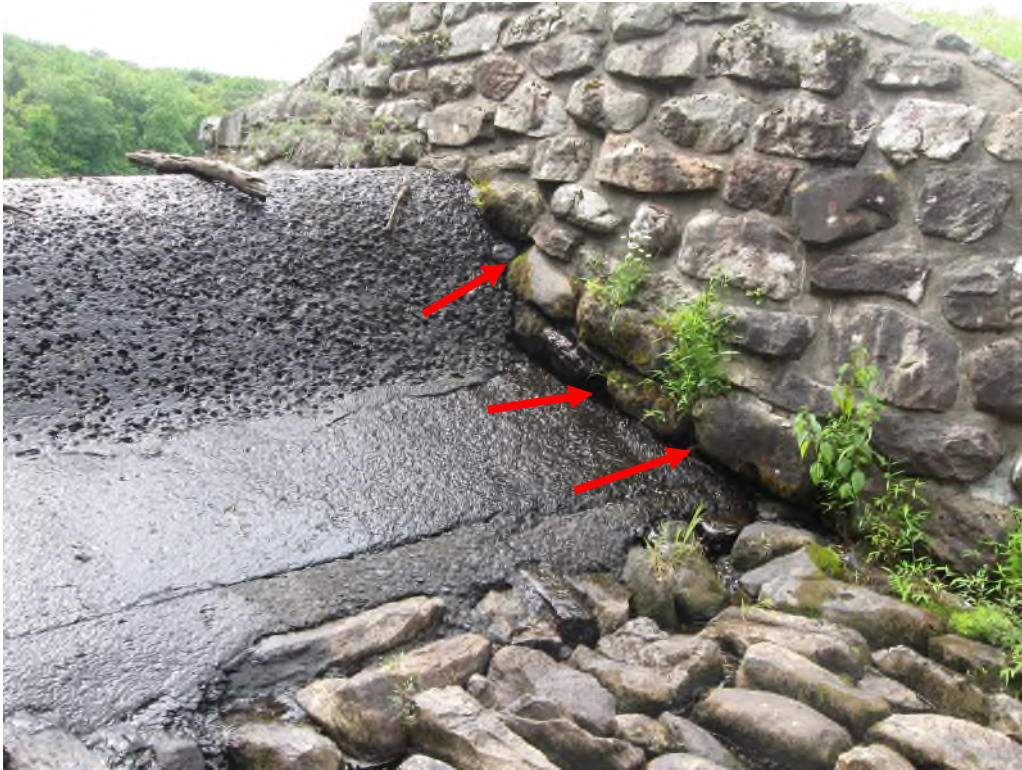
- Drains:** None observed.
- Unusual Conditions:** Undermining was observed along the base of the left masonry wall at the contact with the spillway. Undermining was measured to be a

maximum depth of about 22 inches. This condition was observed during the 2019 inspection and undermining was slightly deeper.

**Photo No. 23: Left side rock masonry spillway training wall.
Note that undermining has occurred along the base of the wall.**

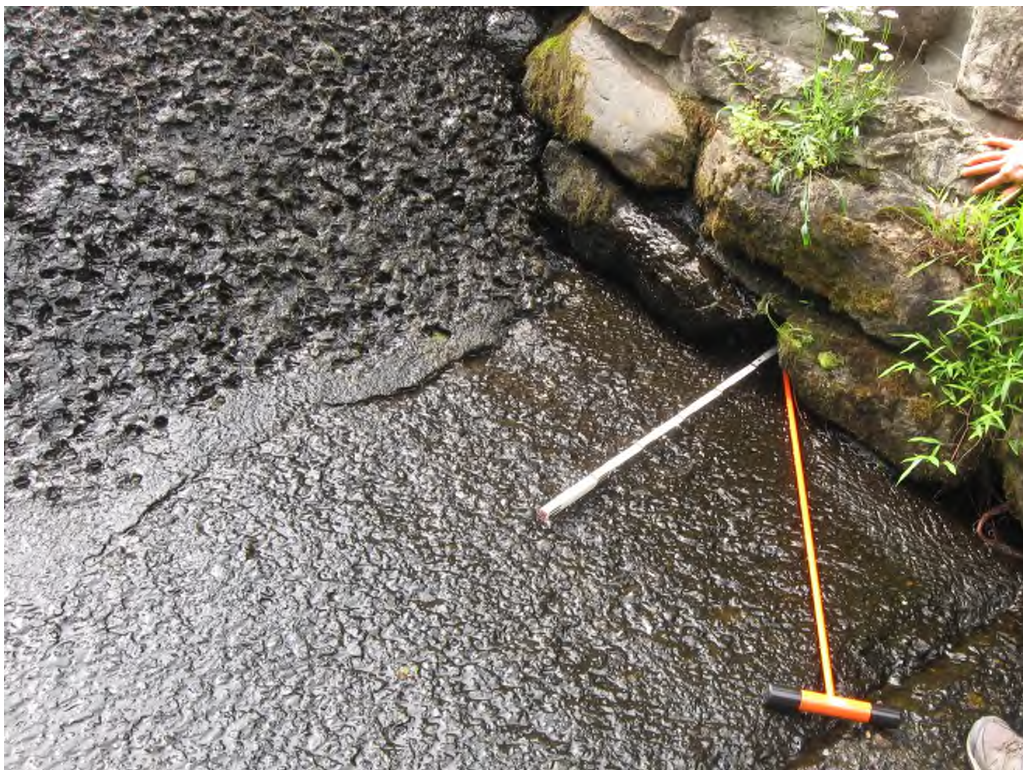
**Photo No. 24: Closeup of the undermining along the base of the
left side rock masonry spillway training wall.**

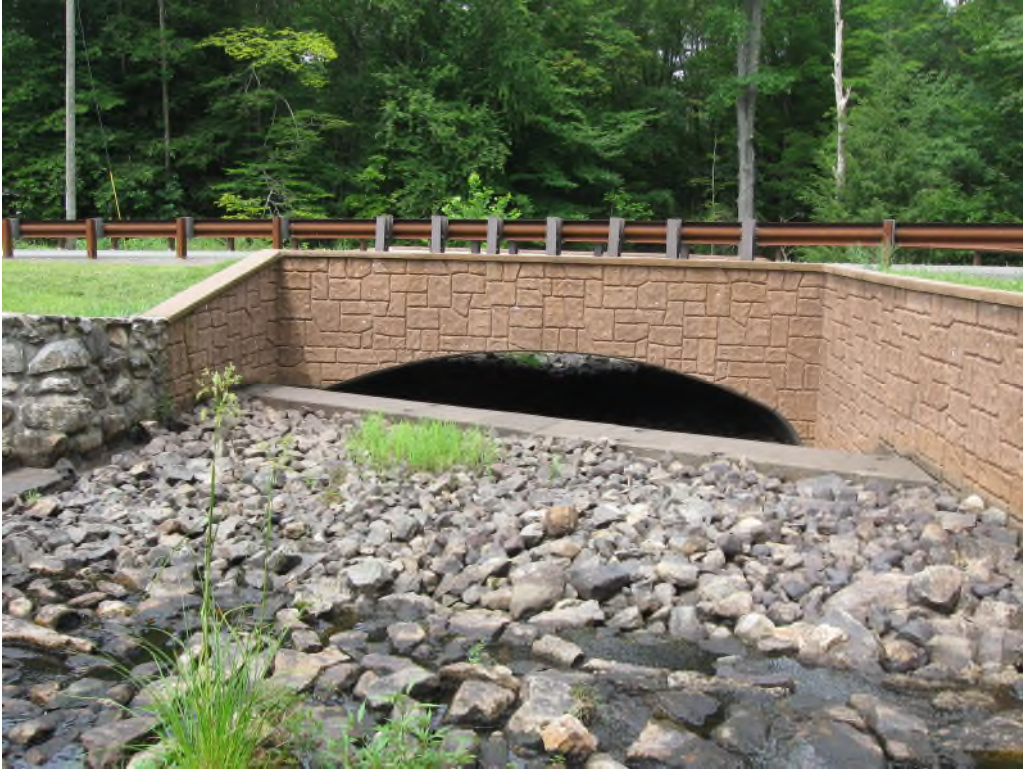
- Unusual Conditions:** Minor woody debris and weedy vegetation observed throughout the riprap apron.

**Photo No. 25: Looking downstream at the downstream riprap apron.
Note the vegetation within the apron.**

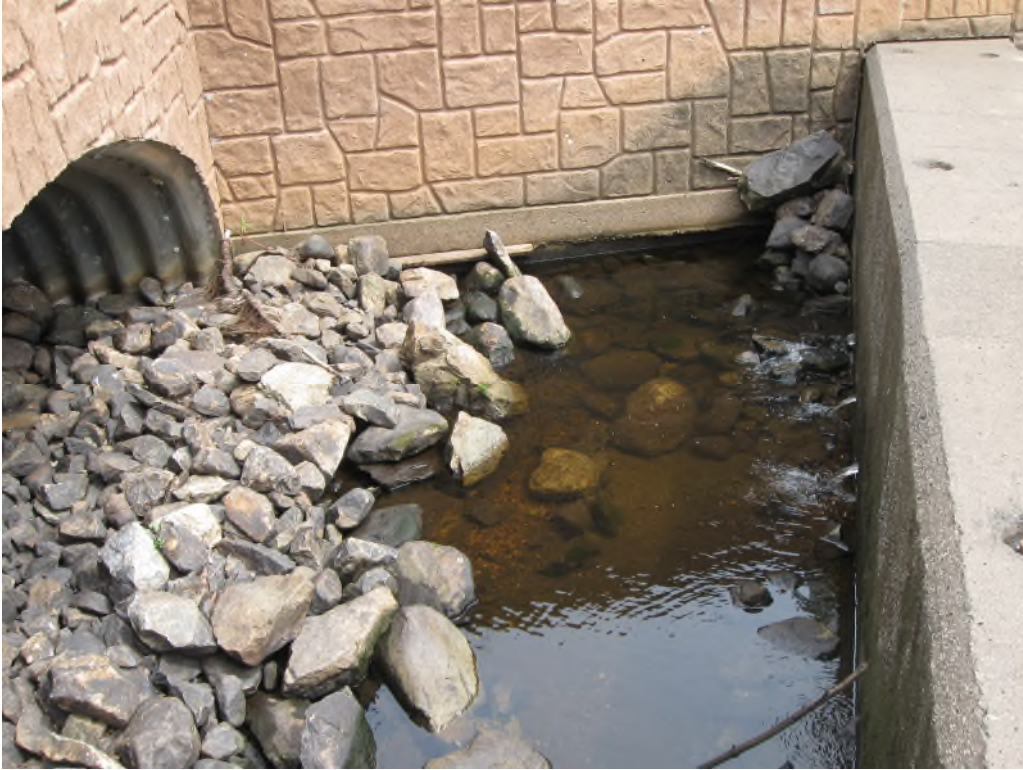
- Signs of Movement:** Some minor displacement of loose riprap was observed upstream of the concrete step. A scour hole (approx. 1 foot deep and maximum of 6 feet wide) was observed between the concrete step and the downstream culvert. Conditions appeared similar to the 2017 and 2019 inspections.

Photo No. 27: Transition area between the concrete step and the discharge culvert looking right. Note the scour hole in this area.

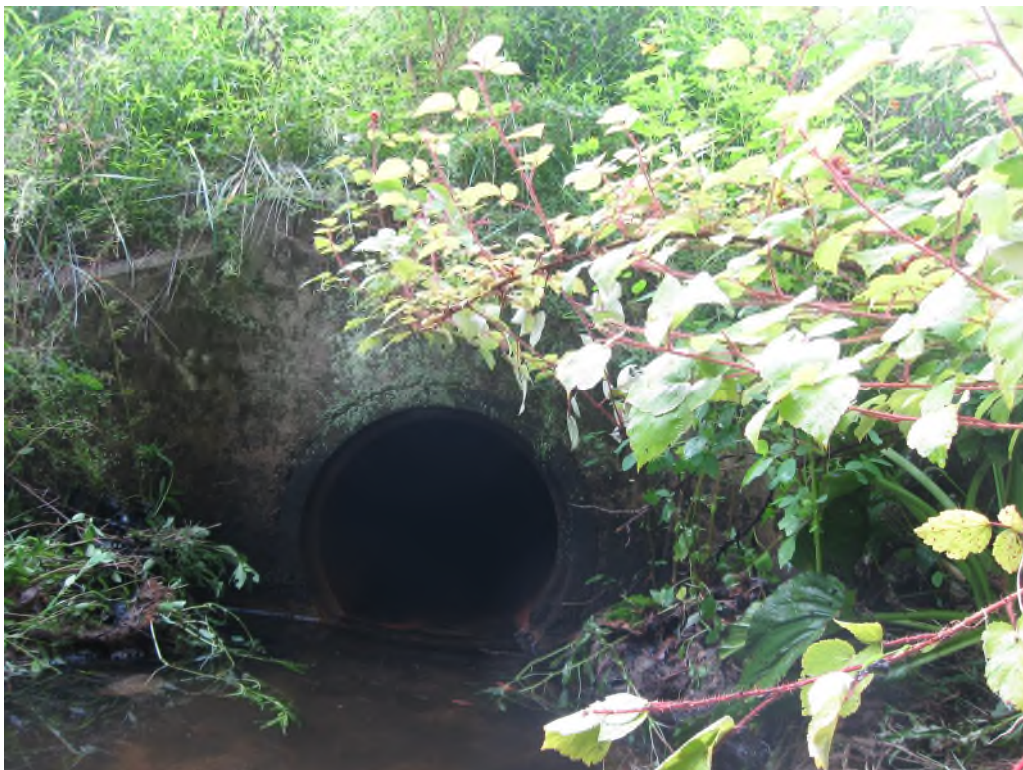
Trash Rack:	New galvanized steel trash rack installed during the 2018 repair work.
Leakage:	Outlet pipe did not appear to be leaking, but toe area does not drain well and the pipe was slightly submerged with standing water. Leakage was not observed prior to operation, but minor dripping was audible after operation.

Photo No. 32: Closeup of the 24-inch diameter low level outlet discharge pipe and headwall. Note the thick vegetation surrounding the headwall and the standing water downstream of the pipe.

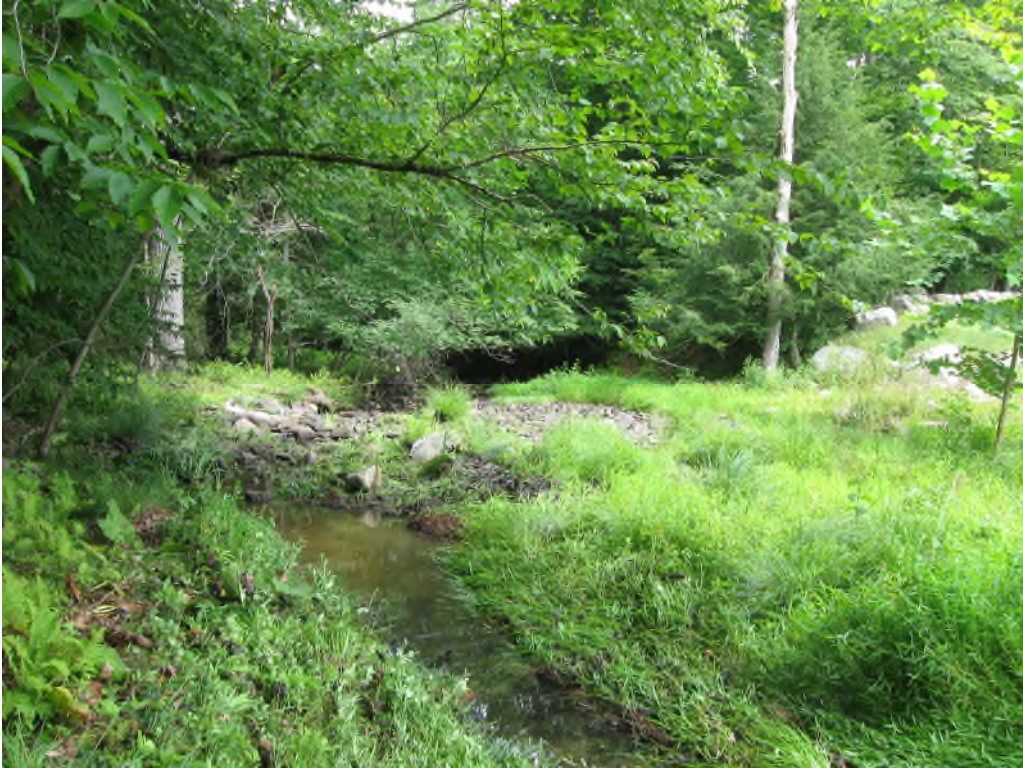
Unusual Conditions:	Portions of the low level outlet channel are too low to drain to spillway exit channel.
Was the Low Level Outlet operated during the inspection?	Yes, the sluice gate was 100-percent opened and closed.
Were there difficulties operating the Low Level Outlet?	No problems were reported.
When was the Low Level Outlet last operated and did this conform with the Operation and Maintenance procedures?	The low level outlet sluice gate was replaced and exercised during the 2018 repair work. It is unknown if the valve was exercised since then because the prior Operator (New Jersey School of Conservation) no longer occupies the property.
Miscellaneous:	Level indicator on the operator stem became dislodged during the exercise and needs repair. Operation of the gate was not impacted.

Photo No. 33: Low level outlet exit channel looking downstream. The channel flows toward the spillway exit channel. Note the standing water in the channel from the earlier low level outlet operation.

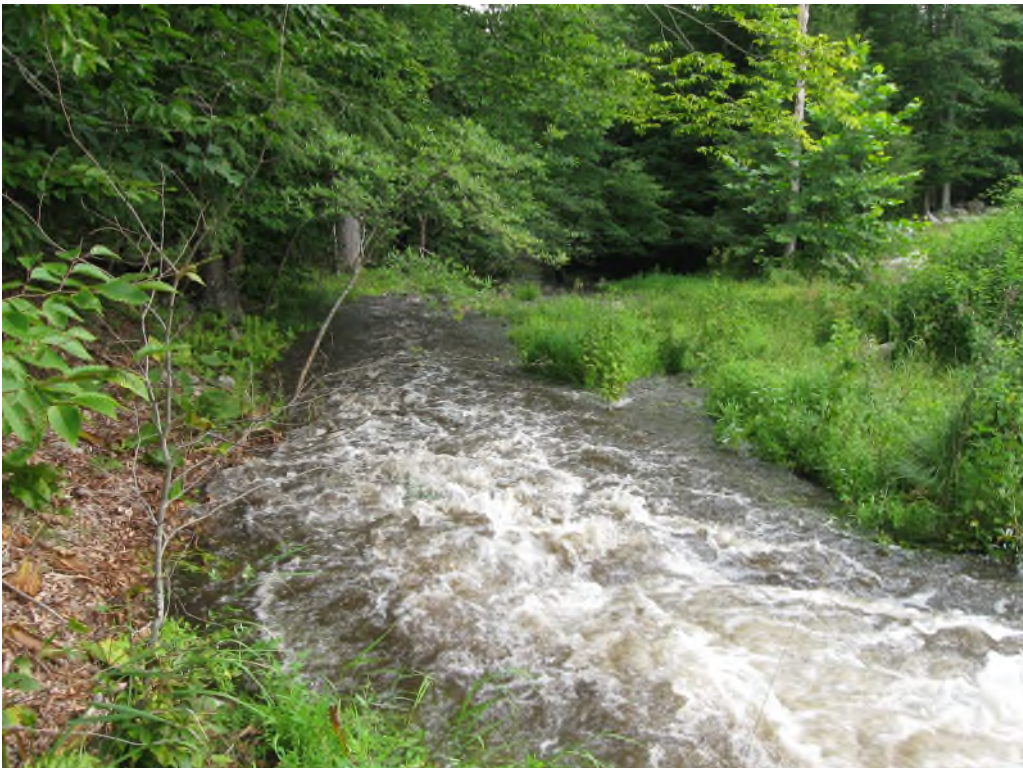
Unusual Conditions: The exit channel is narrow and shallow and does not have the capacity to pass the full flow from the low level outlet pipe. During the low level outlet operation, the flow was observed spreading across an area about 20 feet wide, beyond the limits of the channel. Minor scouring of the rock channel bottom was observed 10 to 15 feet downstream of the outlet.

Photo No. 34: Low level outlet exit channel looking downstream during operation of the low level outlet. Note that the exit channel is narrow and shallow and does not have the capacity to pass the full flow from the low level outlet pipe.
