# Proposed Natural Resource Restoration Settlement: Ciba-Geigy Superfund Site, Toms River, N.J.

March 13, 2023

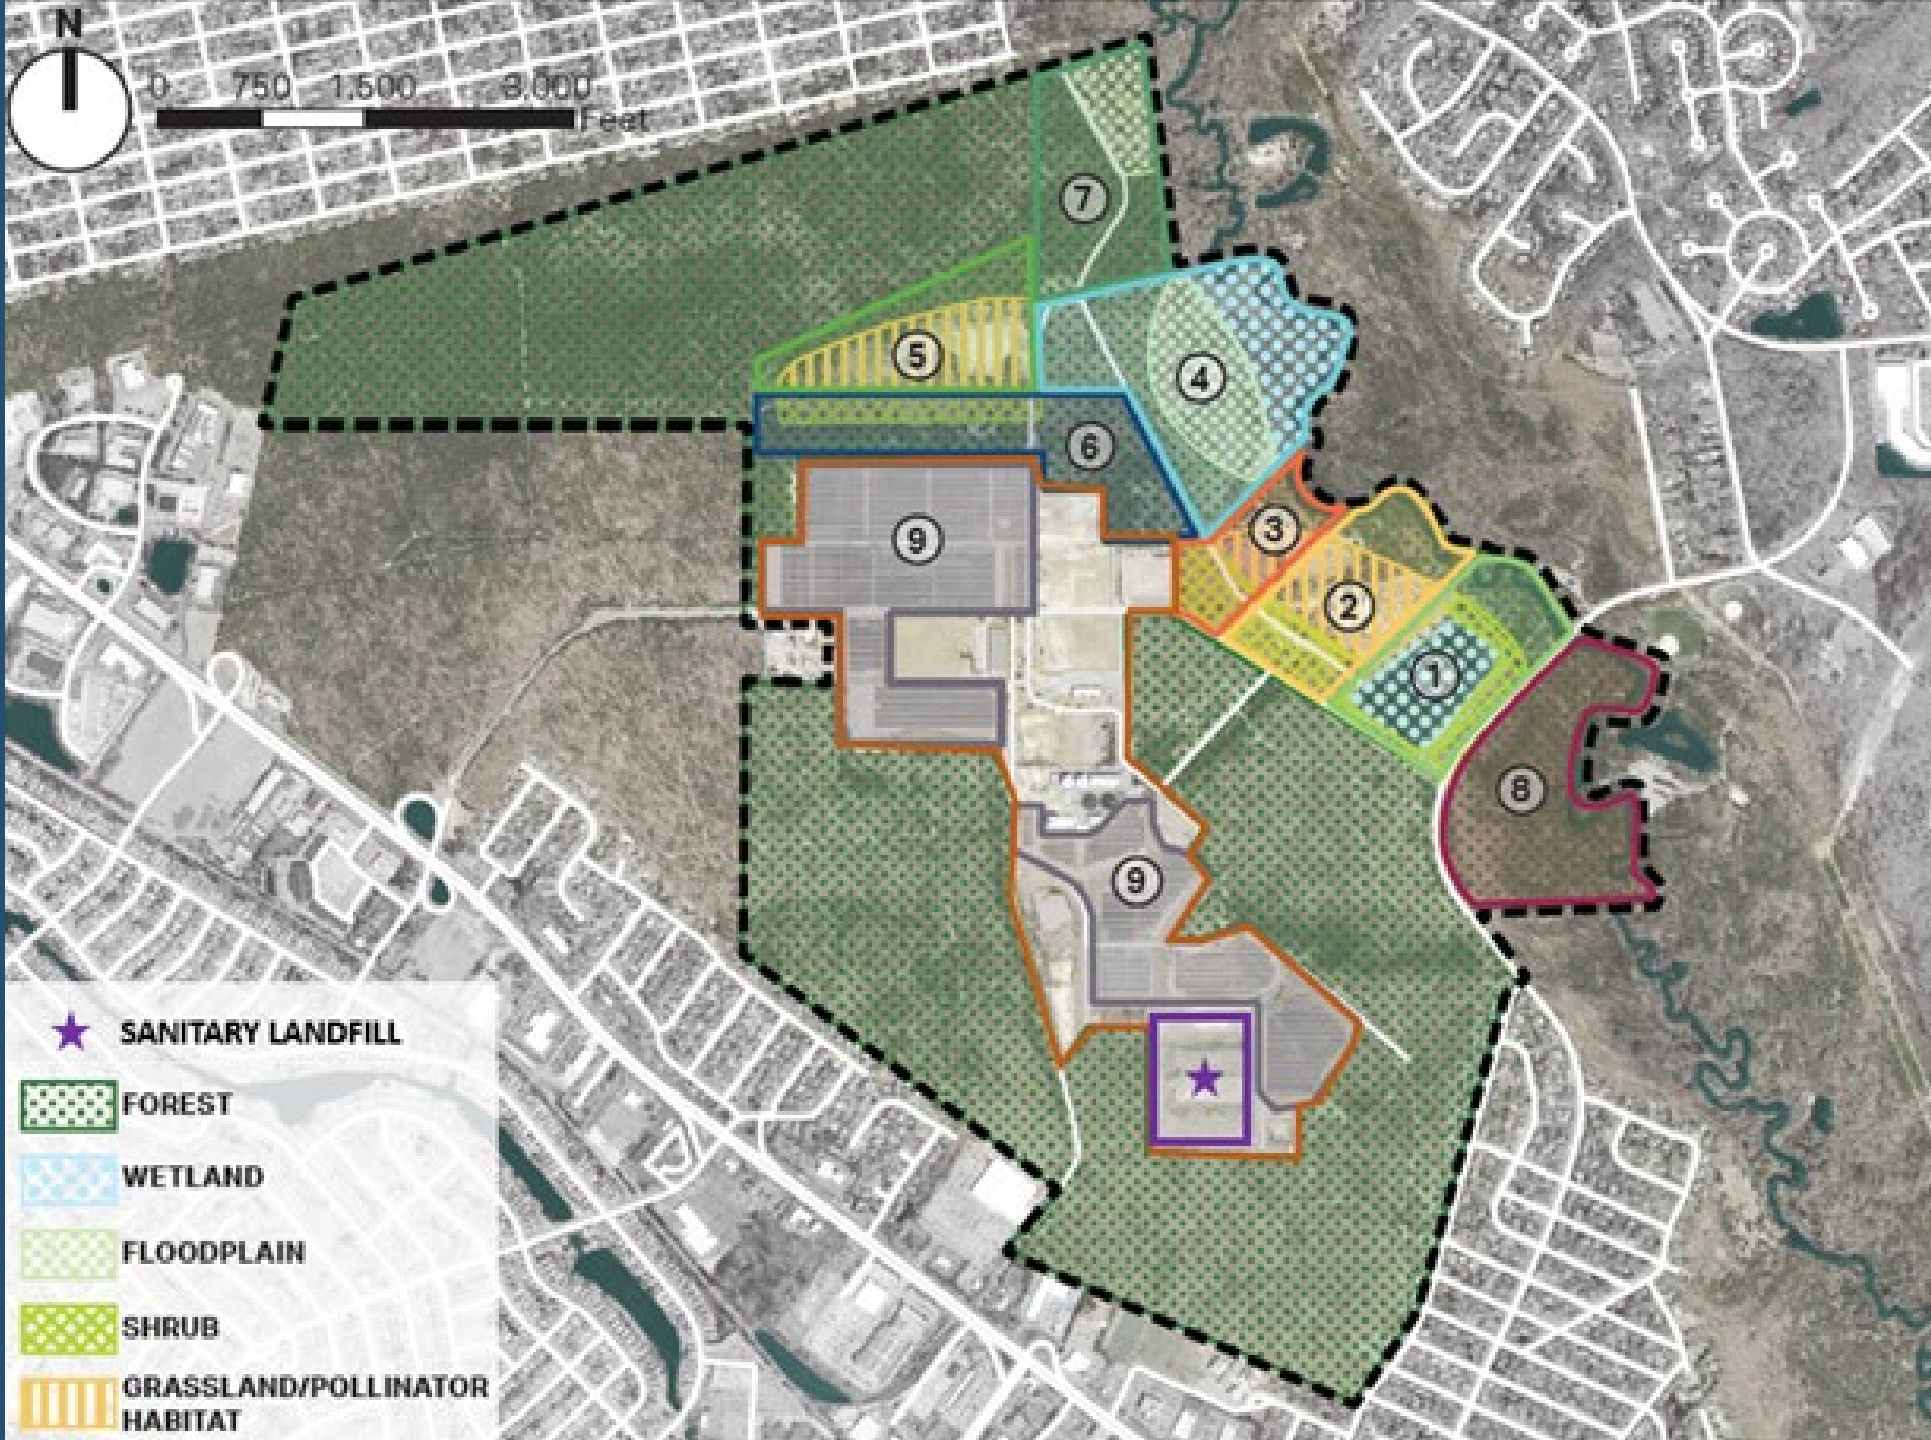
**SANITARY LANDFILL**

**FOREST**

**WETLAND**

**FLOODPLAIN**

**SHRUB**

**GRASSLAND/POLLINATOR  
HABITAT**

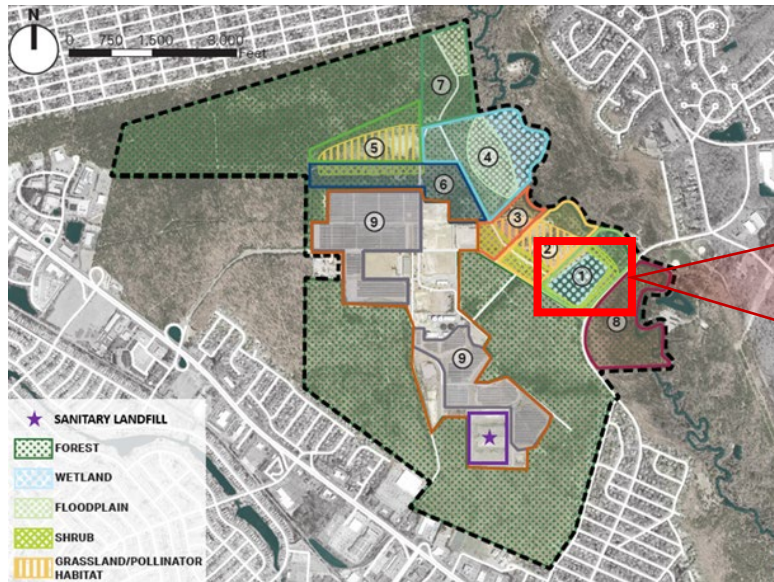
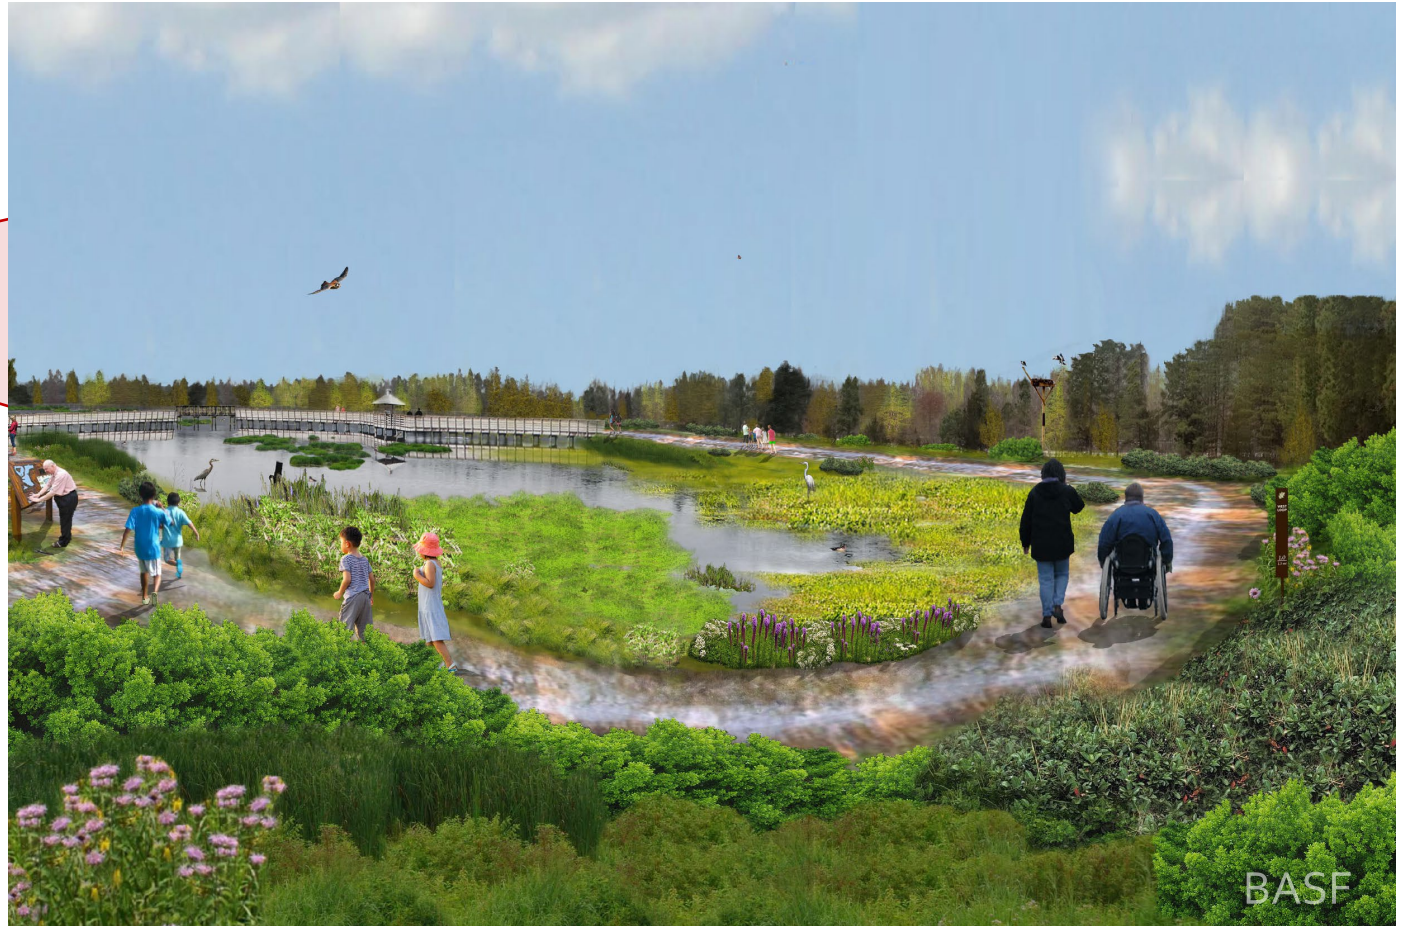
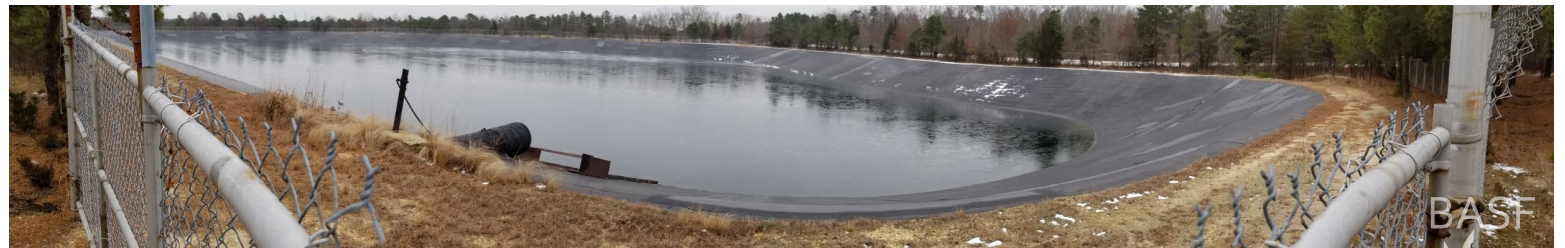
## 1. Perched Wetland/Pond Wooded Buffer

~25 acres of uplift

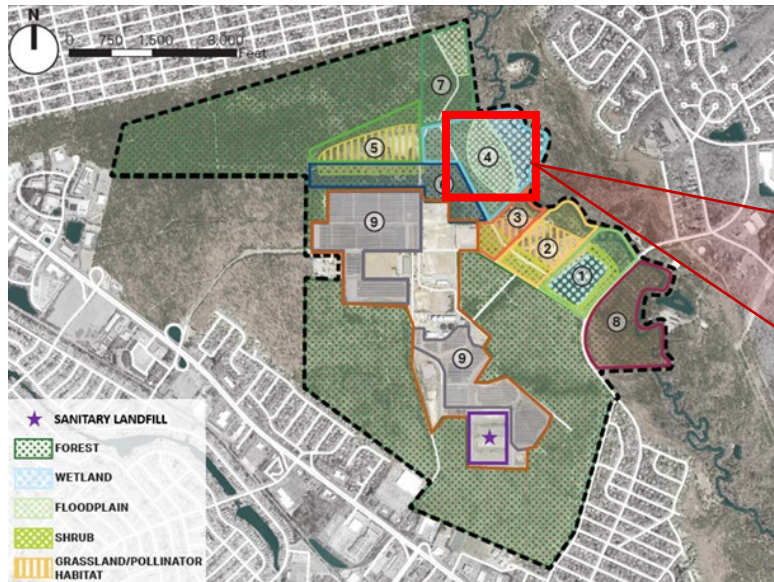
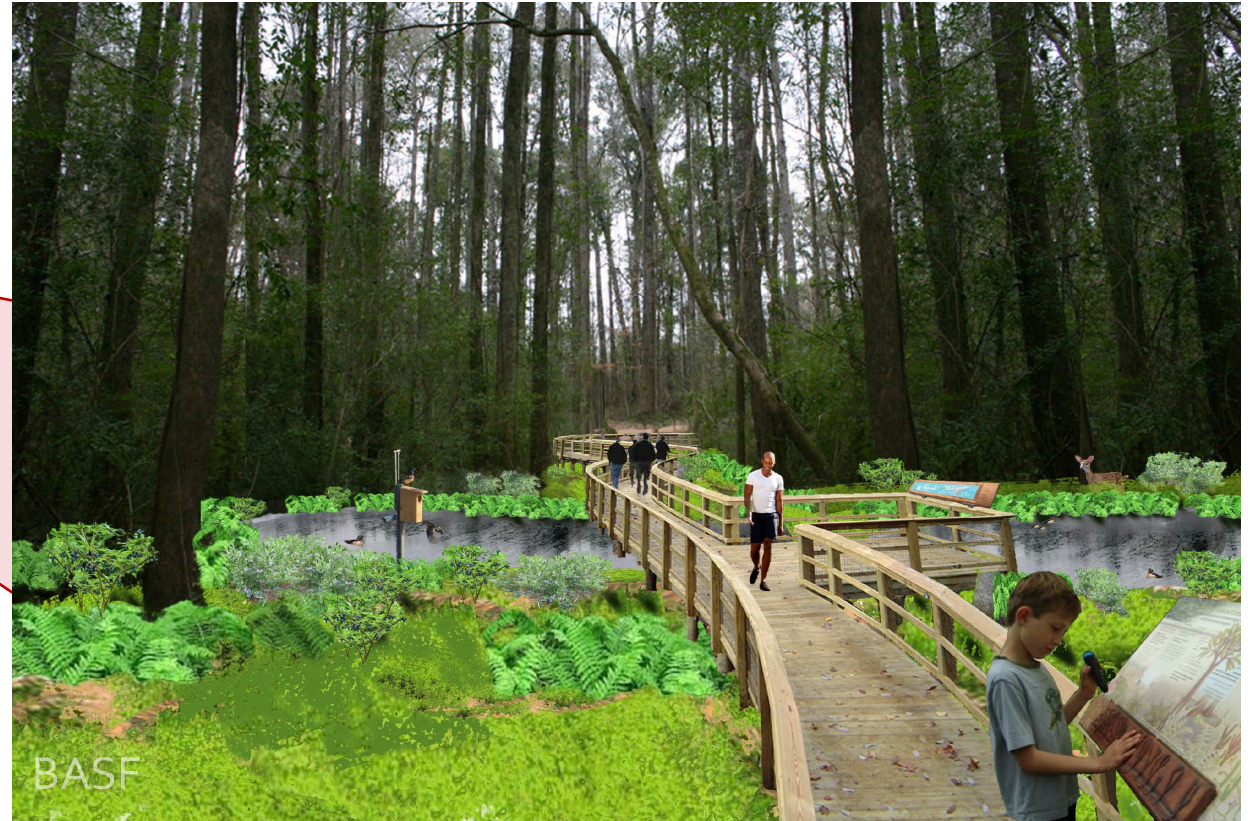
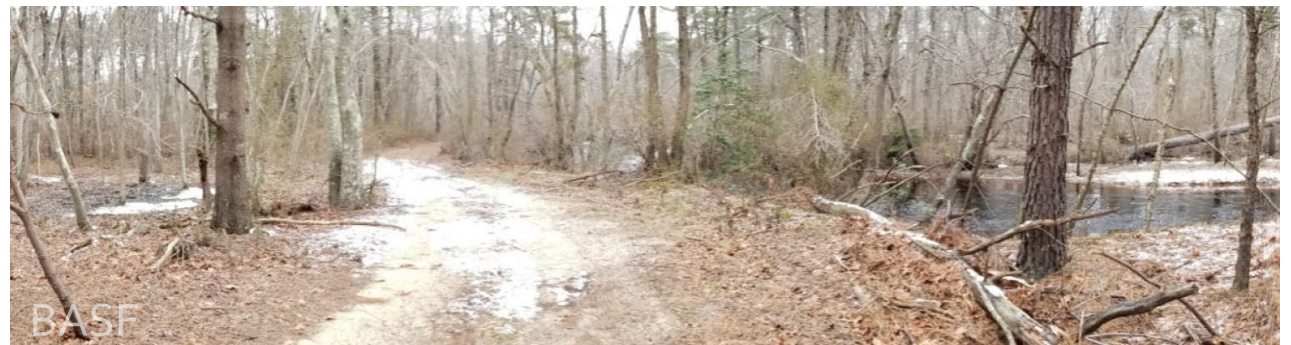
## 4. Floodplain/ Wetland Enhancement

~27 acres of uplift

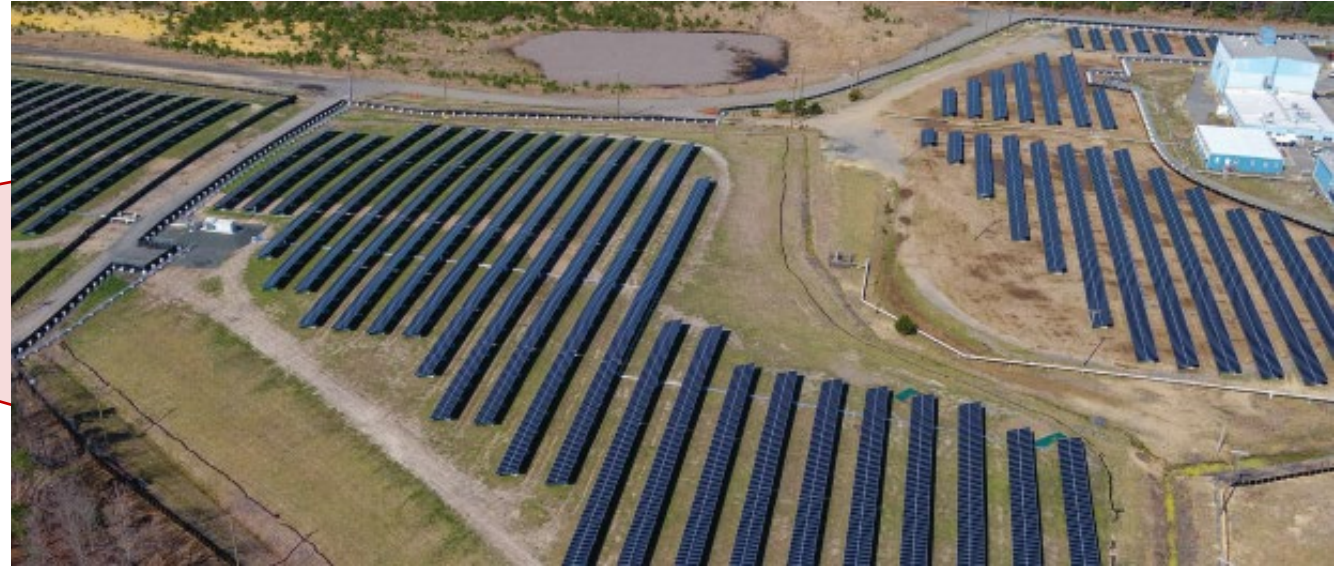
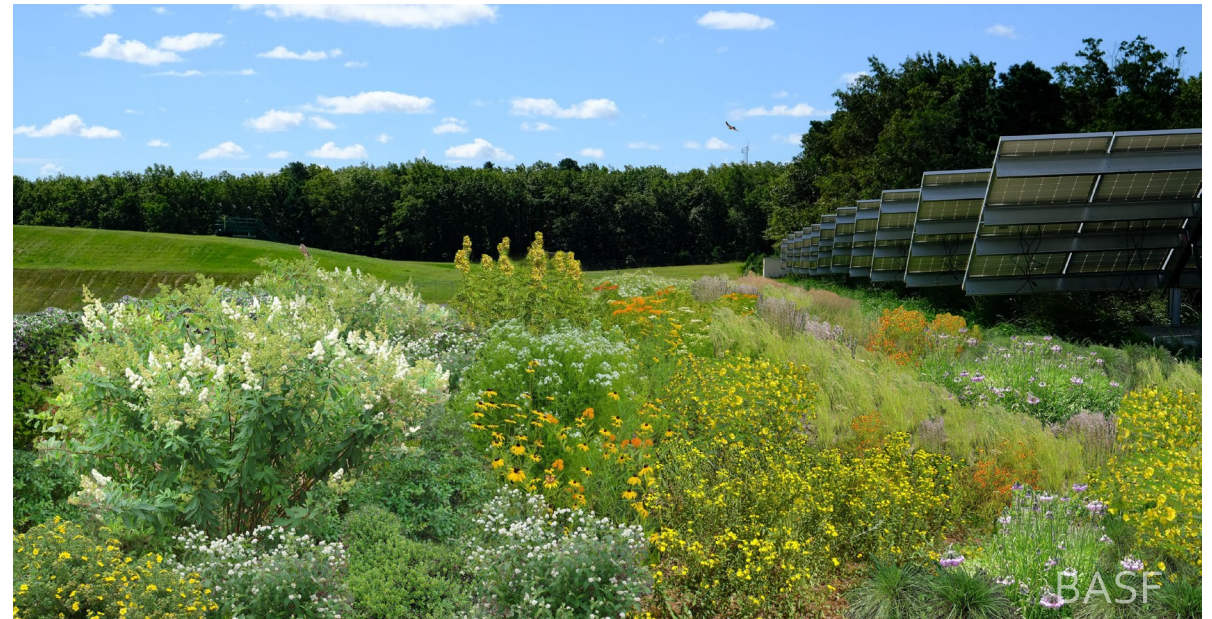
## 9. Uplifted Grassland/ Pollinator Habitat/ Solar Array

~120 acres of uplift
