New Jersey Department of Environmental Protection Water Monitoring & Standards Land Use Management Post Office Box 409, Trenton

SANITARY SURVEY MANASQUAN RIVER

October 1, 1994 – September 30, 2005 February 2007

Water Monitoring Report Prepared by: Tracy Kirwan

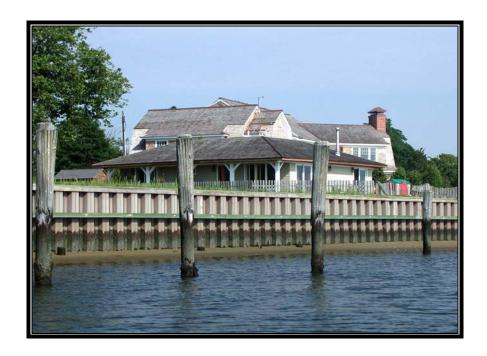
The survey shows some shoreline new/repaired sections of bulkheading along the Manasquan River (see Figure 7). Beach and shallow water habitats are taken away from birds and other creatures bulkheads when are constructed. Additionally, bulkheading is often made of pressure-treated wood, which harbors many harmful chemicals, like arsenic, chromium, and copper. However, there are new bulkheads, which are not made of pressure treated wood, but plastic. Not all of the long-term effects of the plastic bulkheading have been determined (i.e. ability for mussel attachment) (Lampo, 1999).

FIGURE 7: NEW BULKHEADING, THE WOODEN POLES ARE REMNANTS OF THE OLD BULKHEAD

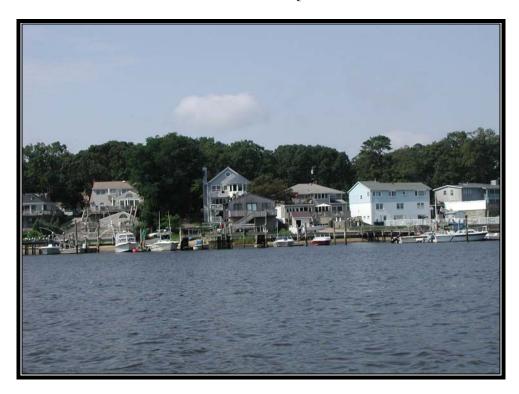
FIGURE 9: RESIDENTIAL HOUSING ON THE MANASQUAN RIVER

The majority of land use surrounding the Manasquan River is urban (see Figure 8). Much of the Manasquan coastline is residential housing, with commercial sections near the inlet. The residential homes often have one or more boats on a private dock; some residences even fit within the definition of a marina, having the ability to support 5 or more boats (see Figure 9). Commercial land use is common around the inlet where there is a cluster of marinas (see Figure 10).

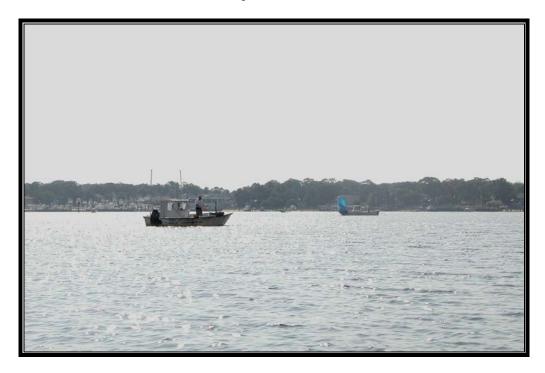
FIGURE 13: CLAMMERS IN THE MANASQUAN RIVER

Overall, the Manasquan is moderately harvested. The Manasquan River is also home to commercial clam boats which harvest shellfish from ocean waters (see Figures 13 & 14).

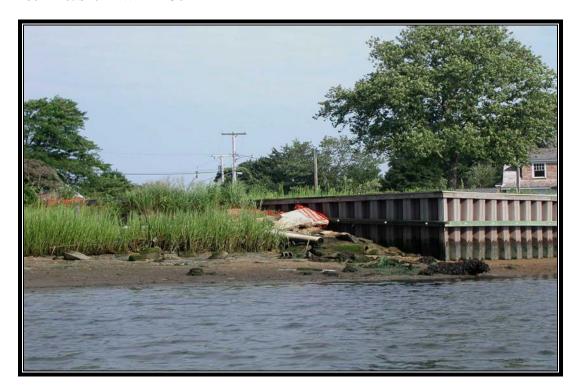
FIGURE 16: STORM WATER OUTFALL

outfalls are mostly found in urban areas, and are especially common within lagoon communities. Although there are no lagoons in this area, there are areas that resemble lagoons near the Glimmer Glass section and the Manasquan Inlet (see Figure 17). Lagoon stormwater discharges are especially harmful because lagoons see little tidal flushing, heavy boat usage, and high quantities of bulkheading.

The Bureau of Marine Water Monitoring conducts stormwater projects to help lessen the effect of stormwater runoff. Water samples are taken during a storm event and the preceding days in order to determine the effect of runoff. Once a possible source of the problem is identified, the appropriate people (usually the municipality/county) are notified to remedy the situation. Currently, there are no stormwater projects planned or ongoing for the Manasquan River.

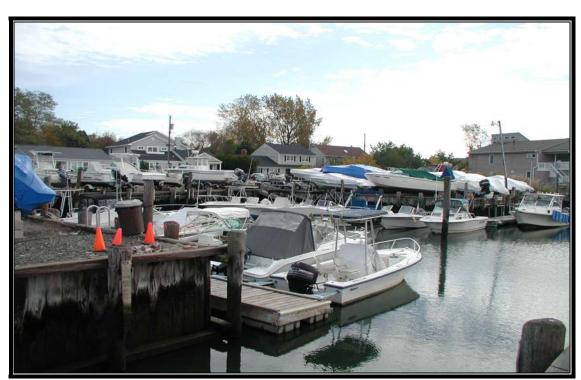
FIGURE 19: MARINA ON THE MANASQUAN RIVER

Boating is a very popular summertime activity within the Manasquan River, and there are also many commercial boats that work year-round. In the Manasquan River there are a total of 38 marinas (see Figures 19 & 20 and Table 4).

In the past, the marinas and boats in this growing area were considered to be a leading contributor to the poor water quality. Since then, many marinas have attempted to improve their practices in order to contribute less pollution. The EPA, with efforts from the Monmouth-Ocean Alliance and the NJDEP, also declared the Manasquan a "No Discharge Zone" in 1998 (USEPA, 1998).

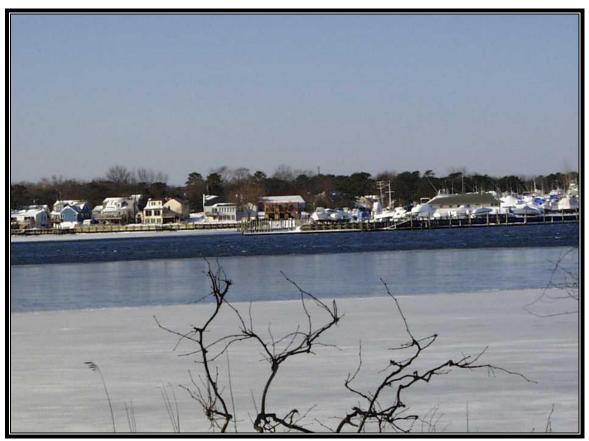
FIGURE 24: WINTERTIME ON THE MANASQUAN RIVER

Twenty-three stations in the Manasquan River growing area exceeded the *Approved* total coliform criteria during the winter months (see Figure 24 for wintertime conditions). However, none

of the sampling stations exceeded the *Special Restricted* criteria, so there is no discrepancy in classification since there are no *Approved* waters in the Manasquan River.
