# THE SECRETARY OF THE INTERIOR'S STANDARDS FOR REHABILITATION &

# ILLUSTRATED GUIDELINES ON **SUSTAINABILITY** FOR REHABILITATING HISTORIC BUILDINGS

U.S. Department of the Interior  
National Park Service  
Technical Preservation Services

2011

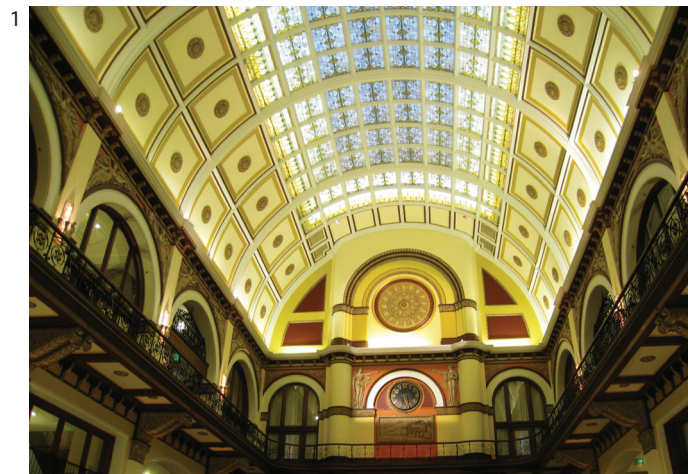
[1] Stained glass skylight provides natural light in a historic train station.

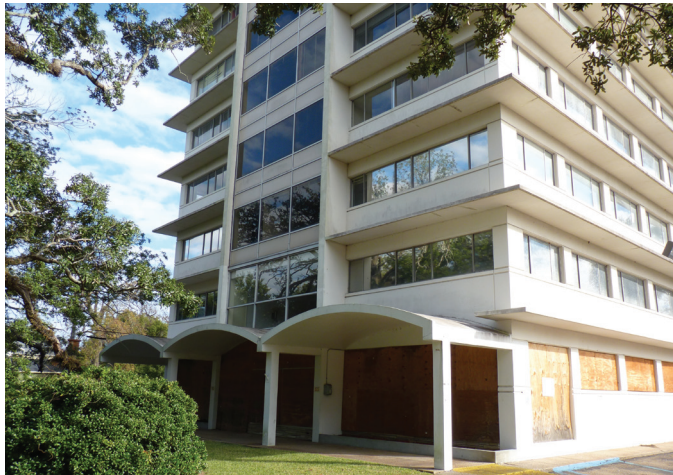
[4] Covered walkways and horizontal sun screens are distinctive and sustainable features in some mid-century modern office buildings.

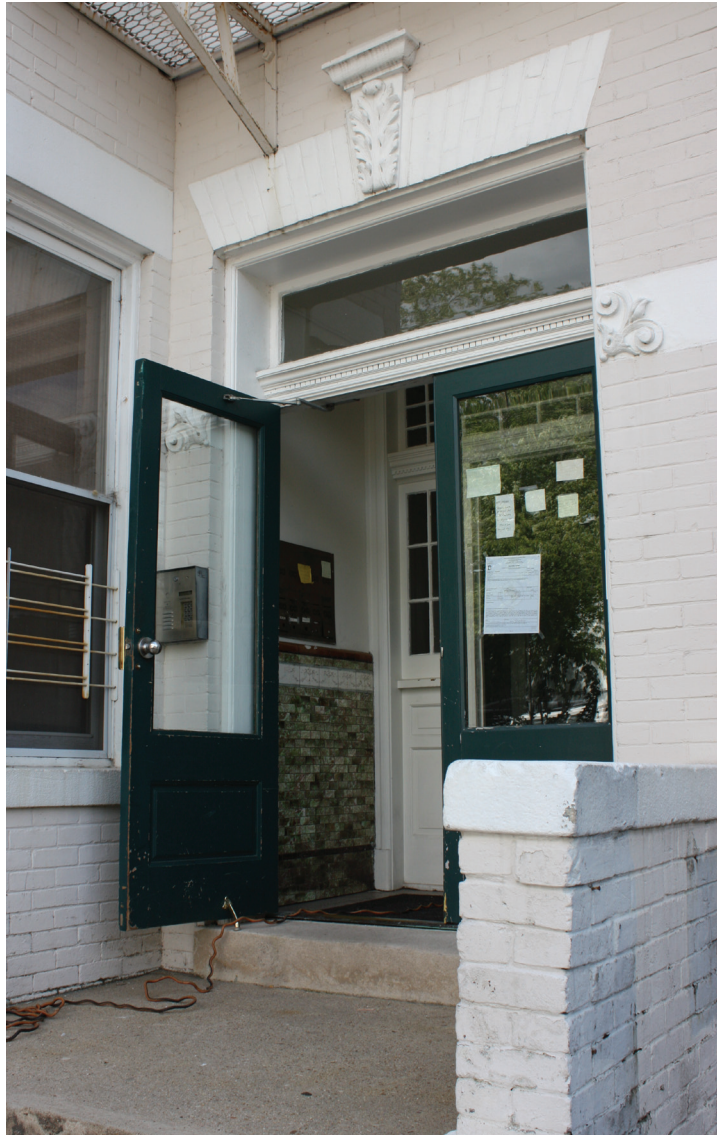
11

[11] A vestibule helps retain interior conditioned air in the living space in this historic row house.

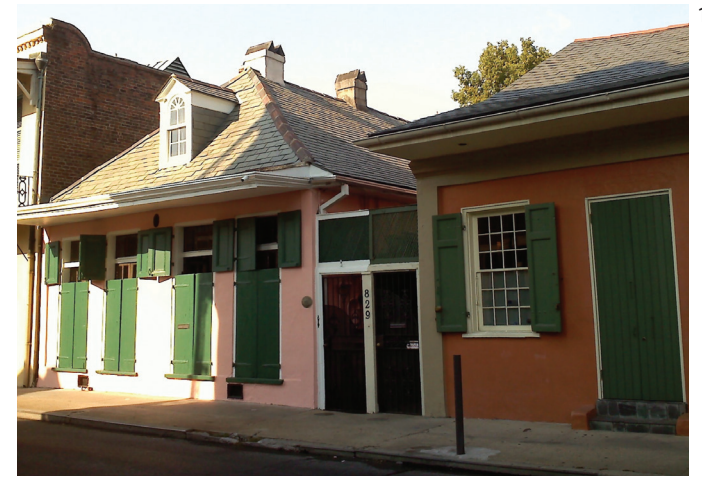
10

[10] Wood shutters provide natural light when open and keep interiors cool when closed in historic residential buildings.

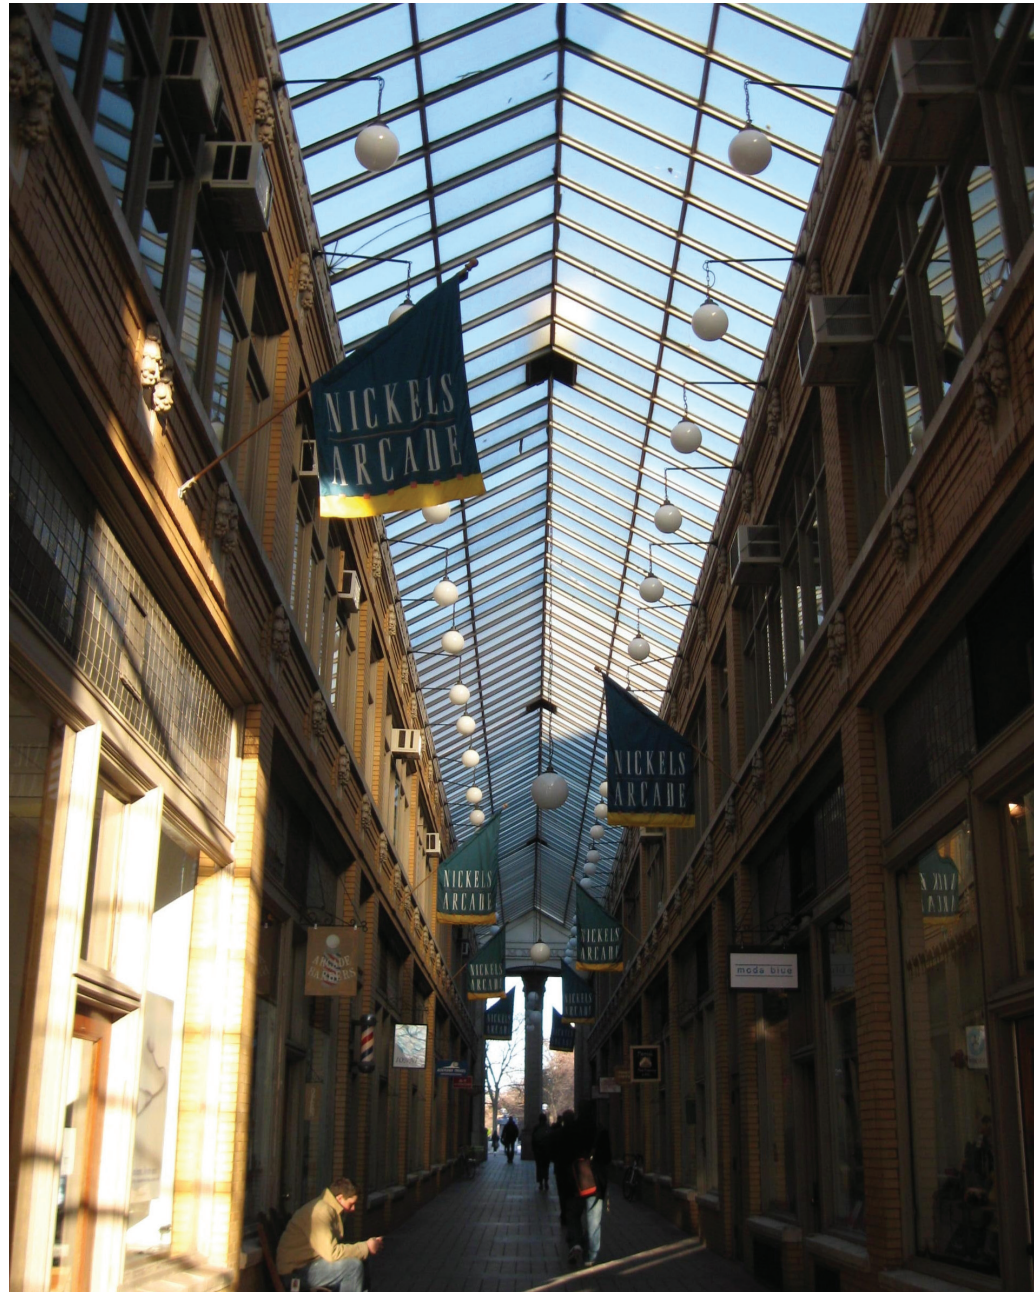
[15] Glass skylight illuminates historic shopping arcade.

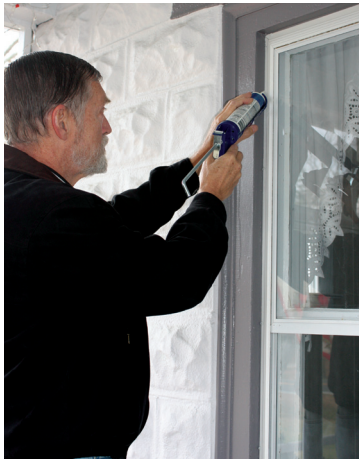
20

**Recommended:** [19] Caulking the gap between the aluminum storm window and wood window frame helps maximize thermal efficiency in this historic residence.

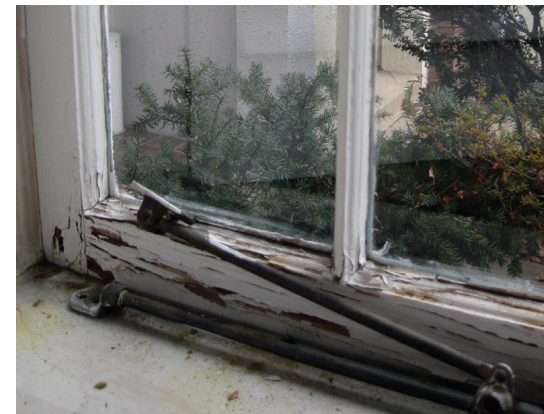
22

**Not Recommended:** [21-22] The peeling paint on an exterior window sill and on the interior of a window indicates that these features have not received regular maintenance. The broken casement window hardware also needs to be repaired to make the window operable.

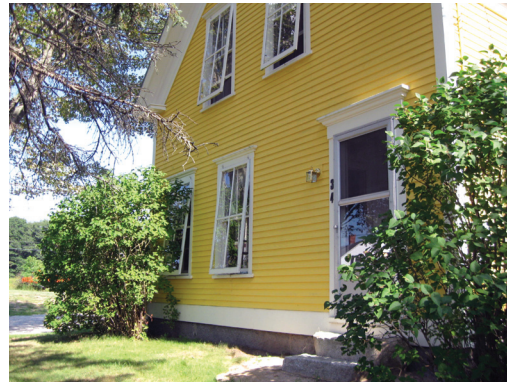
**Not Recommended:** [27] A broken sash cord can be repaired easily and does not justify replacement of the window.

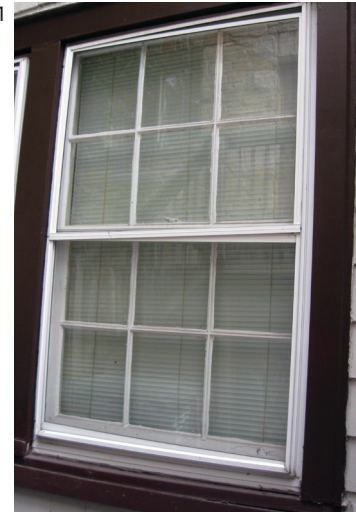
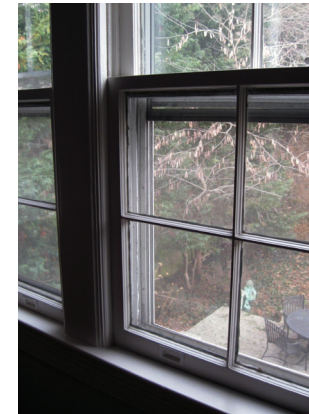
**Not Recommended:** [31-32] Ill-fitting exterior aluminum storm windows viewed from both inside and outside are clearly not energy efficient.

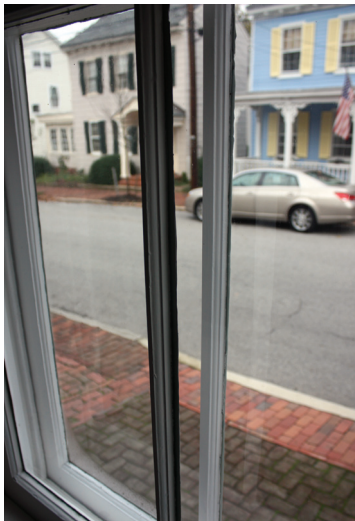
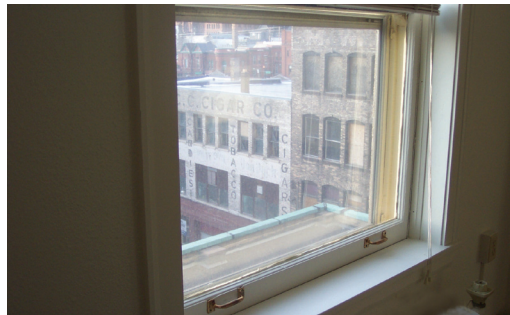
**Recommended:** [28-29] These exterior storm windows match the pane configuration of the historic interior windows in a residence and in a multi-story hotel building.

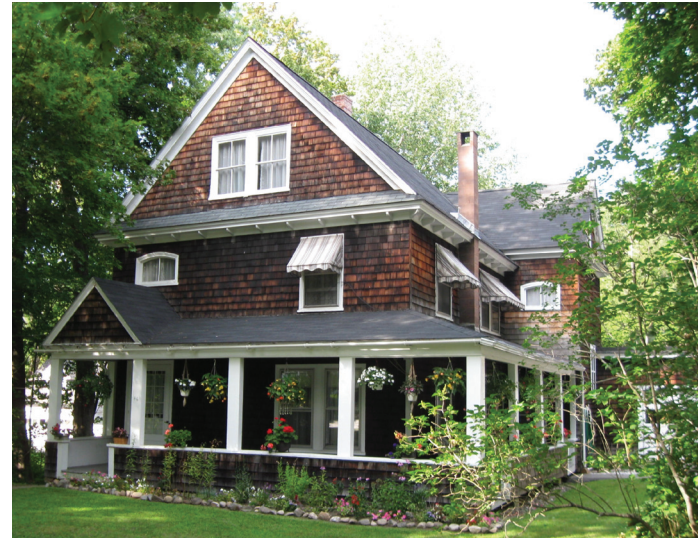
41

**Recommended:** [41] Traditional canvas awnings should be retained when they exist on historic buildings.

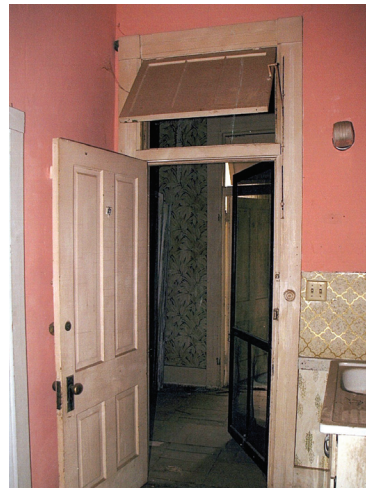
**Recommended:** [42] Transoms and screen doors are distinctive and practical features that provided cross ventilation in this historic hotel.

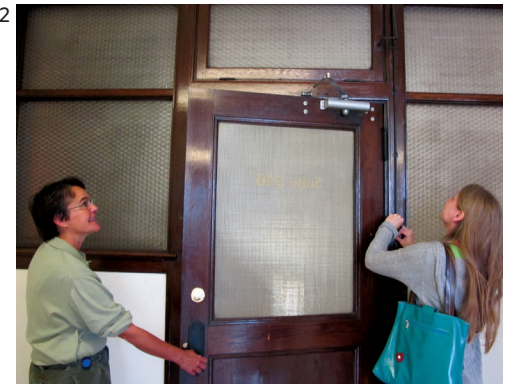
43

**Recommended:** [43] The wall and door glazing ensures that the corridor receives natural daylight and the operable transom helps air to circulate in this historic office building.

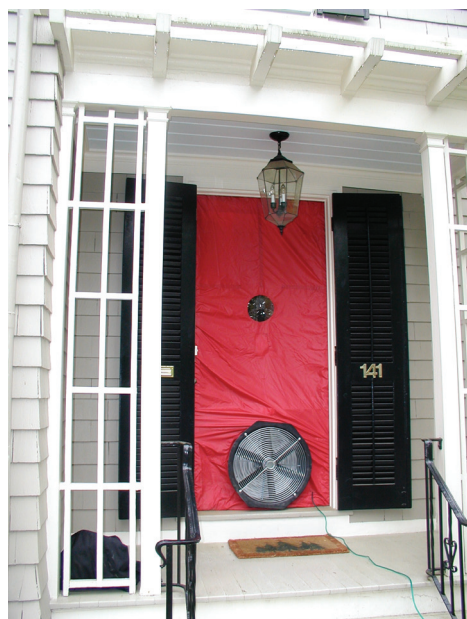
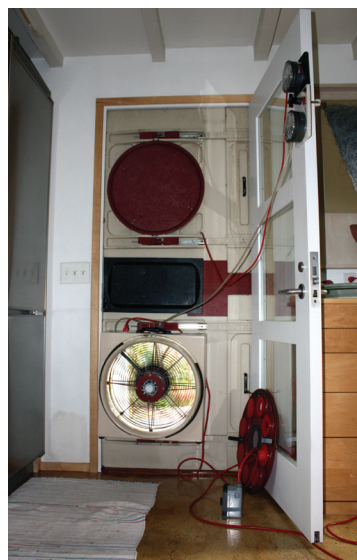
**Recommended:**  
[44-45] A blower door test is a useful tool to help identify air infiltration in a historic building before undertaking weatherization or retrofit treatments.  
Top Photo: Robert J. Cagnetta, Heritage Restoration, Inc.

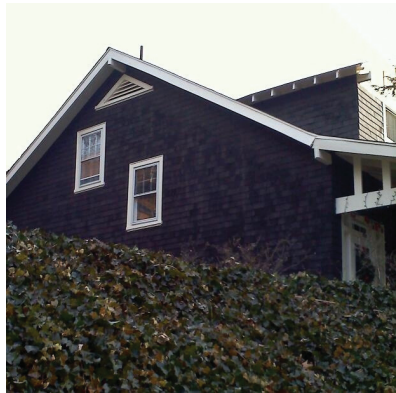
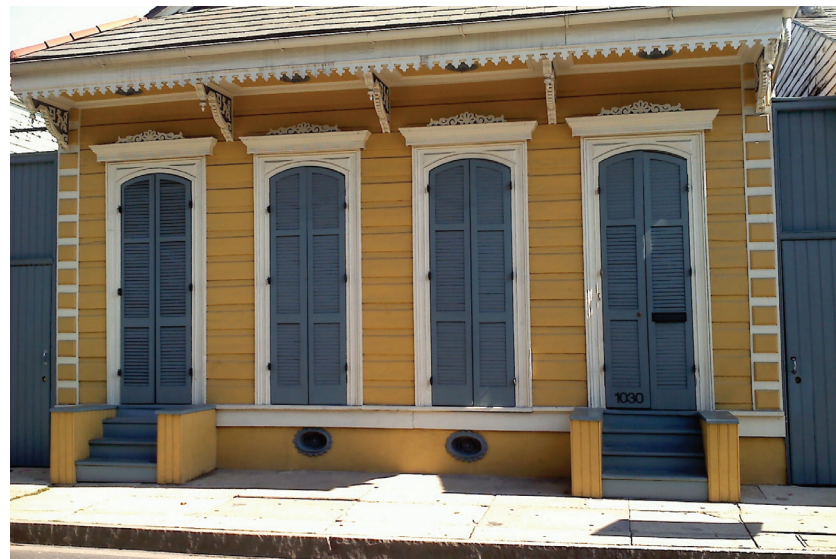
**Recommended:** [55-57]  
Wood vents in the gable ends of a historic house and a barn and cast-iron oval vents in a masonry foundation traditionally helped air circulate.

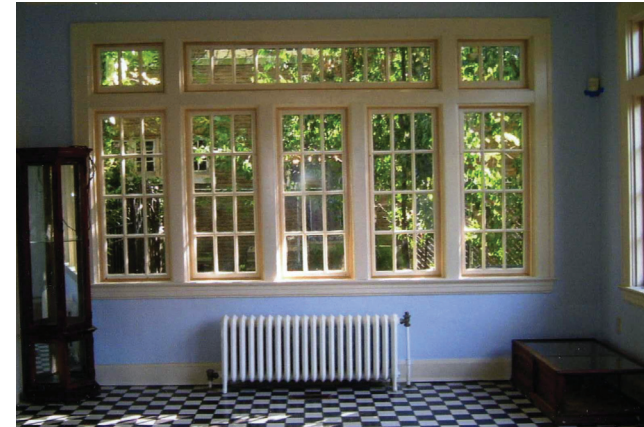
60

**Recommended:** [60] Original radiators that are still functional and efficient were retained in the rehabilitation of this historic house.

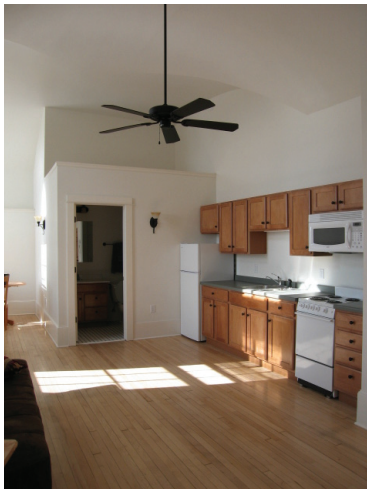
58

**Recommended:** [58] Ceiling fans enhance the efficiency of HVAC systems in historic buildings.

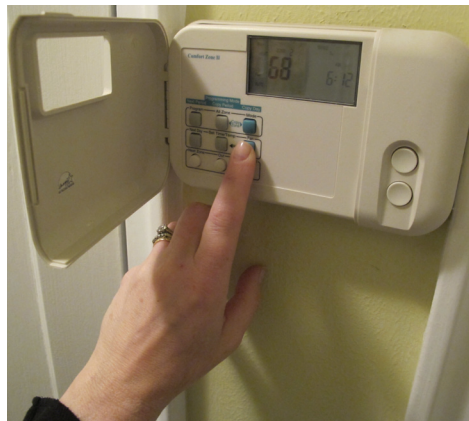
59

**Recommended:** [59] Installing a programmable thermostat can help existing systems to operate more efficiently.

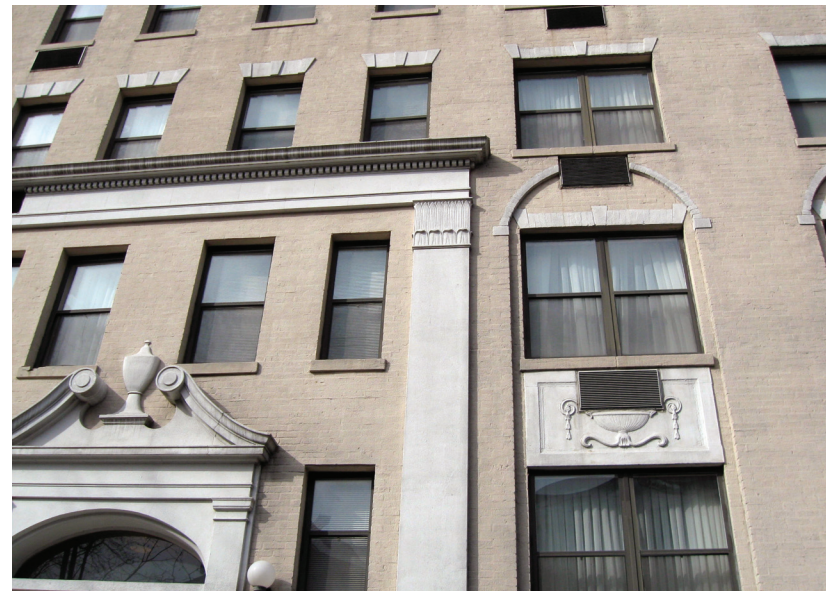
61

**Not Recommended:** [61] The cuts made in the brick and the decorative stone trim to install through-the-wall air conditioners have not only destroyed building material, but have also negatively impacted the character of this historic apartment building.

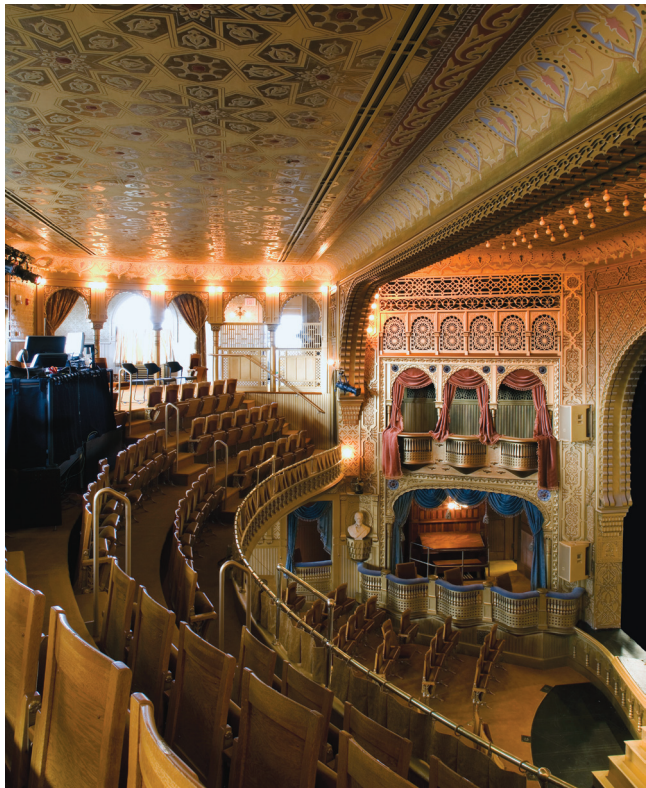
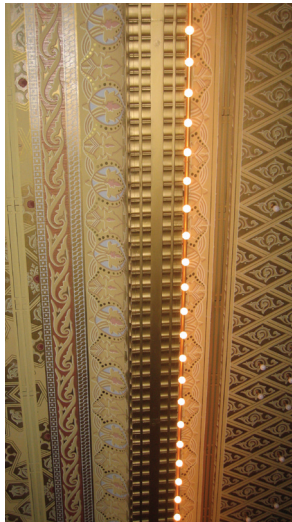
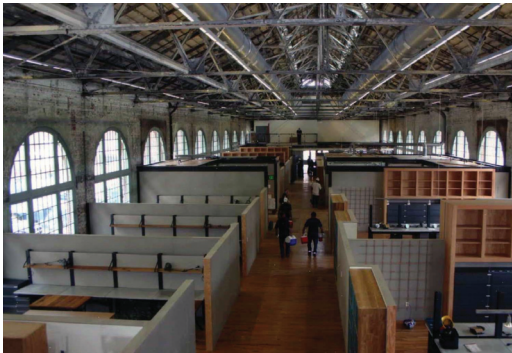
**Recommended:** [62-63] Carefully installed new mechanical ductwork is barely visible in the elaborately decorated ceiling of this historic theater.  
[64] The ductwork has been left unpainted which is compatible with this historic industrial interior.  
[65] To avoid damaging the metal ceiling, the ductwork was left exposed and it was painted to minimize its impact, thus preserving the historic character of this former bank.

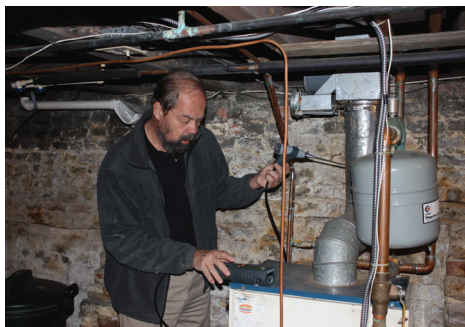
67

**Recommended:**[67] A professional energy auditor analyzes the performance of an existing furnace to ensure it is operating efficiently.

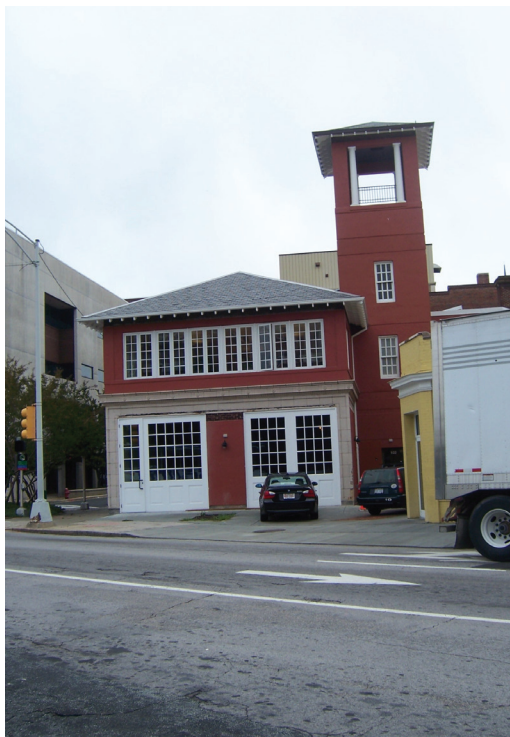
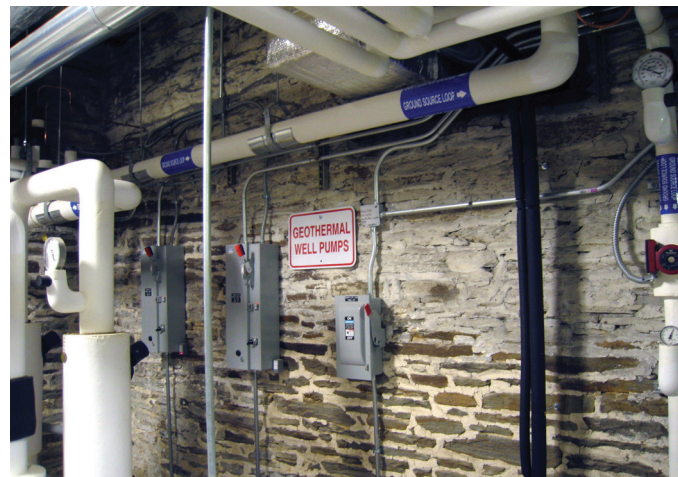
**Recommended:** [70-71] A geothermal system was installed on the property of this historic mansion, but only after an archeological investigation was conducted of the grounds.

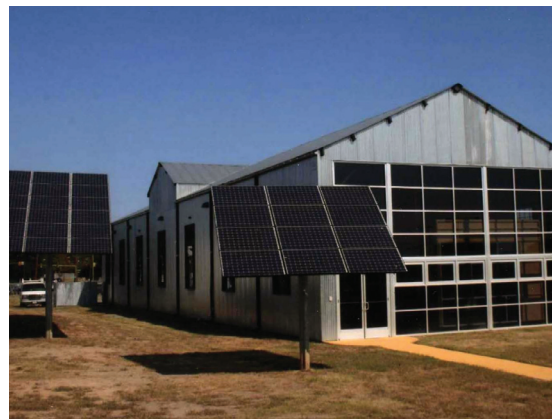
**Recommended:** [74] Free-standing solar panels have been installed here that are visible but appropriately located at the rear of the property and compatible with the character of this industrial site.

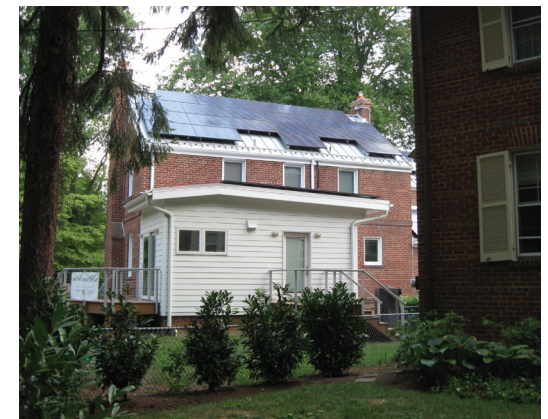
**Not Recommended:** [75] Solar roof panels have been installed at the rear, but because the house is situated on a corner, they are highly visible and negatively impact the character of the historic property.

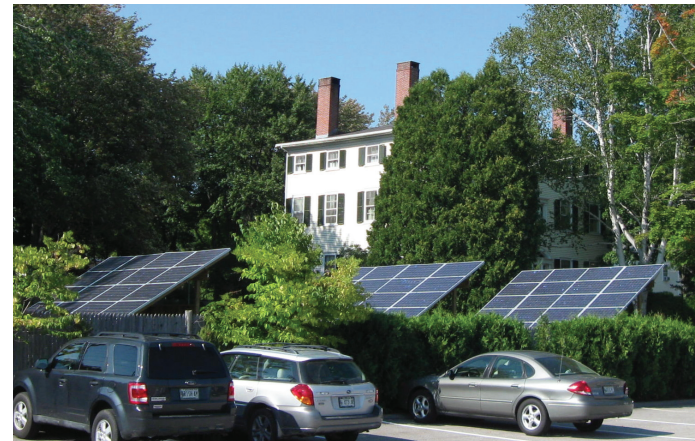
79

**Not Recommended:** [79] Although installing solar panels behind a rear parking lot might be a suitable location in many cases, here the panels negatively impact the historic property on which they are located.

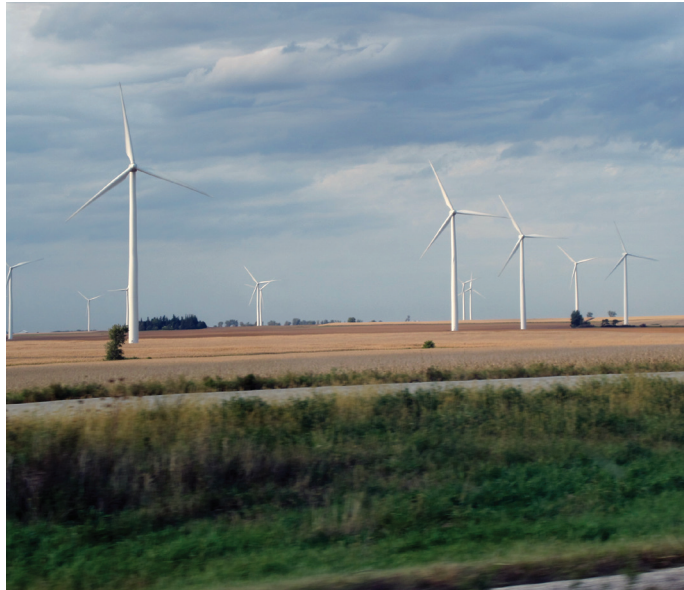
80

**Recommended:** [80] It is often best to install wind-powered equipment in off-site, rural locations to avoid negatively impacting a historic building and its site.

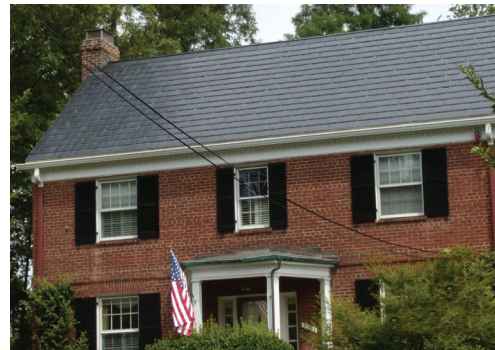
87

**Not Recommended:** [87] Historic roofing materials in good condition should be retained rather than replaced with another material perceived as more sustainable, such as, in this case, solar roofing shingles.

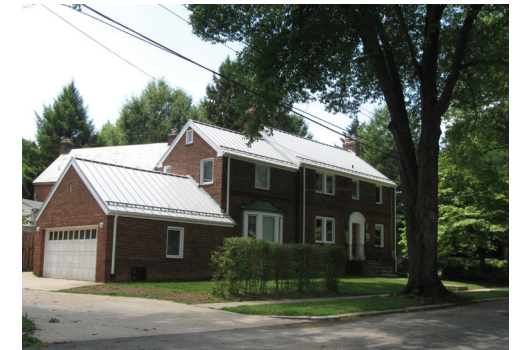
88

**Not Recommended:** [88] This new, cool white metal roof is not an appropriate material or color for this historic mid-20th century house.

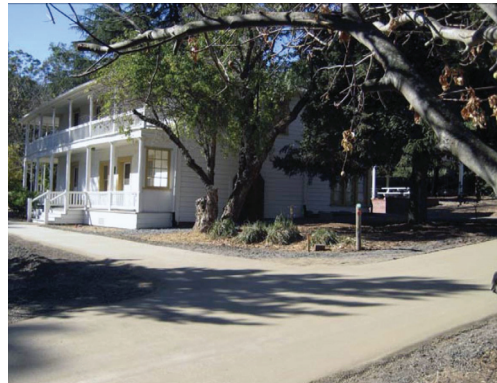
**Recommended:** [94-95] Permeable pavers were used at this historic residential property for a driveway and parking (above) and a hard-packed, construction aggregate provides environmentally-friendly paths for visitors at this historic site (below).

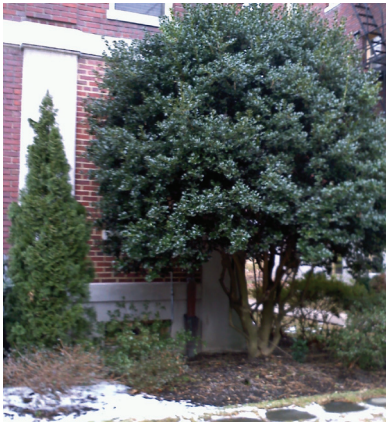
97

**Not Recommended:** [97] This tree, which was planted too close to the building, has caused the masonry wall to retain moisture that damaged the mortar and required that the brick be repointed in this area.

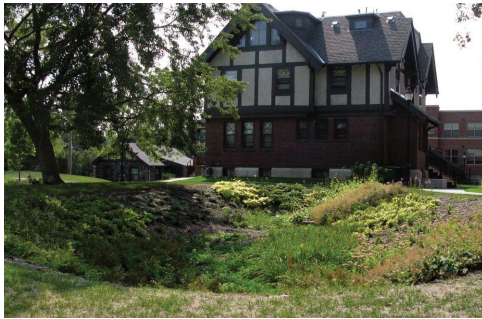
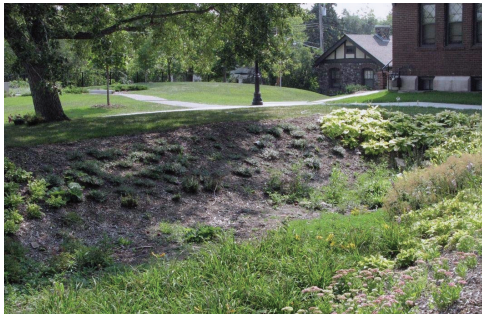
**Recommended:** [98-100] Rain gardens and rain-water collection tanks are features that may be added to a historic property to improve storm-water management and increase on-site water use.

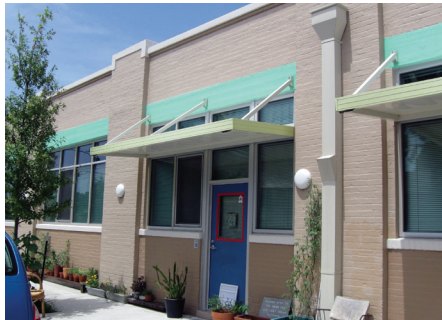
107

**Recommended: [107]** Traditional canopies compatible with the industrial character of this former factory building were installed when it was converted for residential use.
