THE SECRETARY  
OF THE INTERIOR'S  
**STANDARDS** FOR  
THE TREATMENT  
OF HISTORIC  
PROPERTIES

WITH  
**GUIDELINES** FOR  
PRESERVING,  
REHABILITATING,  
RESTORING &  
RECONSTRUCTING  
HISTORIC  
BUILDINGS

U.S. Department of the Interior  
National Park Service  
Technical Preservation Services

2017

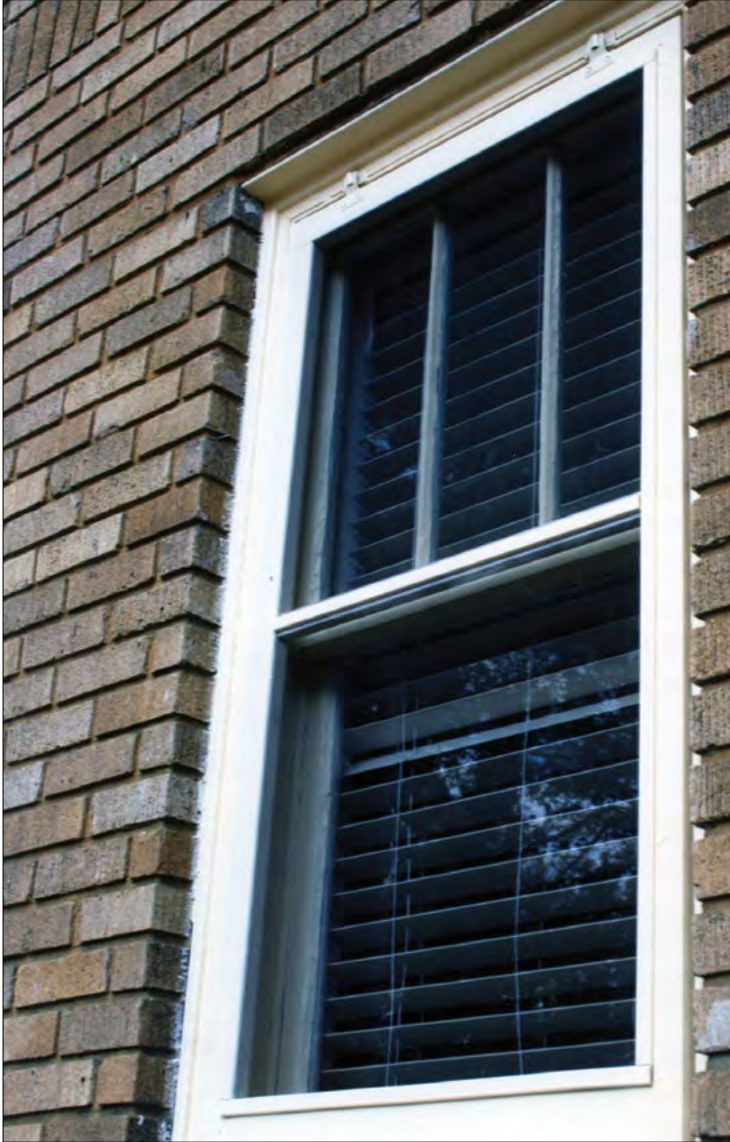
[10] Historic exterior storm windows preserve and help to insulate wood windows.

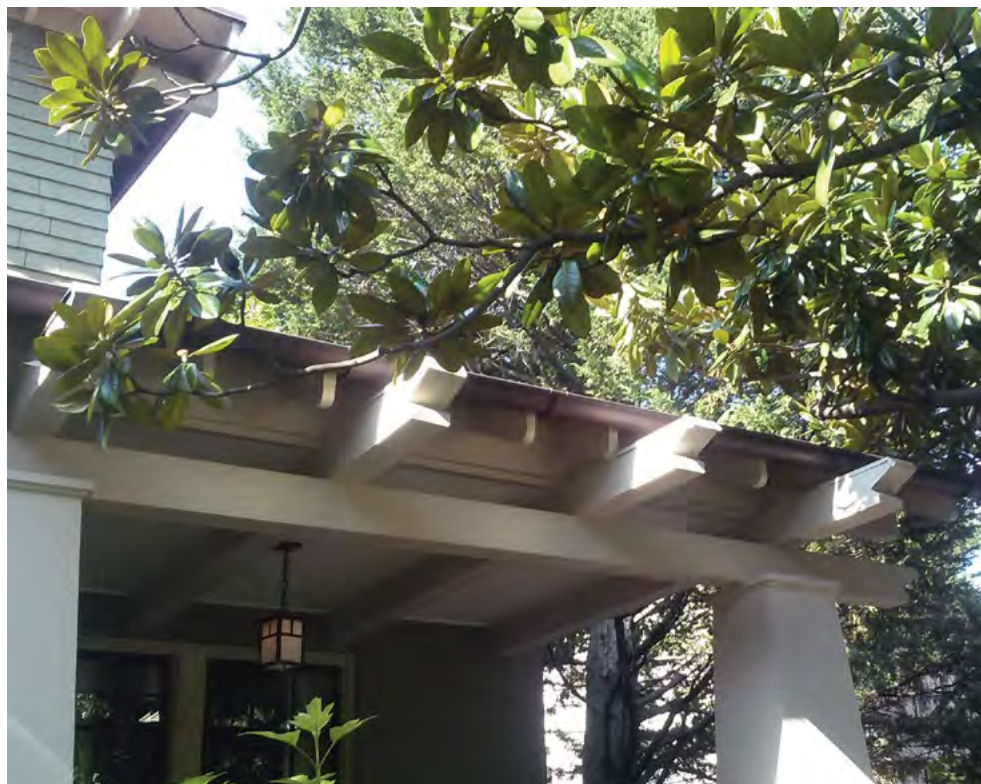
[12] Repair and limited replacement in kind to match deteriorated wood porch features is always a recommended preservation treatment.

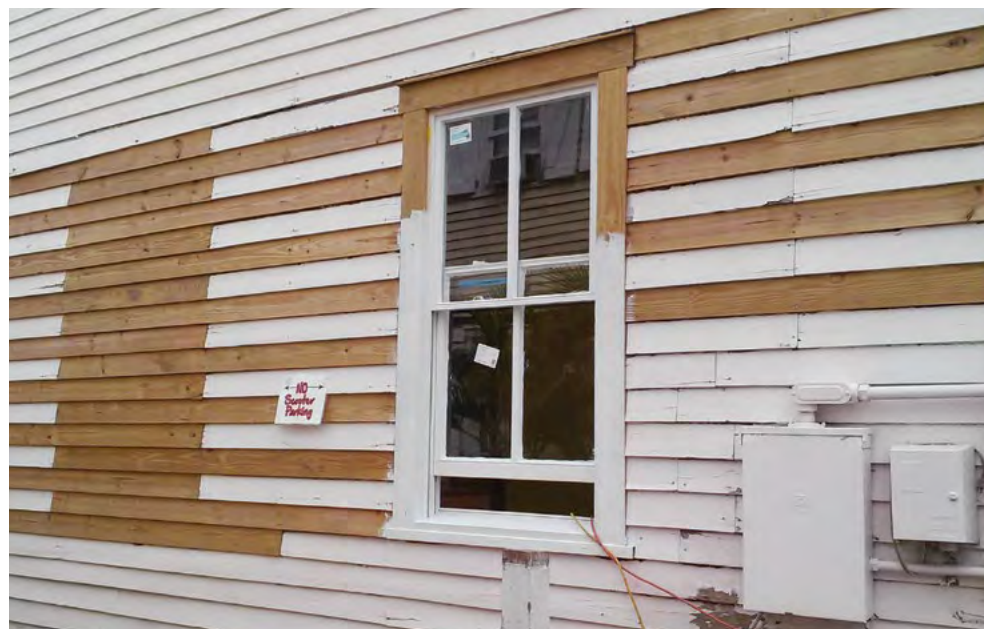
[8] Rotted clapboards have been replaced selectively with new wood siding to match the originals.

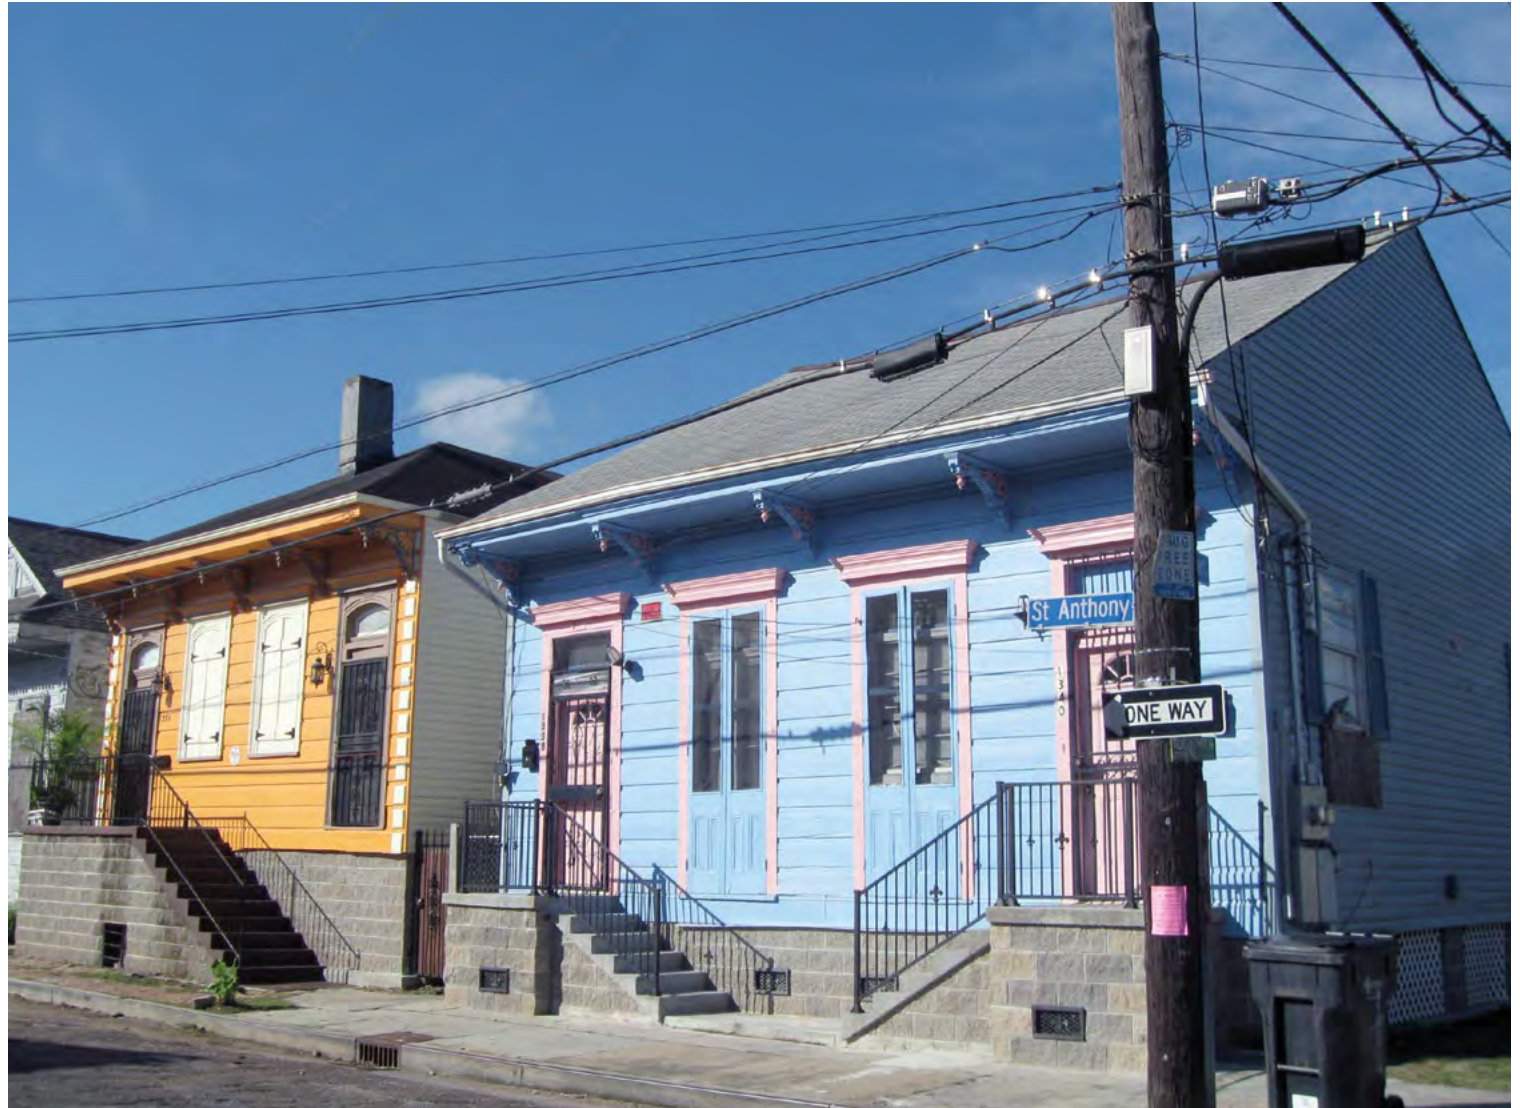
[60] In some instances, it may be necessary to elevate a historic building located in a floodplain to protect it. But this treatment is appropriate only if elevating the building will retain its historic character, including its relationship to the site, and its new height will be compatible with surrounding buildings if in a historic district. The house on the right, which has been raised only slightly, has retained its historic character. The house on the left has been raised several feet higher, resulting in a greater impact on the historic character of the house and the district.

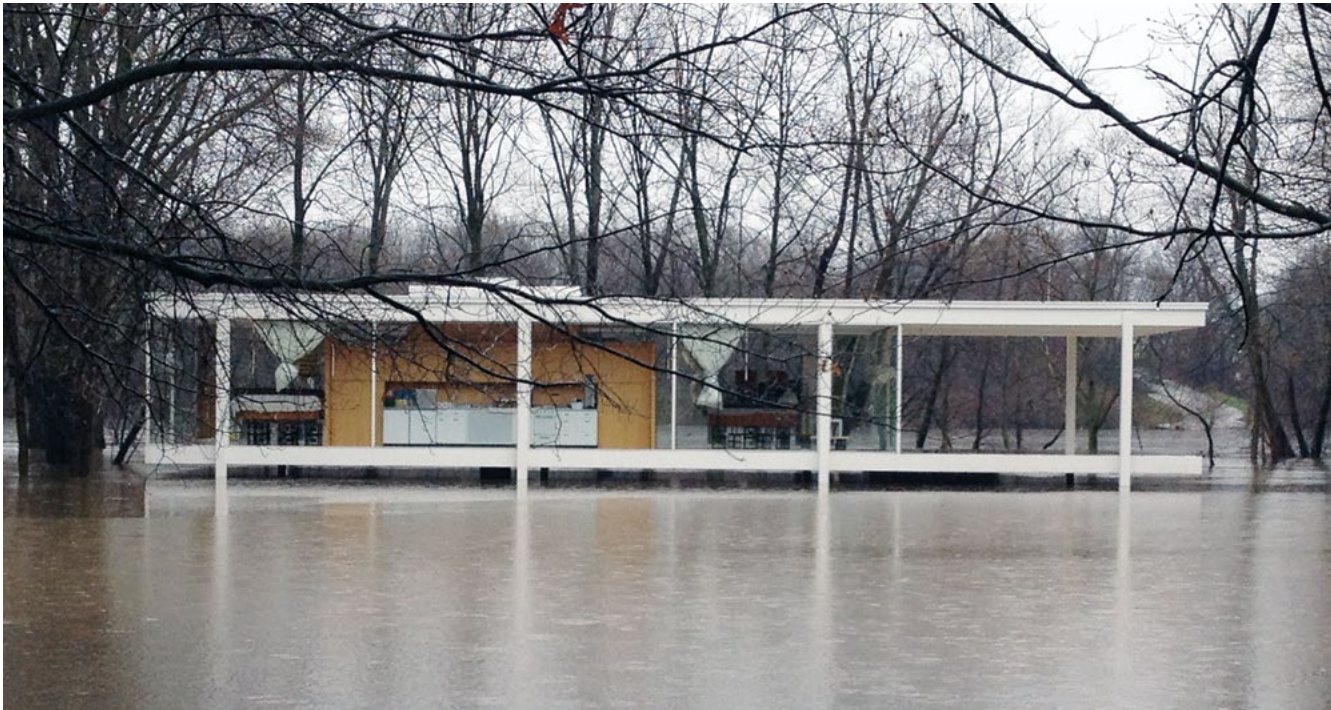
[19] The 1951 Mies van der Rohe-designed Farnsworth House, Plano, IL, was built close to the Fox River, which is increasingly prone to floods. To preserve the house in its original location, historic preservation architects and engineers continue to explore ways to protect it from the flooding, including a possible system that would lift the house above the flood waters and lower it back to the ground. Photo: Courtesy Farnsworth, A Site of the National Trust for Historic Preservation.
