Living Shorelines in the Decade Since Sandy

Lessons Learned and Implications for
Future Design

Jon K. Miller, Laura Kerr, Amy Bredes
Katherine Gannon, and Ian Day

October 26, 2022

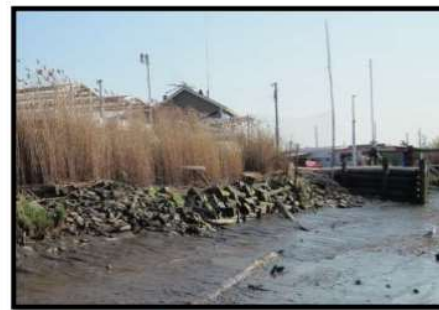
BEFORE: Marina in New Jersey's Heislerville Fish and Wildlife Management Area in April of 2010.

- PDE/Rutgers
- Project initiated in 2008
- Maurice River
- Coir Log & Shell Bag
- Key Takeaways
 - Permitting is painful
 - Effective on moderate/low energy shorelines
 - Can survive large storms
- [Project story map](#) created in 2021

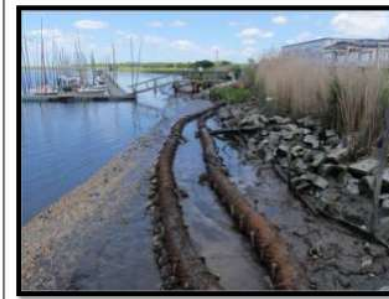
BEFORE: Day of installation of coconut-fiber (coir) logs and mats in New Jersey's Heislerville Fish and Wildlife Management Area in May of 2010.

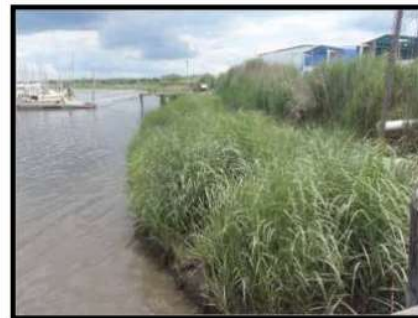
AFTER: One year later, June 2011, native marsh grass can be seen flourishing in the soil that has collected behind the new "living shoreline." Not only does this defend land against destructive waves, but also it serves as fish habitat during high tides.

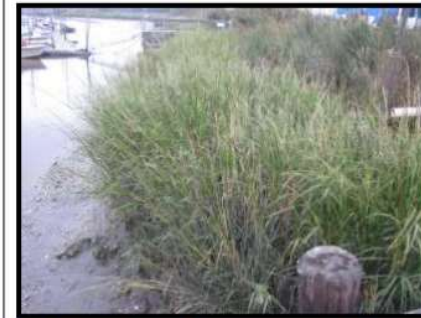
AFTER: September 2011- the site remained stable after Hurricane Irene and Tropical Storm Ike.

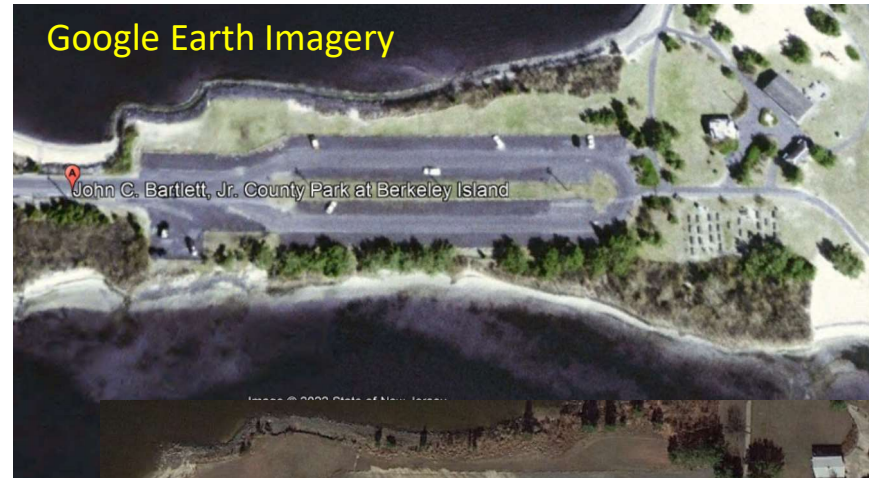
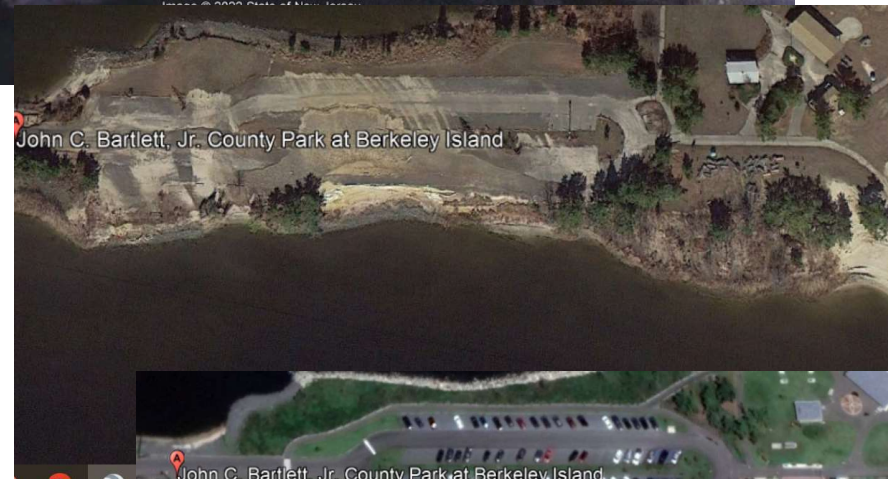
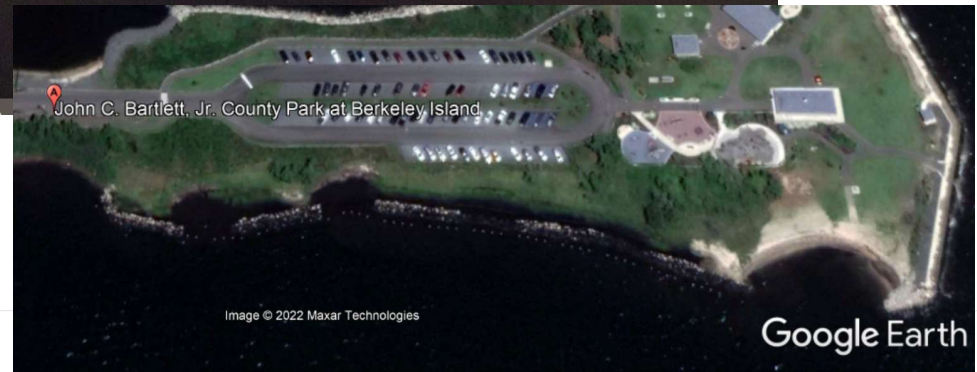
Berkeley Island

- Site characteristics:
 - Erosion Rate: 1-3 ft/yr
 - Estimate Wave Heights: 0.5-1.5 ft
 - Tidal Range: < 0.5 ft
 - Beach type: Marsh
 - Region: Barnegat Bay
- Original design: segmented rock sill
- Final design: linear stone/bulkhead sill

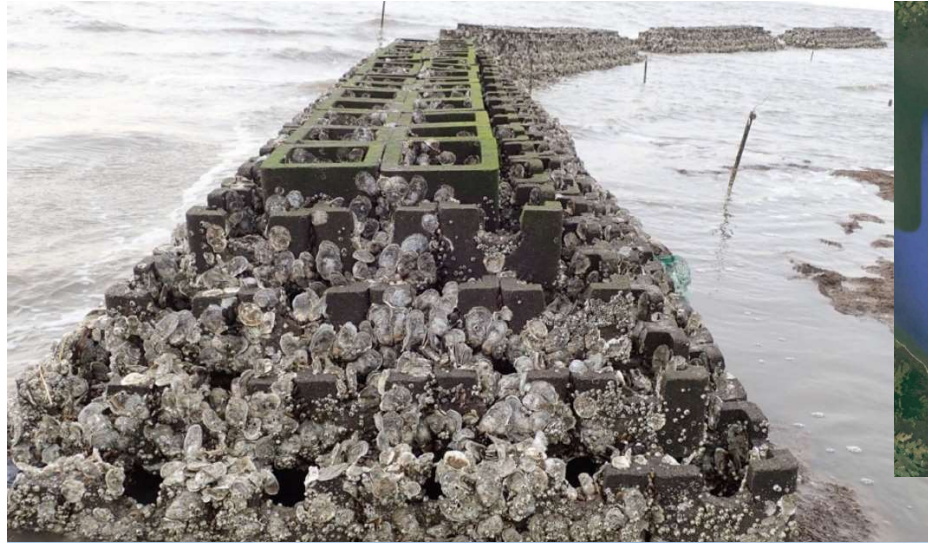
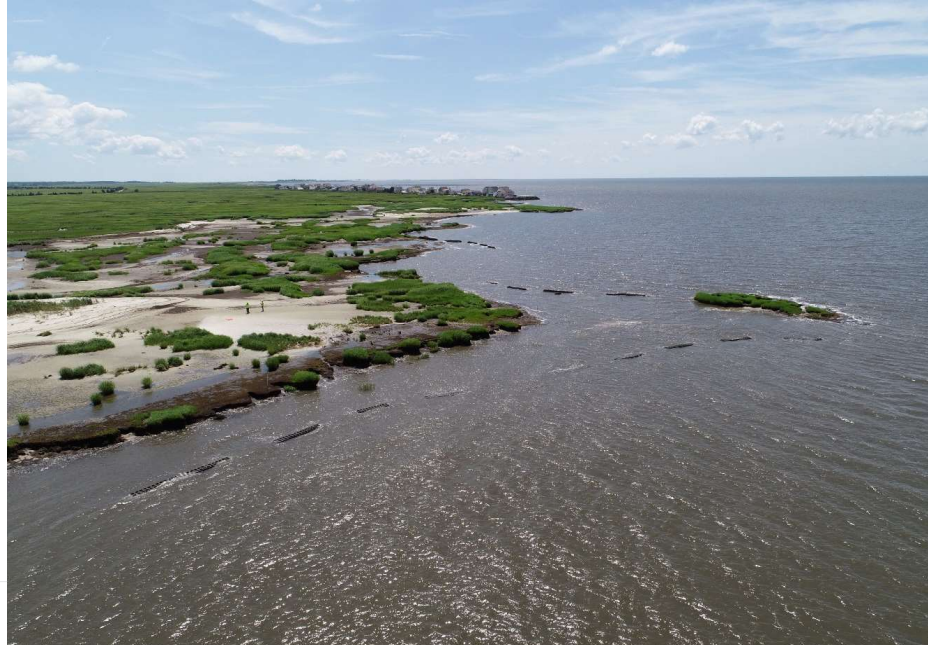
Gandys Beach

- Site characteristics:
 - Erosion Rate: 4-8 ft/yr
 - Estimate Wave Heights: 0.5 – 3 ft
 - Tidal Range: >6 ft
 - Beach type: Marsh and sand
 - Region: Delaware Bay
- Design: Oyster Castle Breakwater
 - Complex
 - Mostly submerged (60-80%)

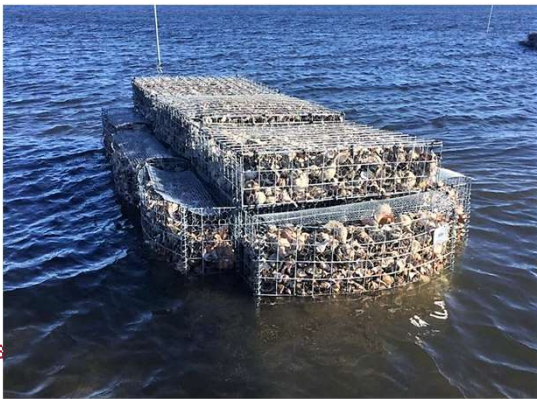
Google Earth Imagery

- Site characteristics:
 - Erosion Rate: 2-8 ft/yr
 - Estimate Wave Heights: 0.5-3ft
 - Tide Range: < 0.5ft
 - Beach type: Sandy
 - Region: Barnegat Bay
- Design: HESCO basket breakwater
 - Varied angles and gaps
 - Rock interior with shell veneer

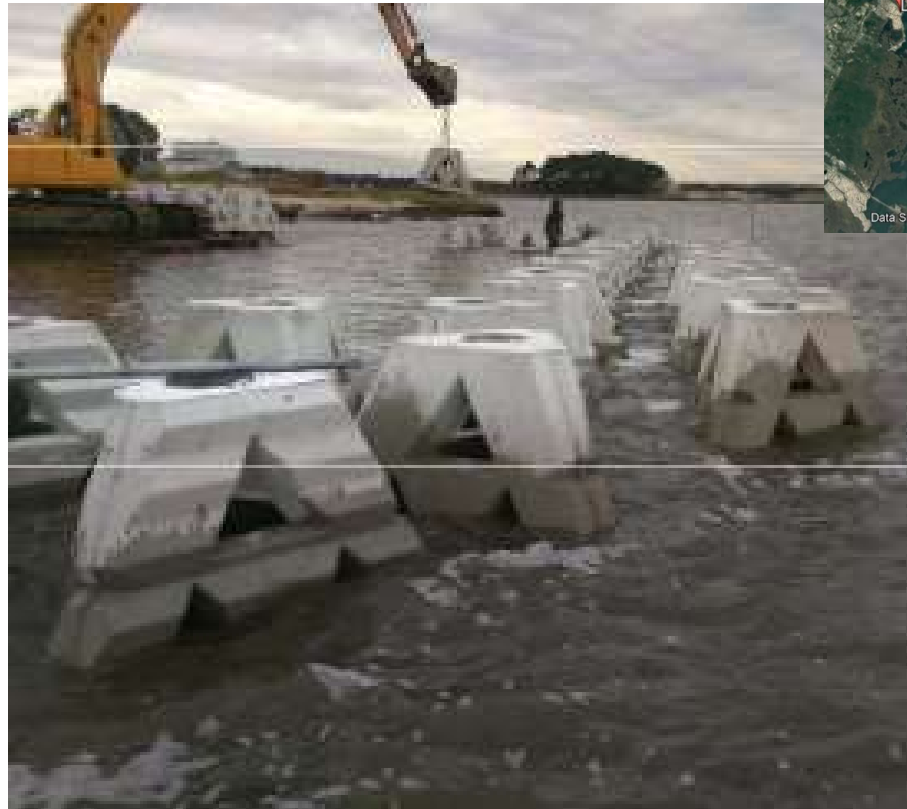
Lighthouse Center

- Site characteristics:
 - Erosion Rate: 1-4 ft/yr
 - Estimate Wave Heights: 0.5-2 ft
 - Tide Range: ~0.5 ft
 - Beach type: Marsh
 - Region: Barnegat Bay
- Design: WAD sill/breakwater
 - Emergent

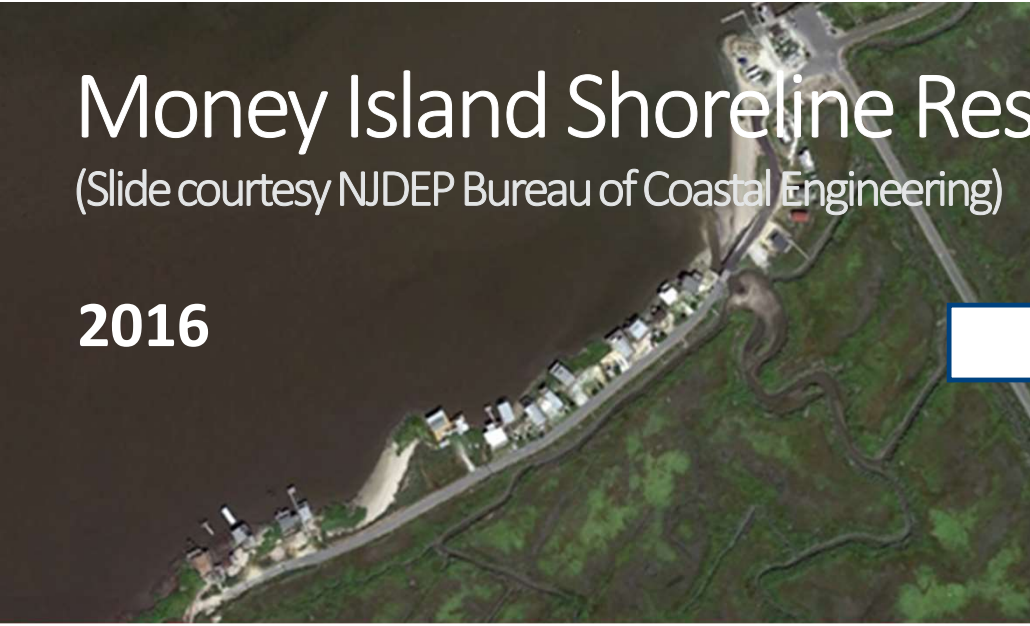
2016

- Description: 1st in the nation effort utilizing FEMA HMGP funds for shoreline/habitat restoration
- Goal: Create horseshoe crab spawning and red knot foraging habitat
- Date Completed: 2022
- Total Cost: \$957k (Shoreline Restoration ONLY)
- Cost Share: 100% FEMA

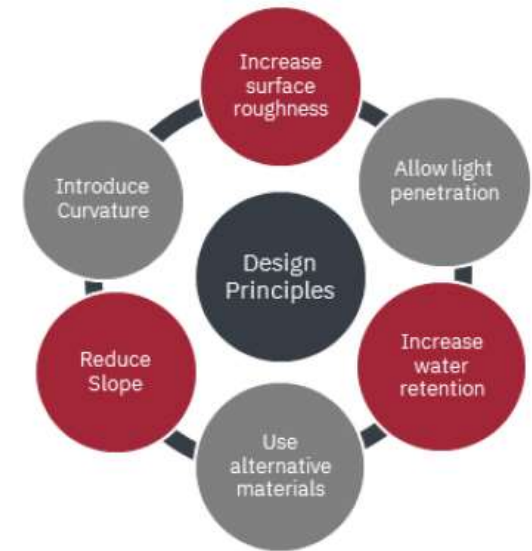
WEDG	IGNBF	Harlem River	Sherman Creek	Brooklyn Bridge	Seattle Seawall	Lardners Point	San Diego
Preserve Natural Areas								
Increased Surface Roughness								
Alternative Materials								
Reduce Slope								
Increase Sinuosity								
Allow Light Penetration								
Increase Water Retention								
Resilience/Adaptability								
Monitoring and Assessment

- Sister document to NJ LSEG
- Review of Existing Guidance
 - Waterfront Edge Design Guidelines (Waterfront Alliance)
 - International Guidelines on Natural and Nature Based Features for Flood Mitigation (USACE)
- Case Studies
 - Harlem River, NY
 - Sherman Creek, NY
 - Brooklyn Bridge Park, NY
 - Seattle Seawall, WA
 - Lardners Point, PA
 - San Diego, CA

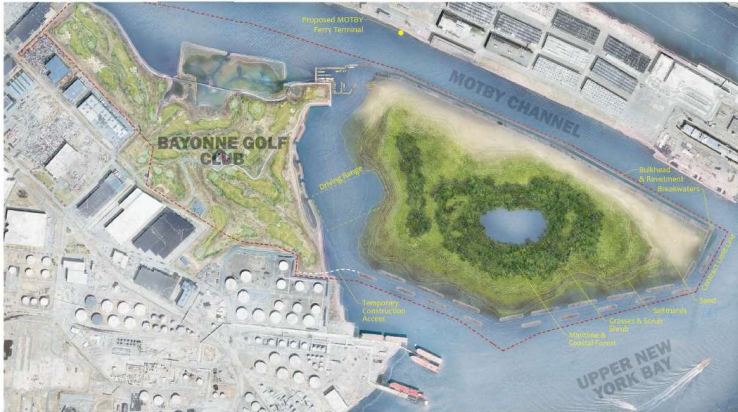
Figure 2. Plan view of the proposed Links Island with section inset. Courtesy of CUES.
