Appendix L – Submerged Aquatic Vegetation Supplemental Material

**Phase 1 - Aerial Submerged Aquatic Vegetation Survey
2019**

New Jersey Submerged Aquatic Vegetation Aerial Survey

HDR Engineering, Inc

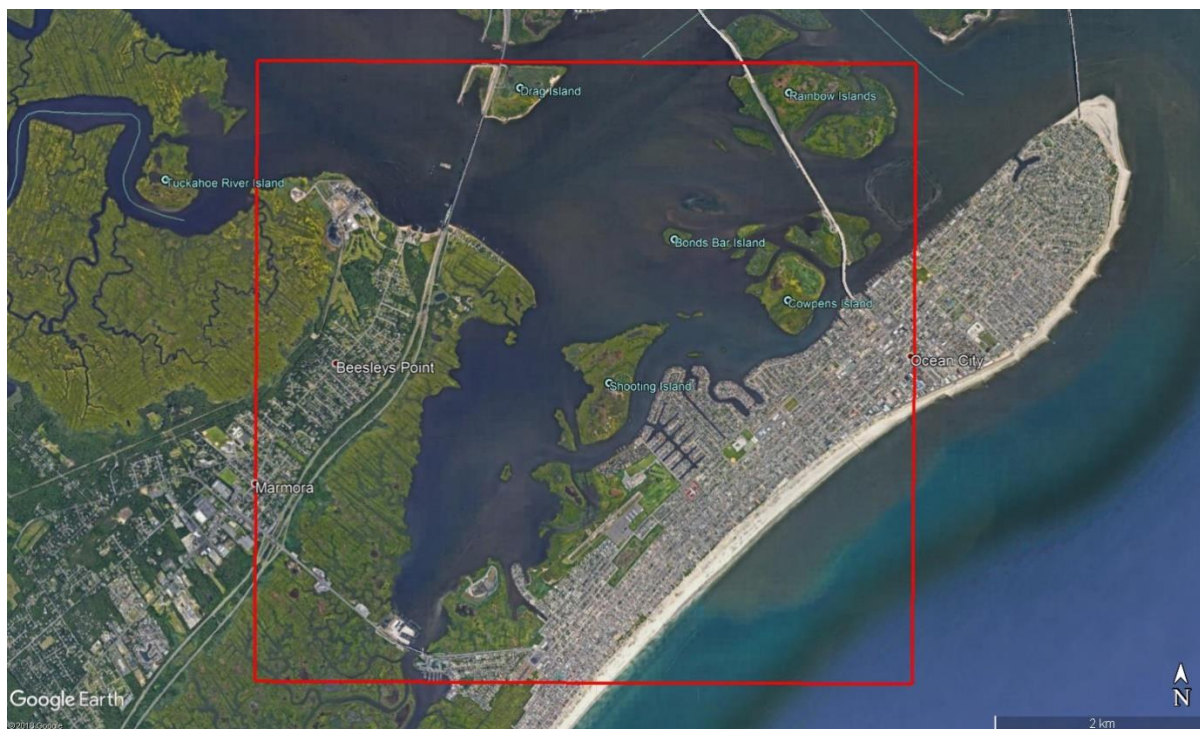
Figure 3. The Great Egg Harbor survey area, outlined in red.

The Great Egg Harbor site measured approximately 13 square miles in area and is shown in more detail in Figure 3.

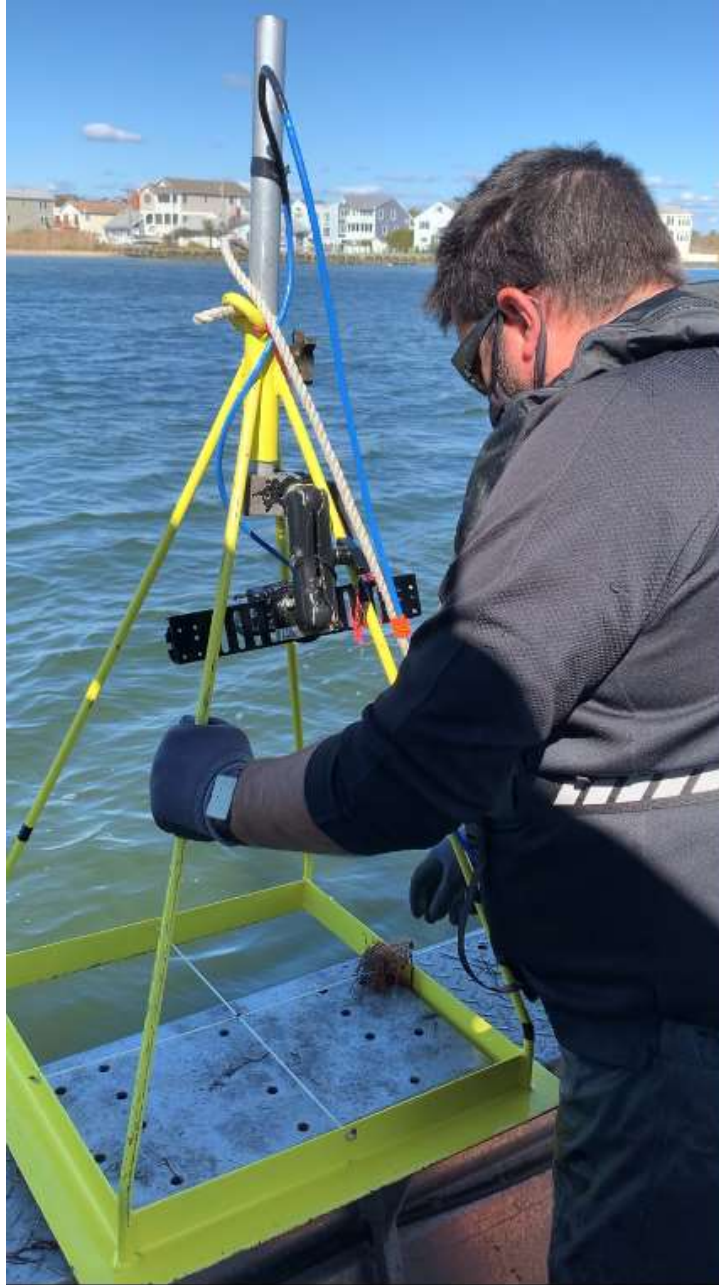
Figure 3. Quadrat Frame with Mounted GoProHero3 for SAV Sampling.

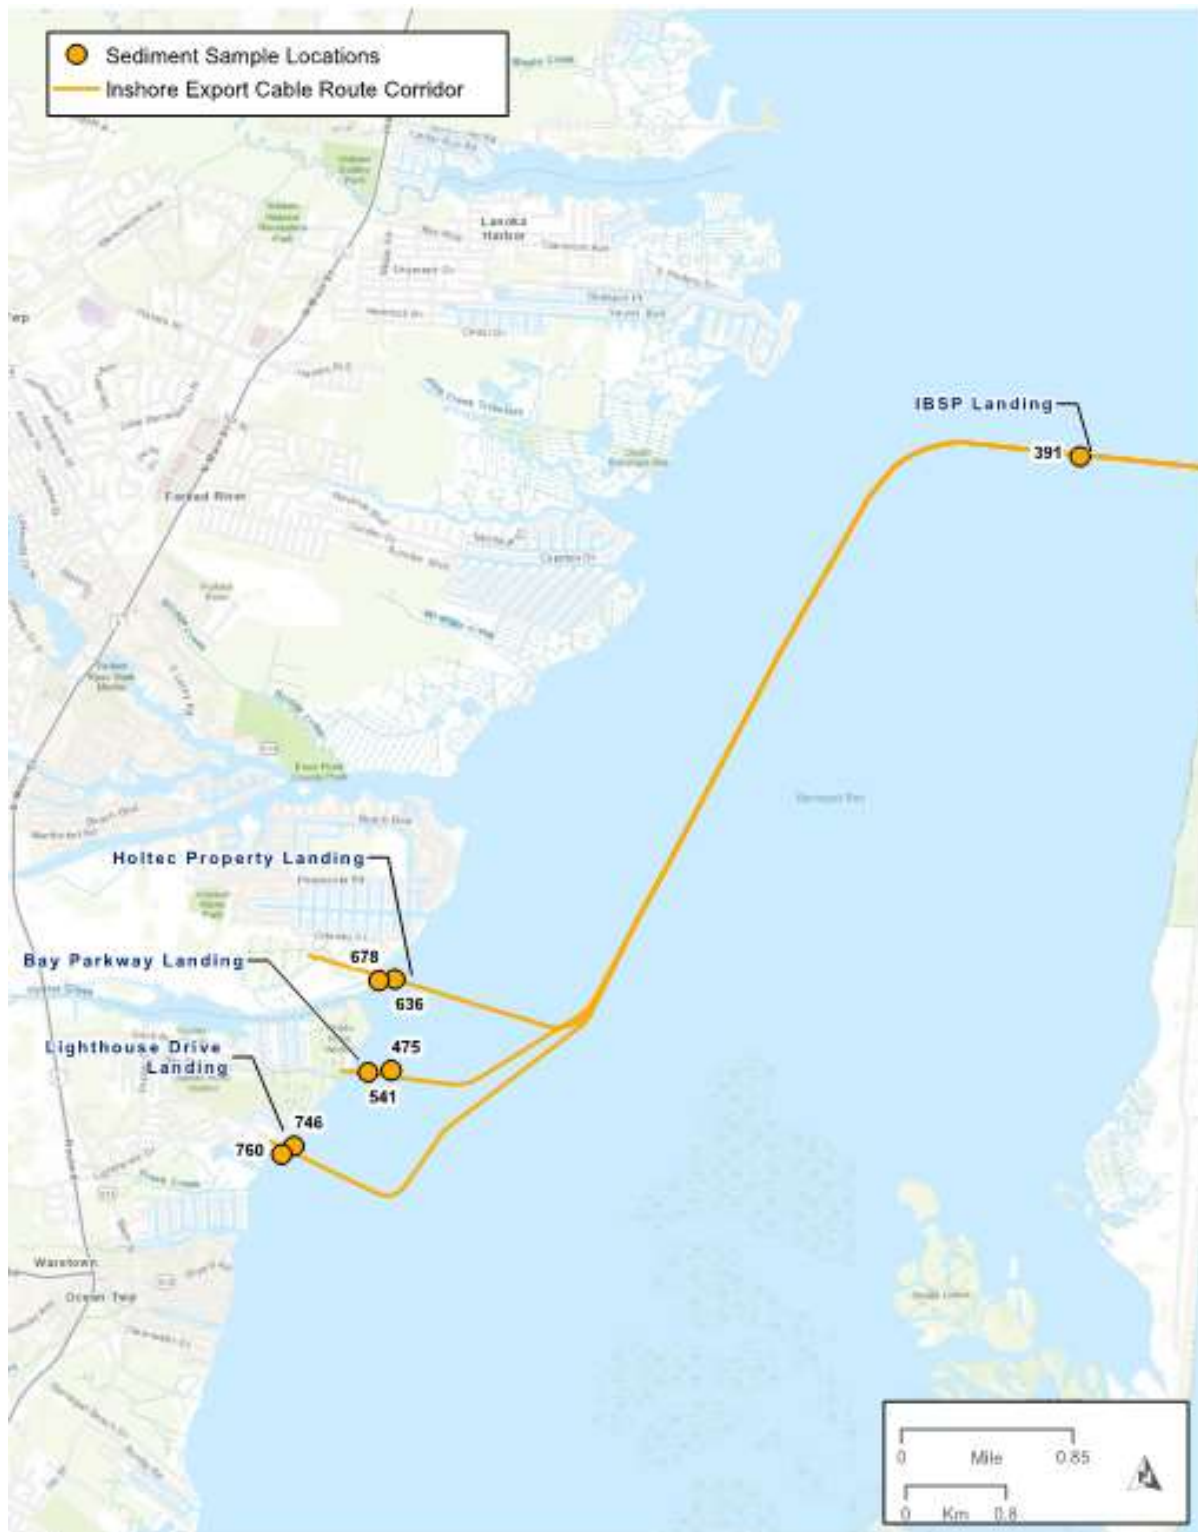
Figure 4. Sediment Sampling Locations.

Per the NJDEP (2015) SAV Survey Guidance document and the Project survey protocol, sediment samples were collected for grain size analysis. The sediment samples were collected on October 8, 2020, using a petite ponar grab from locations representative of the observed sediment types within each of the four potential landfall areas during the SAV survey (**Figure 4**). The sediment samples were photographed, then homogenized, placed in glass jars, and sent to an analytical laboratory for grain size analysis consistent with the American Society for Testing and Materials (ASTM) methods D6913 and D7928. The results were reported according to the Wentworth (1922) grain size scale.

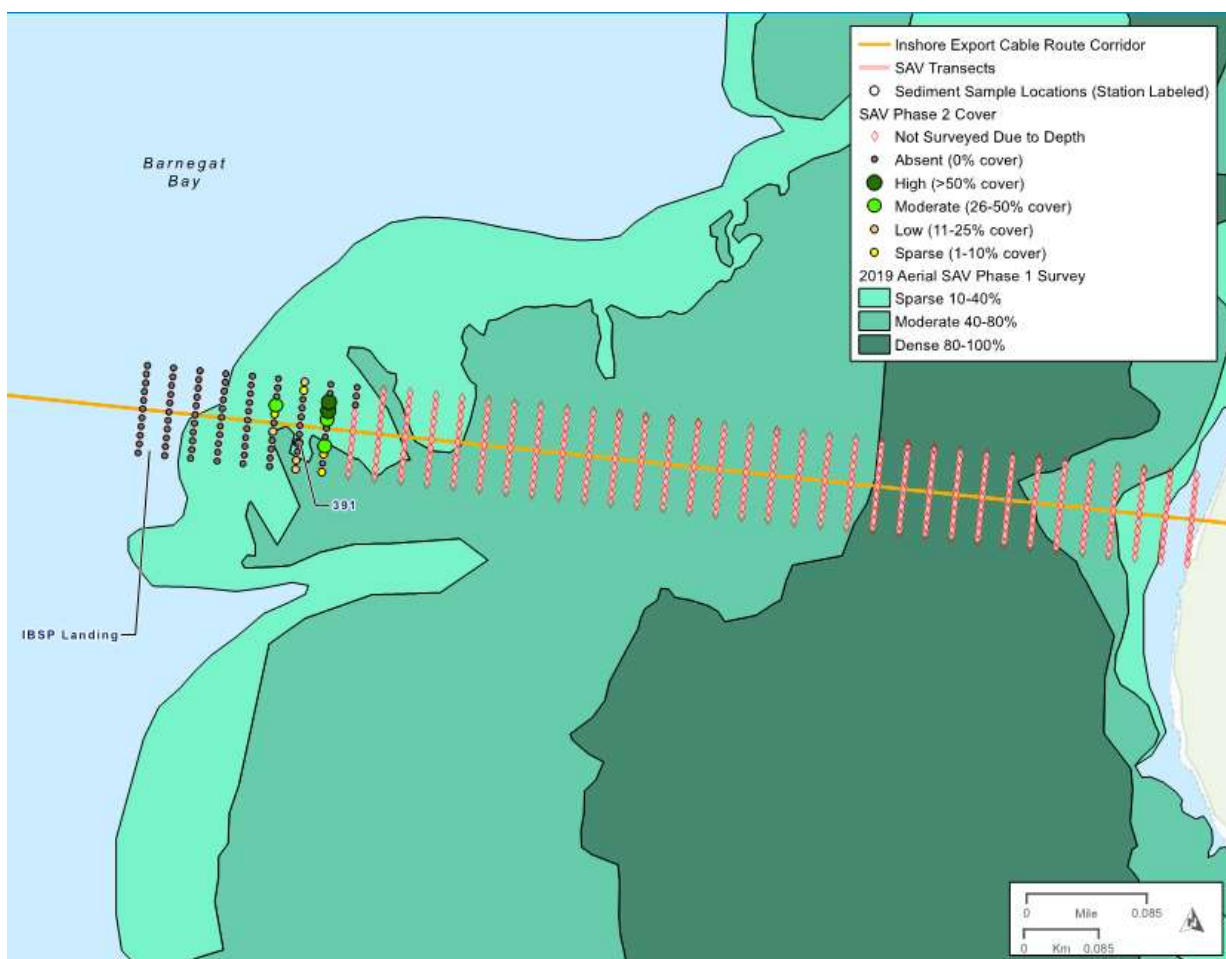
Figure 7. SAV Percent Cover Estimates at IBSP Landing.

For IBSP Landing, the findings of the Phase 2 survey were consistent with the findings of the Phase 1 survey in the areas that were accessible by the vessel. There were patches of sparse to moderate SAV present in the outer fringe during the Phase 2 SAV survey, with smaller areas of high percent coverage. The outer edge of the SAV bed in the IBSP area was found to be closer to shore in the Phase 2 survey than documented in the Phase 1 aerial survey. (Table 4, Figure 7).

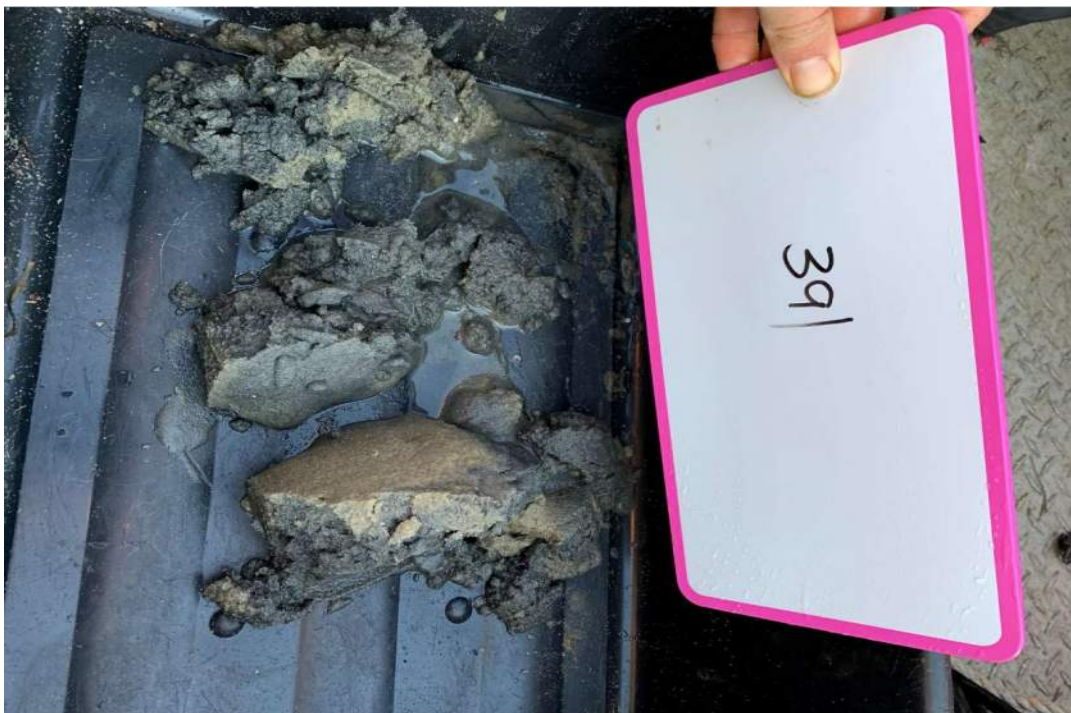
Photo 18: Photo showing sediment sample collected at IBSP Landing Station 391.

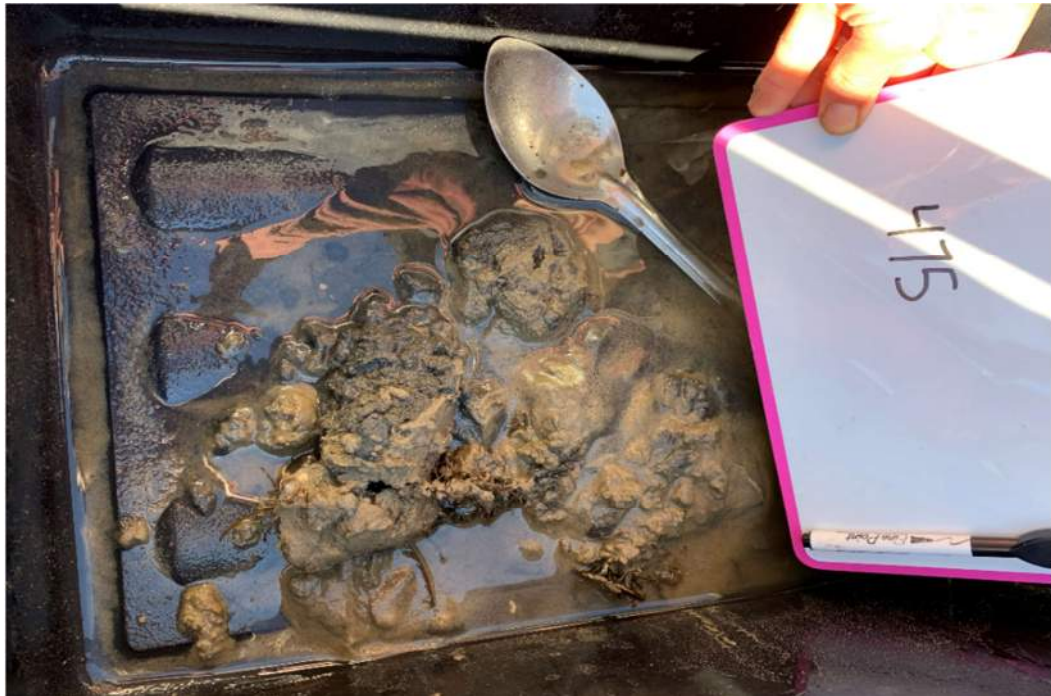
Photo 19: Photo showing sediment sample collected at Bay Parkway Landing Station 475.

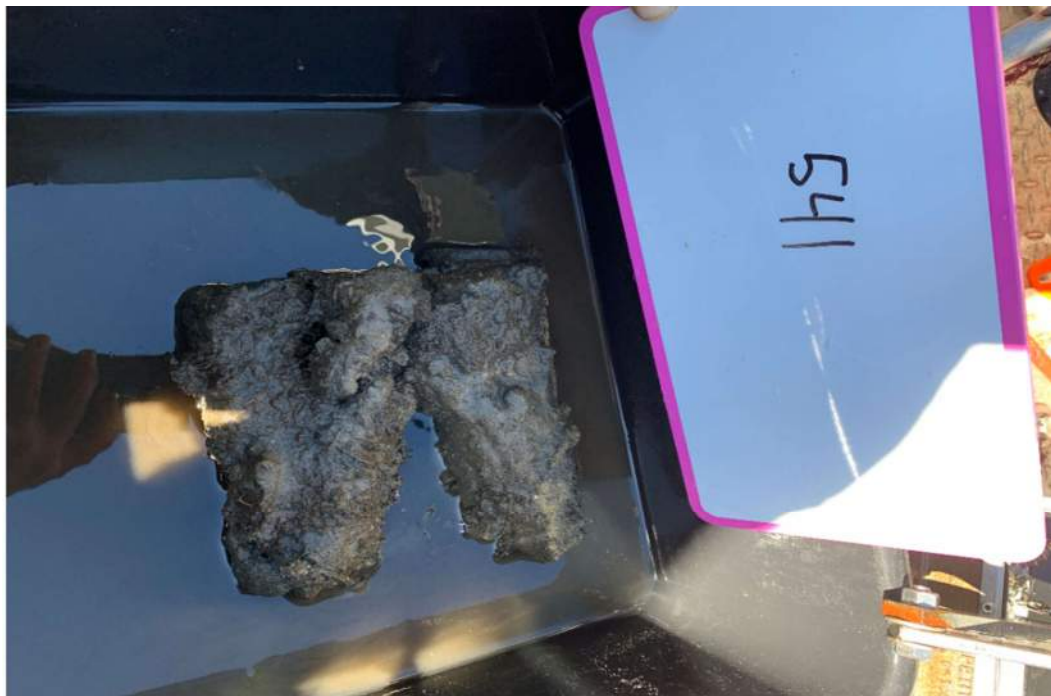
Photo 20: Photo showing sediment sample collected at Bay Parkway Landing Station 541.

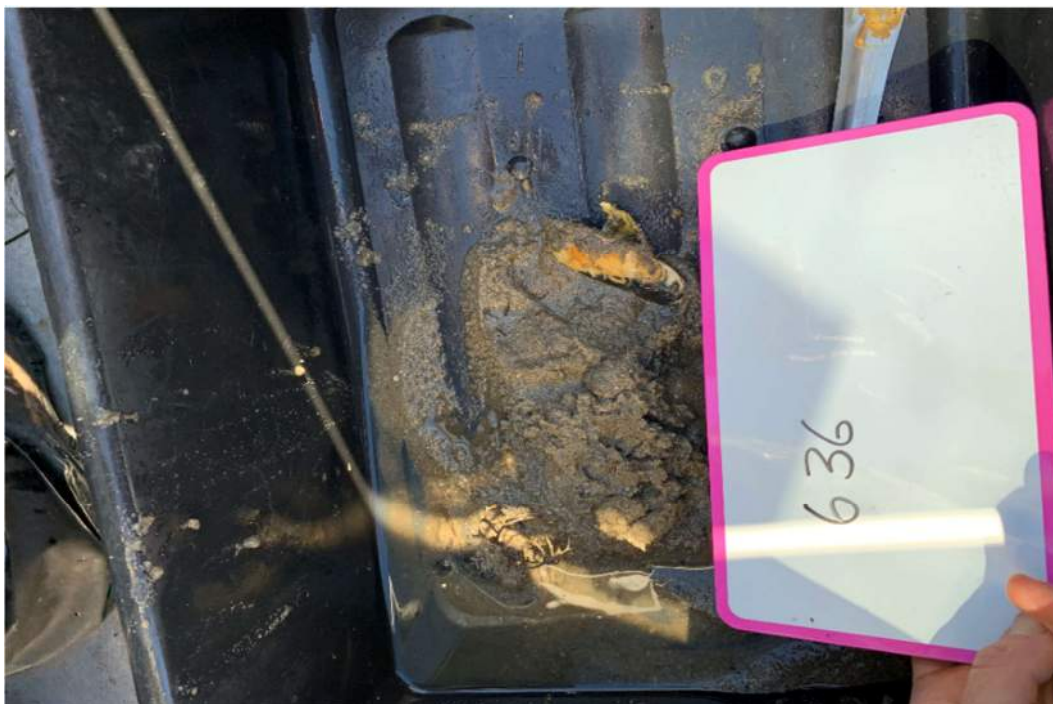
Photo 21: Photo showing sediment sample collected at Holtec Property Landing Station 636.

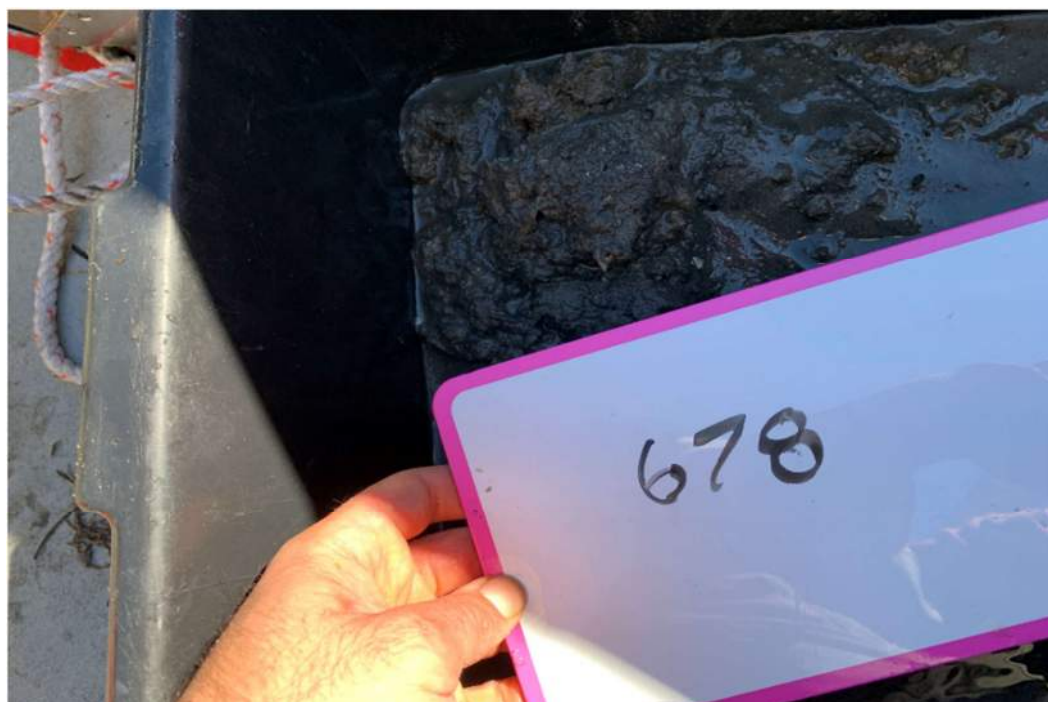
Photo 22: Photo showing sediment sample collected at Holtec Property Landing Station 678.

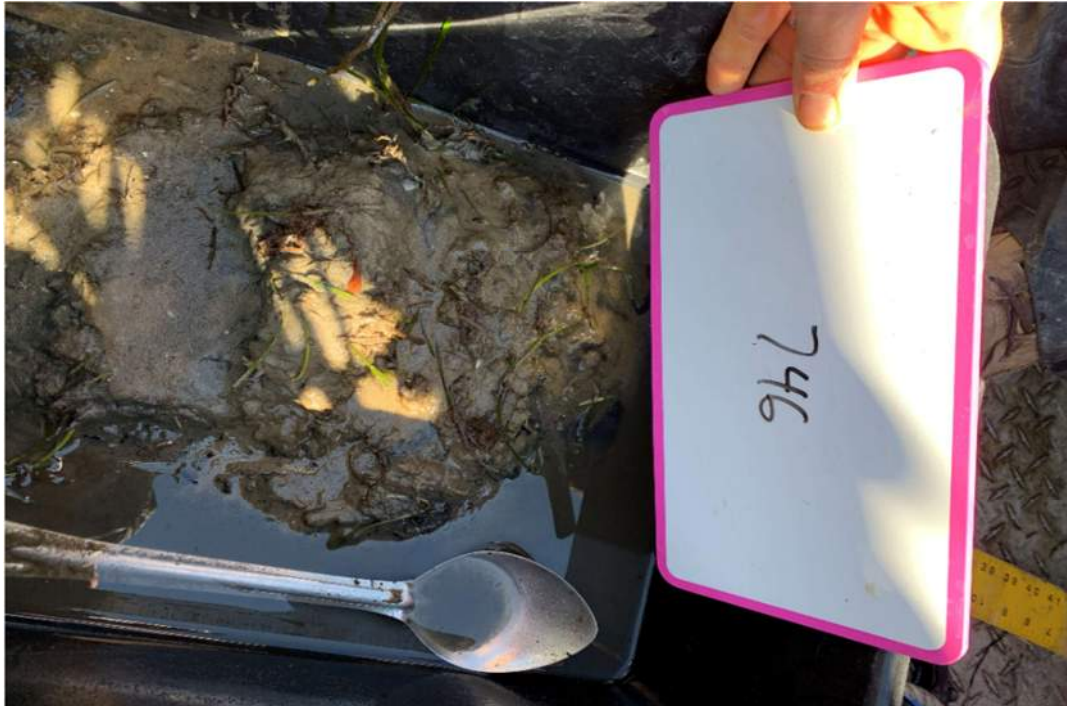
Photo 23: Photo showing sediment sample collected at Lighthouse Drive Landing Station 746.

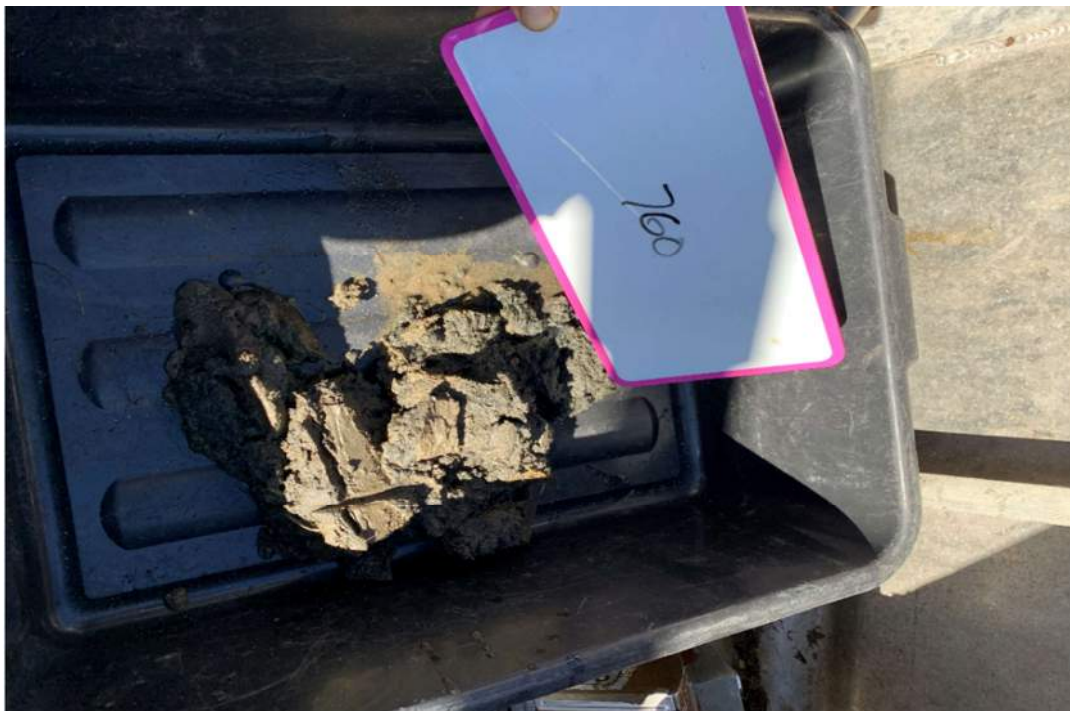
Photo 24: Photo showing sediment sample collected at Lighthouse Drive Landing Station 760.

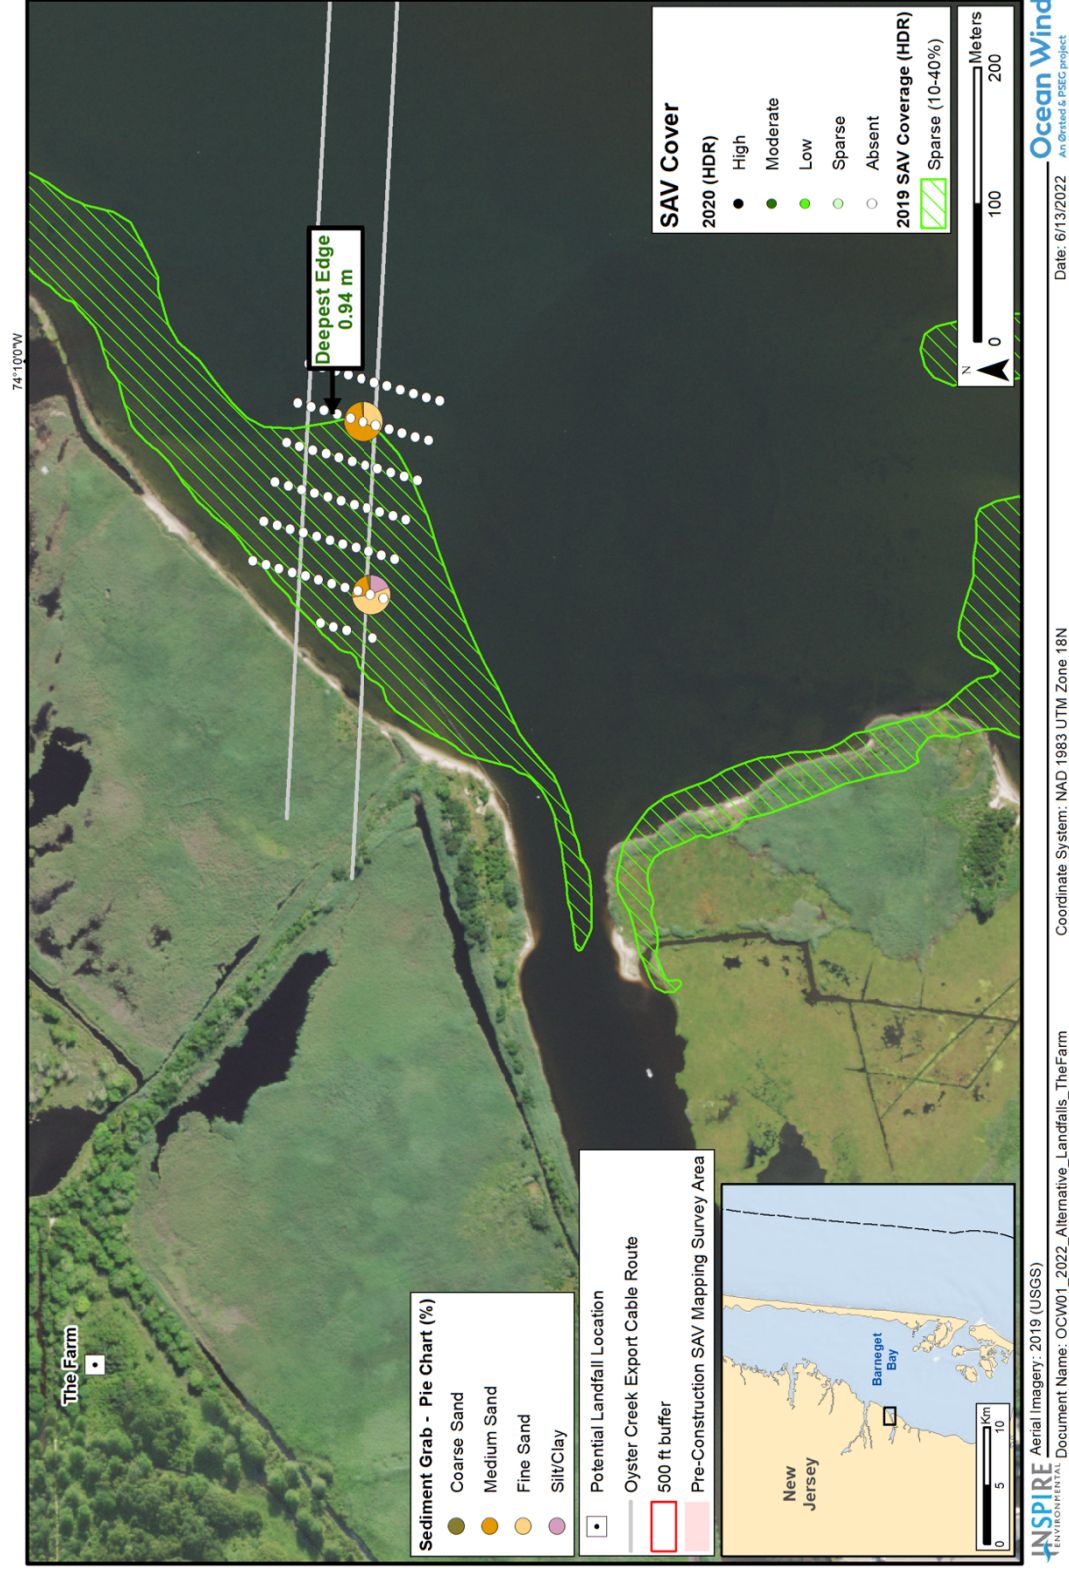
Figure 9. Distribution and estimated percent cover of submerged aquatic vegetation documented in 2019 and 2020 at the Holtec landfall options (also known as the Farm) along the Oyster Creek Inshore Export Cable Route Corridor (Ocean Wind, LLC 2021). Also included are the grain size data collected in 2020.

Patches of historical and/or extant SAV occur along the shoreline of the western bank of Barnegat Bay at the Oyster Creek landfall options (Figures 5, 7, 8 and 9). The drop camera in-water survey in 2020 found the deepest part of the SAV bed near the Bay Parkway Landing option in about 1.6 m (5.2 ft) water depth (Figure 7). At the Lighthouse Drive landing option, the water depth of the deepest edge of the SAV bed ranged from 1.2 to 1.4 m (3.9 to 4.7 ft) (Figure 8). At the Holtec landing option, SAV were observed at one location during the 2020 survey at approximately 1 m (3.2 ft) (Figure 9). Although these data from 2020 are useful, the landfall options in this area have changed since this survey was conducted, so additional pre-construction in-water SAV surveying will be conducted to produce more resolved mapping of the SAV within the project area as described in Section 4.1.
