# **TECHNICAL, MANAGERIAL, AND FINANCIAL CAPACITY EVALUATION**

## **TRENTON WATER WORKS**

H2M Project No.  
NJDP2301

**January 2025**

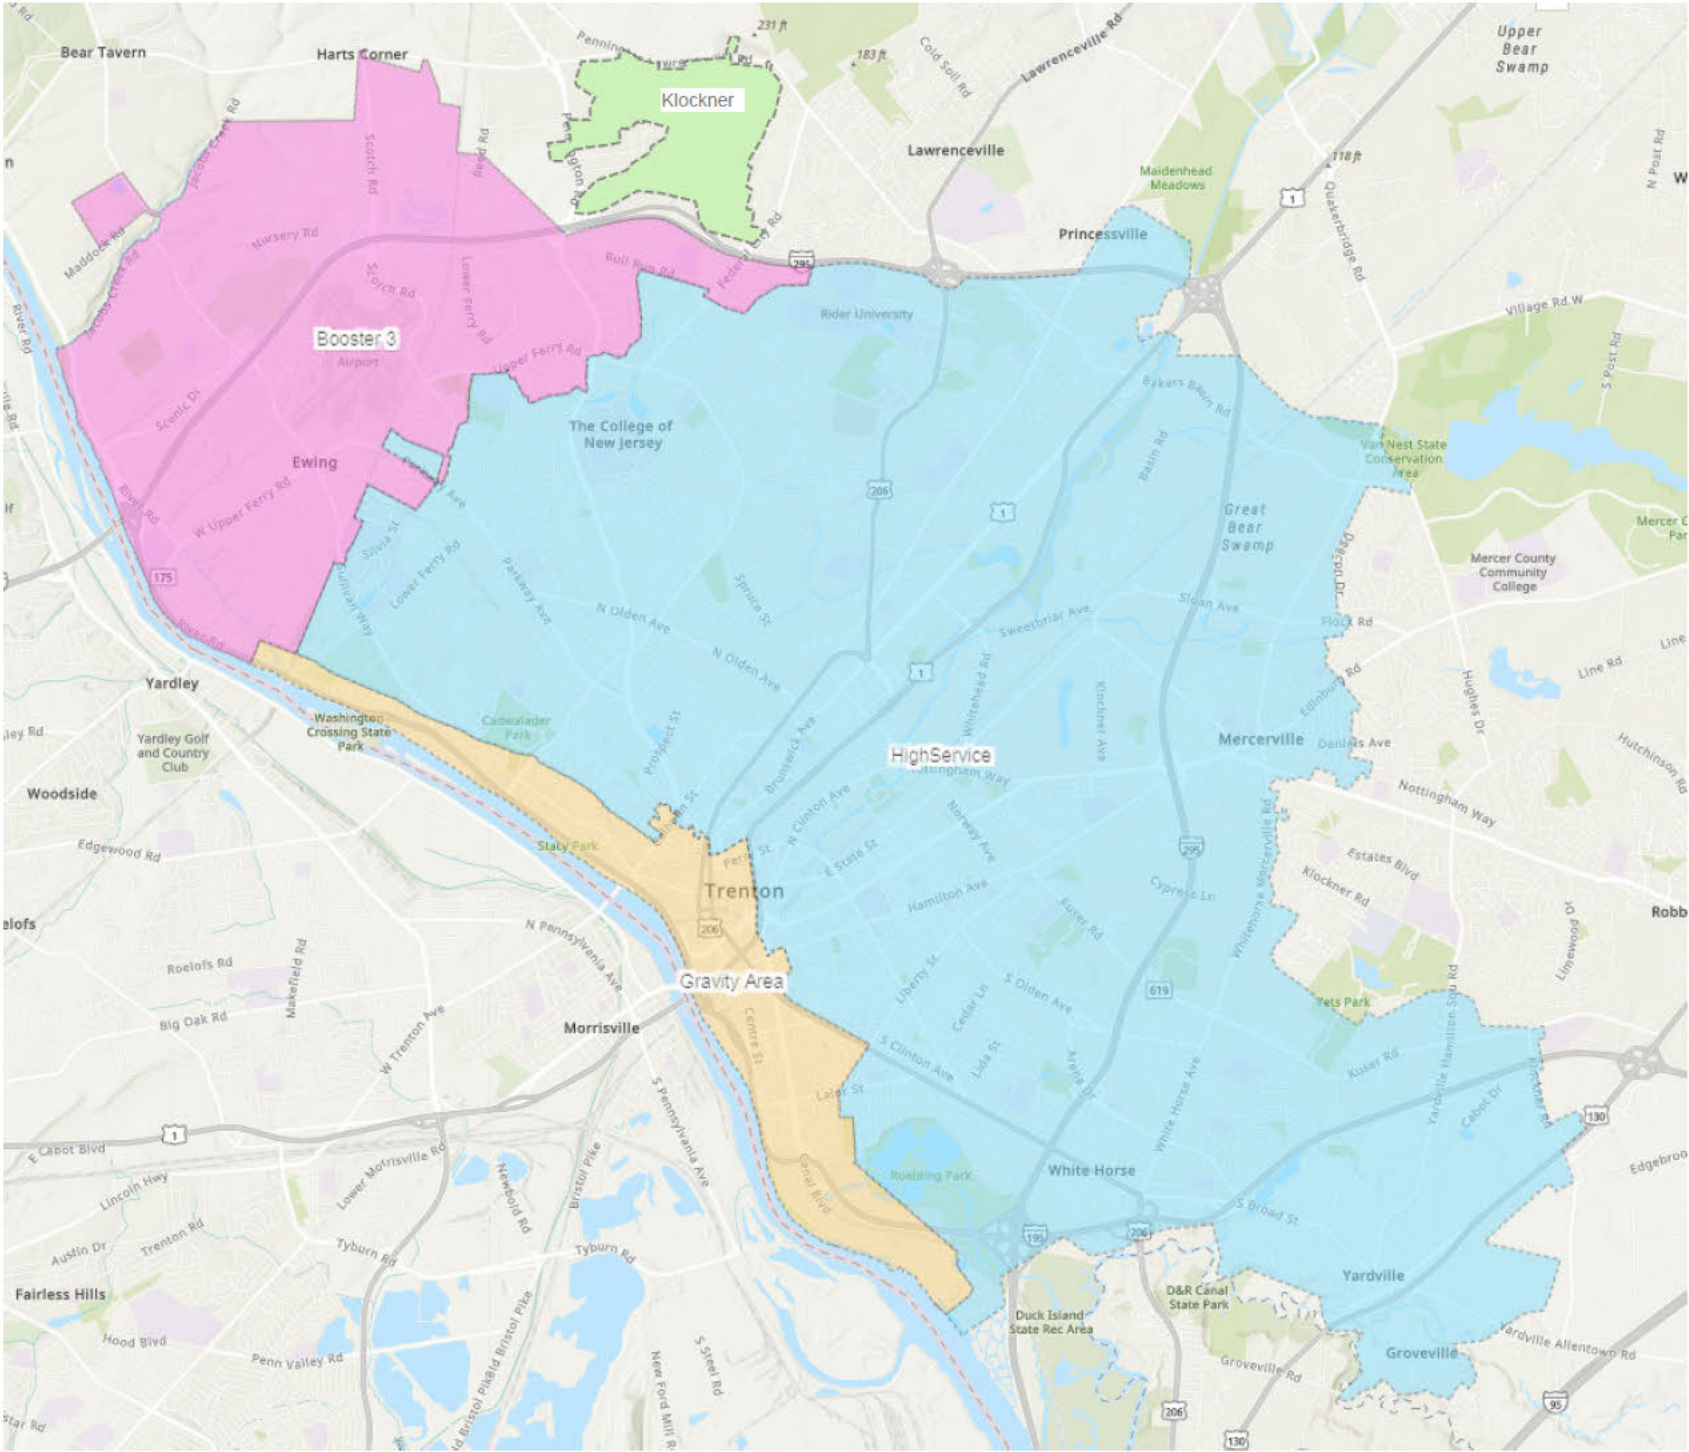
Figure 1-1: Service area of Trenton Water Works, color coded by pressure zone. Source: TWW GIS Database.

1. Gravity Zone – Located along the Delaware River
2. Central Pumping Zone – the majority of the area served by TWW, including most of the City proper, Hamilton Township, Lawrence Township, and portions of Ewing Township
3. Klockner Booster Zone – relatively small region at the north of the TWW service area, also known as the Brandon Farms Area
4. Booster 3 Zone – located on the west side of the TWW service area, includes a portion of Ewing Township and Hopewell Township

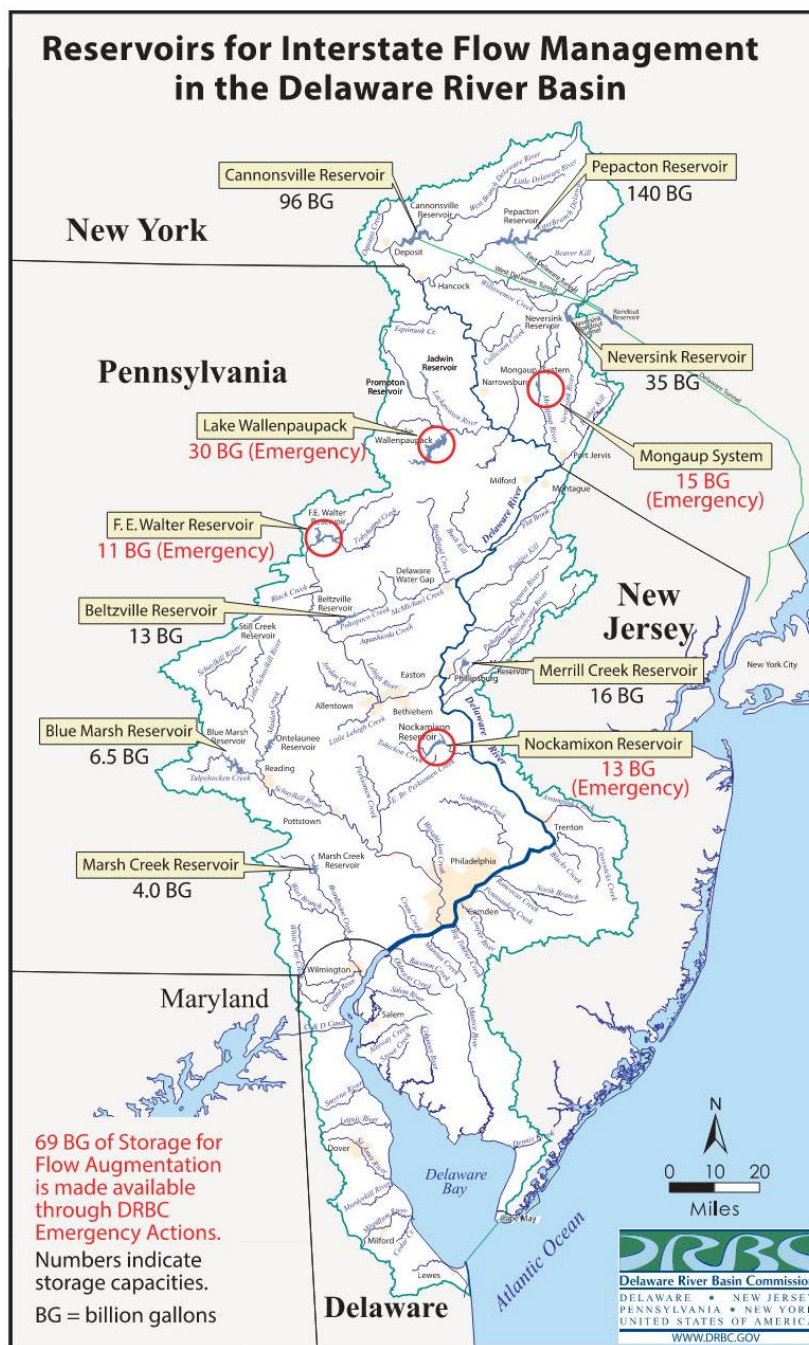
**Figure 3-1: Flow management and emergency reservoirs in the Delaware River Basin**

Along the full route of the Delaware River, there are eleven (11) reservoirs totaling 379.5 billion gallons of storage, sixty-nine (69) of which can be made available through emergency actions taken by the Delaware River Basin Commission (DRBC). A map of these reservoirs is shown in **Figure 3-1**.
