# NEW JERSEY DEPARTMENT OF ENVIRONMENTAL PROTECTION

Water Resource Management  
Division of Water Supply & Geoscience

NJDEP OVERSIGHT REPORT  
TRENTON WATER WORKS  
Period: October 2023

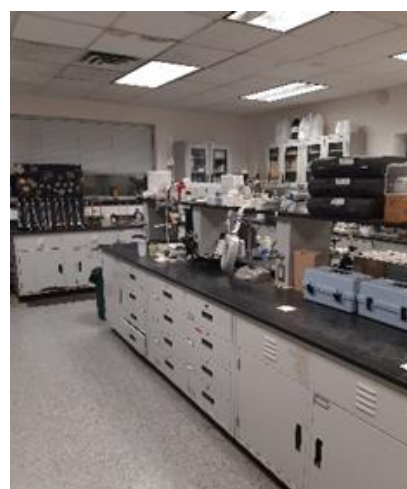
Under the UAO, the TPO's experts are embedded in the system for the purposes of monitoring and assessing system operations and maintenance and making recommendations to bring TWW into full compliance with applicable laws. This included an assessment of laboratory processes and data integrity concerns that the Department had flagged in the September 2022 inspection report. The TPO water quality expert evaluated and made recommendations to the Department regarding TWW's certified laboratory (Figure 1) that included:

Figure 1: TWW's certified laboratory located within the treatment plant.

Following this evaluation, the Department sent correspondence to TWW in October 2023 summarizing necessary actions required by the TWW laboratory to ensure data integrity, improve laboratory efficiency and productivity, and maintain compliance with all rules and regulations. This evaluation is ongoing as improvements are implemented.

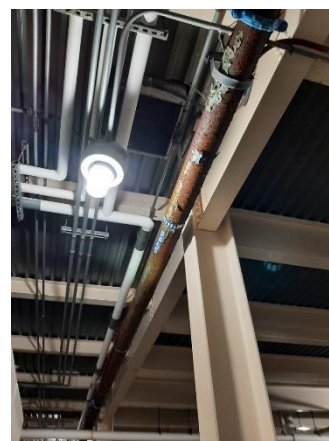
During weekly site visits the TPO and the Department flagged the condition of a 6-inch utility water line, seen in Figure 2. The pipe is highly corroded on the exterior and located in proximity to the electrical room. Based on these observations, the Department required TWW to conduct testing on the pipe's thickness to ensure it is not at risk of failing. Aging infrastructure, especially piping, needs to be addressed and remediated. Following the evaluation by a certified contractor, TWW will be required to take the necessary actions to address the condition of the pipe based on the manufacturer's specifications.

**Figure 2: Severely corroded 6-inch utility water line located within the treatment plant.**
