NEW JERSEY DEPARTMENT OF ENVIRONMENTAL PROTECTION

Water Resource Management
Division of Water Supply & Geoscience

NJDEP OVERSIGHT REPORT
TRENTON WATER WORKS
Period: May 2023

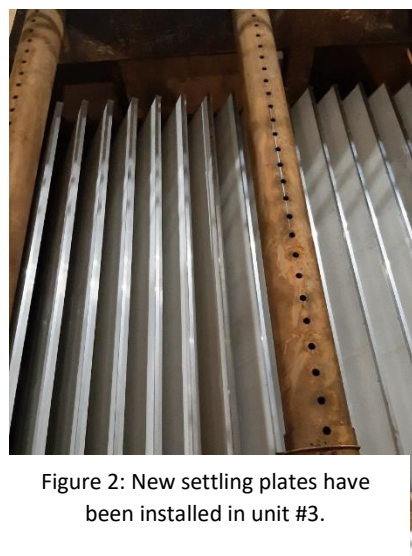
Figure 2: New settling plates have been installed in unit #3.

On February 3, 2023, the Department sent a formal letter to TWW requiring the emergency authorization of funds to be allocated to the rehabilitation of the SuperPulsator units. As mentioned above, these units are critical for the effective operation of the treatment plant to produce finished water that meets the requirements of the Safe Drinking Water Act (SDWA). While TWW is currently operating two units (#1 and #4), the other two units (#2 and #3) are non-operational, and thus there is no fail-safe or back-up unit that TWW can rely on if one of the operational units has a critical failure. Following the emergency authorization for the rehabilitation of the non-operable units, TWW's contractor, Municipal Maintenance, began replacing components of the units. As seen in Figure 2, Units #2 and #3 received new settling plates and these units should be able to be brought online in June 2023, ahead of schedule. When these units are online, units #1 and #4 will be drained, cleaned, and rehabilitated.

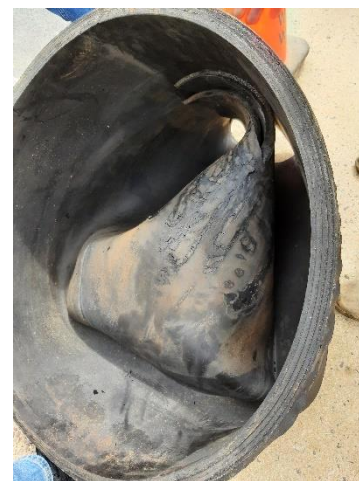
In late April/early May, TWW notified the Department that backflow had occurred into the Reservoir and upon inspection the check valve had failed. The failure resulted in water treated with ZOP entering the reservoir. Fortunately, at that tie temperature and other factors were not conducive to the formation of harmful algal blooms. To mitigate the risk approaching the summer months, TWW suspended the ZOP to the gravity zone on May 9, 2023. The Department is working with TWW to review WQP data and evaluate any impacts to corrosion control in the gravity zone until a solution is finalized. On May 17, 2023, TWW submitted a plan to the Department to address the check valve failure that includes options such as rerouting water through an unused water line or through installing an alternative style of check valve better suited for the prevention of backflow into the reservoir.

FIGURE 3: FAILED DUCKBILL CHECK VALVE
