2013 Chevrolet Cruze 1.8L Eng VIN G LS

**PREMATURE CATALYTIC CONVERTER FAILURES****TECHNICAL SERVICE BULLETIN**

Reference Number(s): PIP5232C, Date of Issue: Mar 4, 2016

Affected Model(s): 2016 and Prior GM Cars and Gasoline-Powered MST Light Duty and HD Trucks

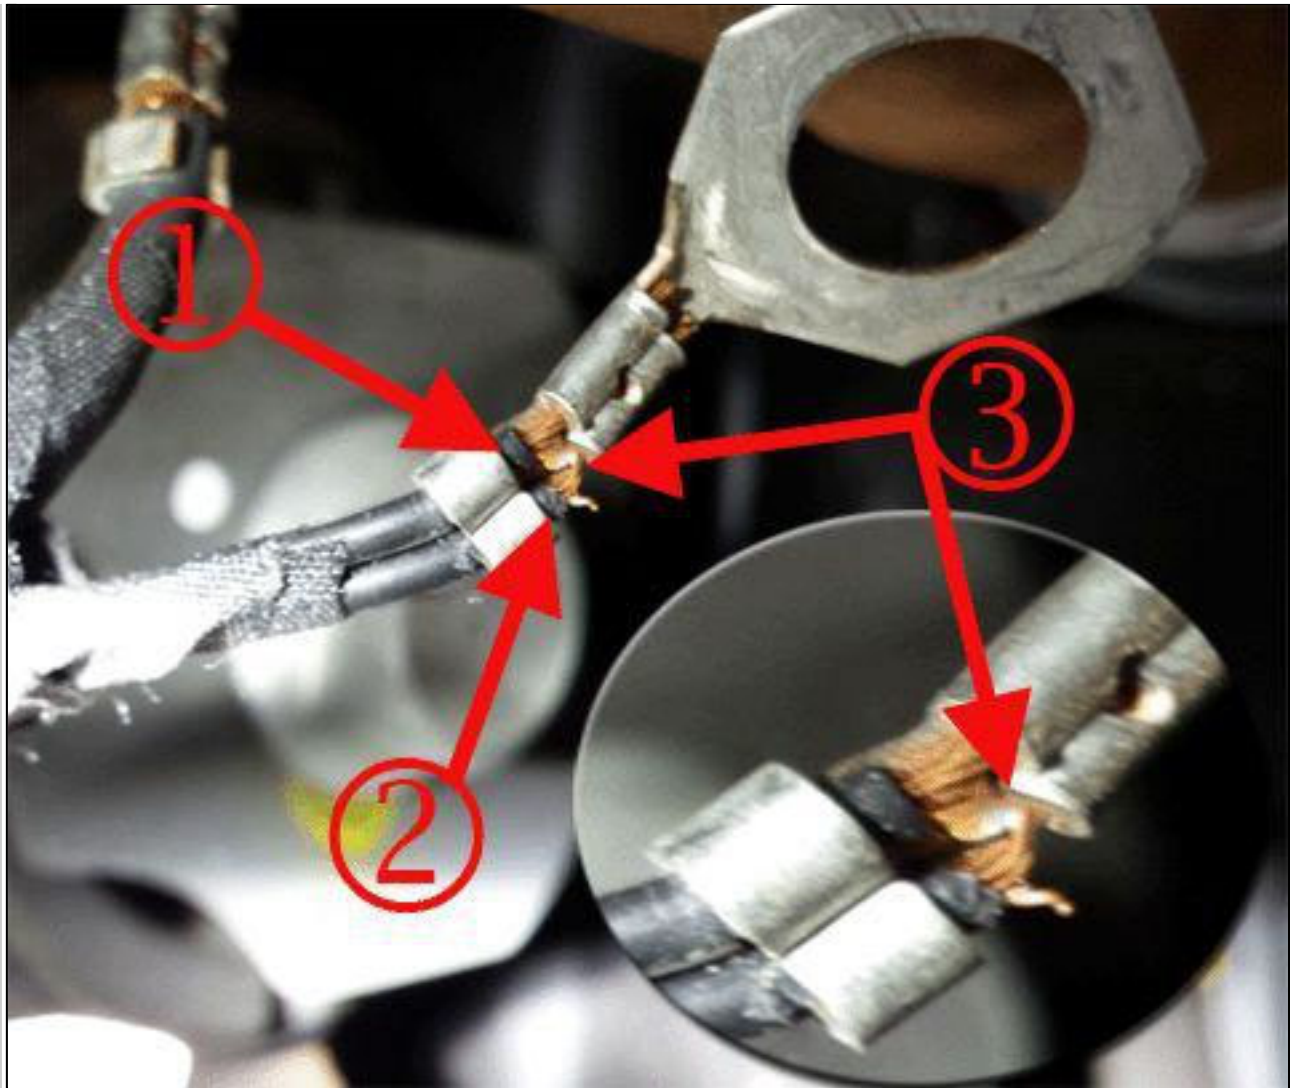
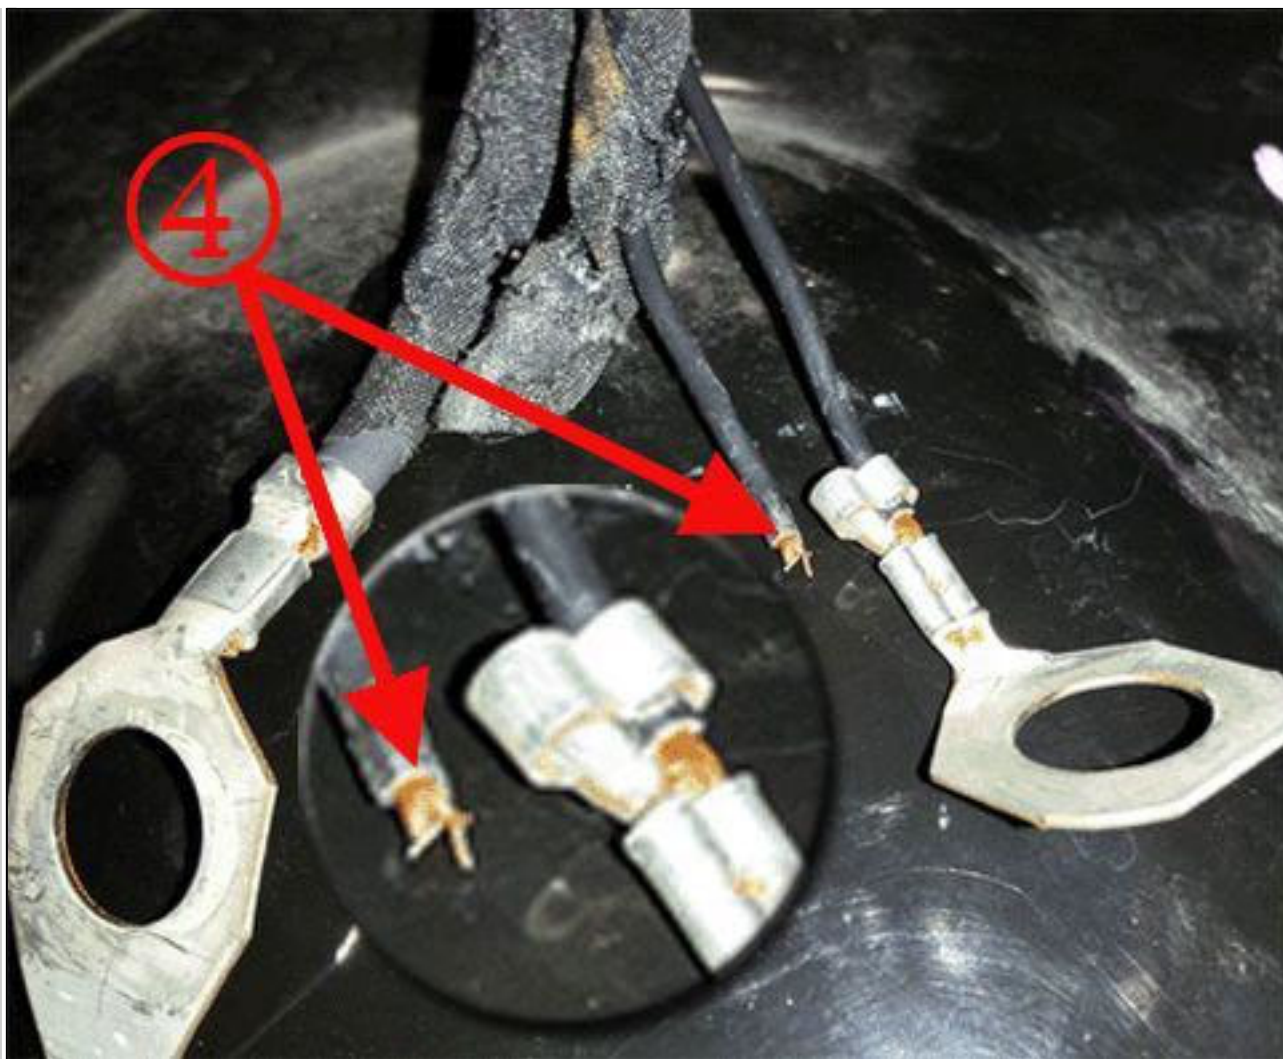
If you believe the catalytic converter has failed with no apparent reason, it is recommended to inspect for a poor crimp for the coil grounds terminal on the engine block for the bank with the concern.

Technicians should inspect the ground for possible corrosion or damage at ground terminal ring, fasteners and grounding surfaces.

If no corrosion or damage is found, tighten the ground bolt to the proper torque
