# NEW JERSEY DEPARTMENT OF ENVIRONMENTAL PROTECTION

NJDEP OVERSIGHT REPORT  
TRENTON WATER WORKS  
Period: July 2023

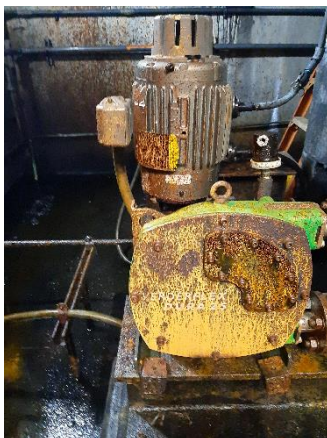
While the June 2023 chemical feed incidents were attributed to the TWW operator's reaction time and responsive actions, an incident regarding the ferric feed pumps in July highlighted the inadequate preventative maintenance program. Not providing required preventative maintenance to pumps, chemical feed lines, or other critical treatment components can cause continuous failures of the asset. In July, a chemical feed line on one of the ferric pumps ruptured (see figure 1

*Figure 1: A ferric pump covered in the chemical following a ruptured feed line.*

below) and caused a reduction in feed rate. This, in turn, impacted the performance of the Superpulsator Clarifier® units (units), resulting in an increase in the amount of solids in the water leaving the units. Inadequate removal of solids can contribute to the formation of disinfection-by-products throughout the TWW distribution system, raise chlorine demand, increased the risk to the public from waterborne pathogens such as *Cryptosporidium*, *Giardia lamblia*, viruses, and *Legionella*.

The June and July 2023 chemical feed incidents shed light on TWW's lack of preventative and ongoing maintenance as well as the need for improved protocols and staff training to respond to such incidents. TWW responded by scheduling training for all maintenance staff with the pump manufacturer to ensure they have the proper knowledge of how to conduct preventive maintenance on these assets. The Department also responded by requiring the TPO's water utility maintenance expert to return to TWW to evaluate operation and maintenance protocols.
